Piper PA-25-260 (Modified), G-TOWS, 25 January 1997

AAIB Bulletin No: 4/97 Ref: EW/G97/01/19 Category: 1.3

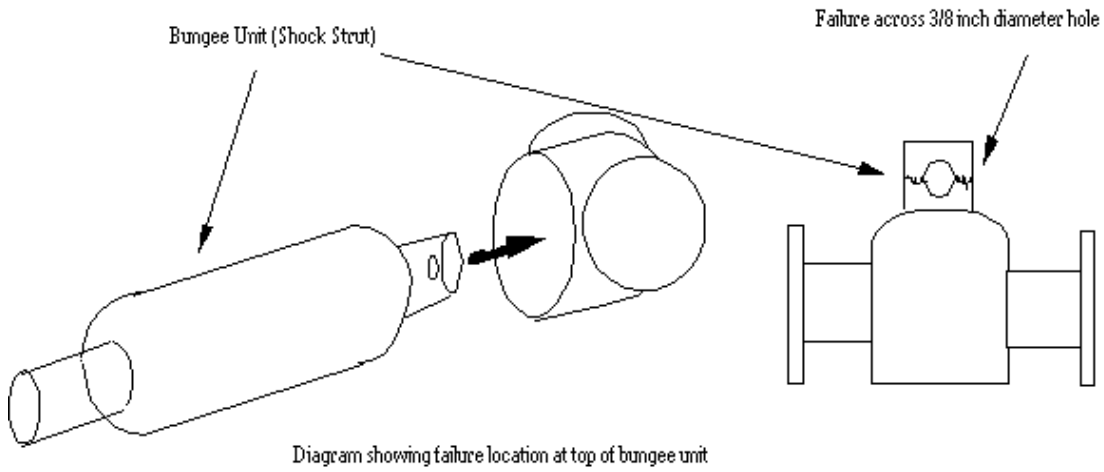
A failure had occurred to a suspension unit in which an old crack had grown through approximately 80% of the metal before the final 20% had failed in overload. Further investigation revealed that the right suspension unit was in a similar condition. The engineering organisation had observed wear at

the upper shock strut attachment, had ordered the replacement parts and had deferred the defect. The point of failure was hidden from view unless the assembly was dismantled.
