No: 11/88

Ref: EW/C1071

Gemini Flash Microlight, G-MMUF

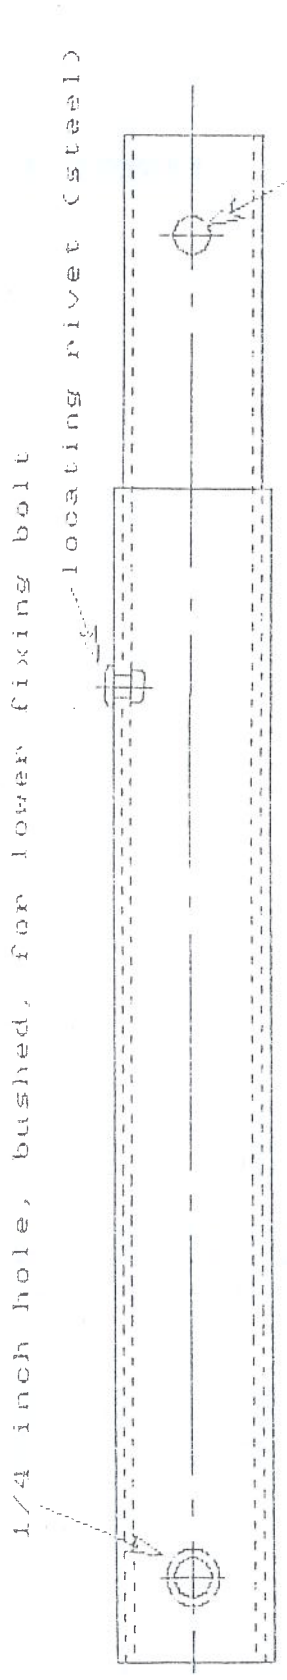
The front strut bottom section was constructed from two aluminium tubes (see diagrams 1 and 2). The bottom end of the inner tube had been cut short with a pipe cutter, leaving tensile loads in the strut to be taken only by the aluminium pop rivet shown in the diagrams. This rivet is intended for location only and does not carry any flight loads when the strut is constructed correctly. Compressive loads in the strut were transmitted directly into the centre section by the ends of the outer tubes butting together, so relieving the rivet. Diagram 1 shows the correct arrangement of the front strut bottom section with the inner tube taking tensile loads between the rigging pin and the bottom attachment bolt. It could not be established with certainty when the front strut was modified from the design standard.

Diagram 1
 Gemini front strut bottom section correct to drawing

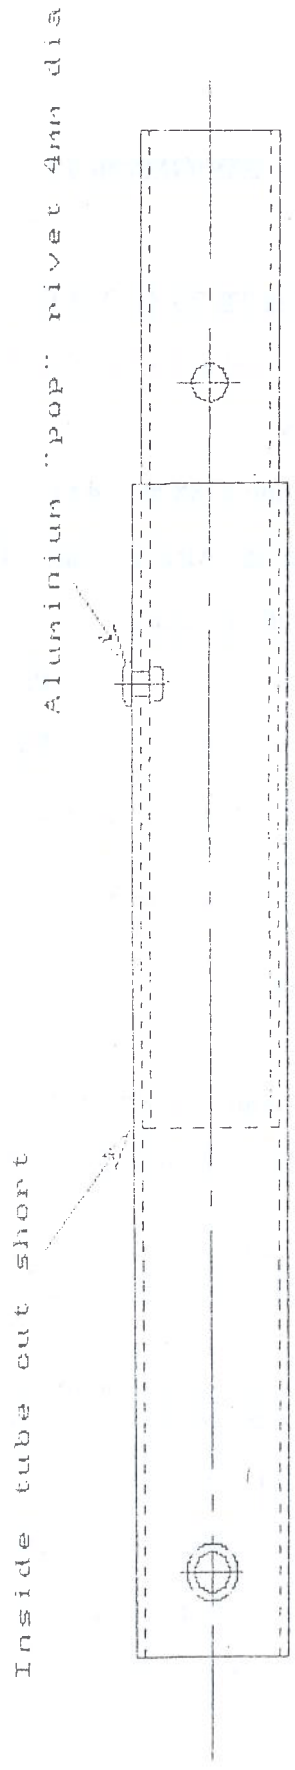
In an effort to understand the loads applied to the front strut more fully, the AAIB carried out some test flying with another Gemini-Flash microlight fitted with strain gauges. This work indicated that with reasonably careful flying and ground handling the rivet could have survived a number of flights. Of the nine take-offs, circuits and landings for which data was recorded, only one touch-down generated tensile loads large enough to fail the rivet. The results confirmed that the front strut carries significant loads in normal operation and is an important structural member.

Diagram 2
 Front strut from G-MHUE

The AAIB has written to the BMAA to recommend that they reinforce their requirement that any structural modifications or repairs should be inspected by a BMAA approved inspector before further flight.
