INCIDENT

Aircraft Type and Registration:	Boeing 737-8AS, EI-DAP	
No & Type of Engines:	2 CFM 56-7B24 turbofan engines	
Year of Manufacture:	2003	
Date & Time (UTC):	26 November 2005 at 1020 hrs	
Location:	Stand 4 at Glasgow Prestwick Airport	
Type of Flight:	Public Transport (Passenger)	
Persons on Board:	Crew - 6	Passengers - 181
Injuries:	Crew - None	Passengers - None
Nature of Damage:	Minor dent in aircraft fuselage and broken radar antenna	
Commander's Licence:	Airline Transport Pilot's Licence	
Commander's Age:	39 years	
Commander's Flying Experience:	10,200 hours (of which 5,000 were on type) Last 90 days - 282 hours Last 28 days - 92 hours	
Information Source:	Report submitted by Airfield Operations Manager and Aircraft Accident Report Form submitted by the pilot

Synopsis

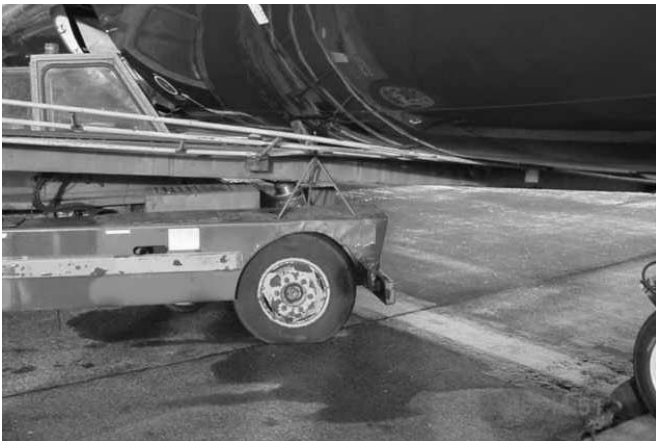
Figure 1

manoeuvred towards the front hold. As the vehicle approached the aircraft the driver put his foot on the brake, however the pedal went all the way to the floor without slowing the vehicle. The driver tried, but failed, to grasp the hand brake and he reacted by steering the vehicle to the right to avoid the open cargo hold. The conveyer belt, which overhangs the front of the vehicle, struck the aircraft bringing the vehicle to a stop (see Figure 1).

Photograph taken shortly after the collision showing the baggage belt vehicle and the aircraft fuselage

It was possible to push the pedal through the full length of travel without resistance. The hydraulic pipe leading to the brake cylinder on the front offside wheel was found fractured which had caused immediate loss of brake fluid pressure and it was concluded that the driver would have had no prior warning of the failure. The independent inspection did not attempt to determine why the pipe had fractured.

The front section of the parking brake cable, which had been replaced in June 2005, was found to be seized. There was therefore no parking or emergency braking available, a defect that would have been noticeable, for example during a daily check. The parking brake system downstream of the seized cable was found to operate satisfactorily.

The incident was caused by a failure in the hydraulic pipe for the brakes. The vehicle had been serviced twice in the 14 months prior to the incident and on two occasions (12 and 14 months prior to the incident) parts of the brake pipe system had been replaced. However, the vehicle became unsafe within six months of its last service. The impending brake pipe failure and the defective parking brake might have been detected had a daily check, or a quarterly service, together with an effective defect reporting system been used.

- a) A full review of: the ground vehicle fleet; the defect reporting system; the maintenance reporting process; the content and the frequency of the servicing schedule and the manning levels in the Motor Transport department.
- b) A review of a range of activities to improve the awareness of prompt and effective use of emergency procedures. This includes the immediate reporting by ground handlers to the aircraft captain of any ground incident.

It is recommended that the Civil Aviation Authority should remind airport operators that their Safety Management Systems should ensure that safe standards of maintenance and use are applied to all vehicles and mobile ground equipment used in the proximity of aircraft.
