ACCIDENT

Aircraft Type and Registration:	Boeing 757-225, TF-ARD	
No & Type of Engines:	2 Rolls Royce RB211-535E4 turbofan engines	
Year of Manufacture:	1985	
Date & Time (UTC):	20 August 2005 at 1210 hrs	
Location:	Palma, Majorca	
Type of Flight:	Public Transport (Passenger)	
Persons on Board:	Crew - 9	Passengers - 229
Injuries:	Crew - None	Passengers - None
Nature of Damage:	Damage to the radome, landing lights and co-pilot's windscreen	
Commander's Licence:	Airline Transport Pilot's Licence	
Commander's Age:	43 years	
Commander's Flying Experience:	8,000 hours (of which 4,000 were on type) Last 90 days - 130 hours Last 28 days - 60 hours	
Information Source:	AAIB Field Investigation

Synopsis

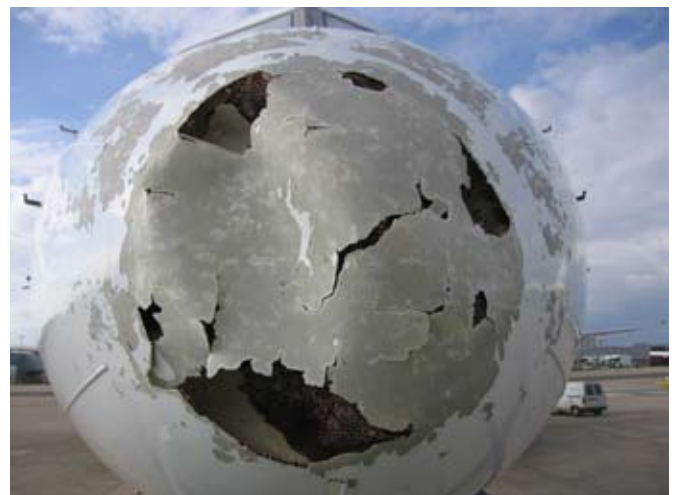
Inspection of the aircraft confirmed that the outer layer of the co-pilot's windscreen had been cracked, both of the wing root landing light lenses had been shattered and that the radome had been severely damaged, with several large areas of material missing from its most forward region, Figure 1. Due to the length of flight, it could not be determined if the tears in the radome had been caused directly as a result of the hail encounter, or as a result of the aerodynamic loads imposed as the aircraft continued to Gatwick.

The radome is a fibreglass honeycomb structure, comprised of inner and outer skins, bonded to a honeycomb material between the skins, which provides structural rigidity. The outer skin had disbonded from the honeycomb layer over a circular area of some 60 cm radius, and aerodynamic loads had caused it to be deformed inward, which had prevented movement of the weather radar antennae. The antennae itself appeared to have been undamaged. The antennae hinges, latches and fuselage location points were undamaged and the radome itself remained securely located.

Figure 1
Damage to radome

The radome, landing lights, passenger windows and the co-pilot's windscreen were replaced and the aircraft returned to service.
