Ref: EW/G89/09/05

**Aircraft Type and Registration:** Piper PA-34-200-2, G-BASM

**Location:** Southend Airport

**Nature of Damage:** Damage to nose cone and nose landing gear doors

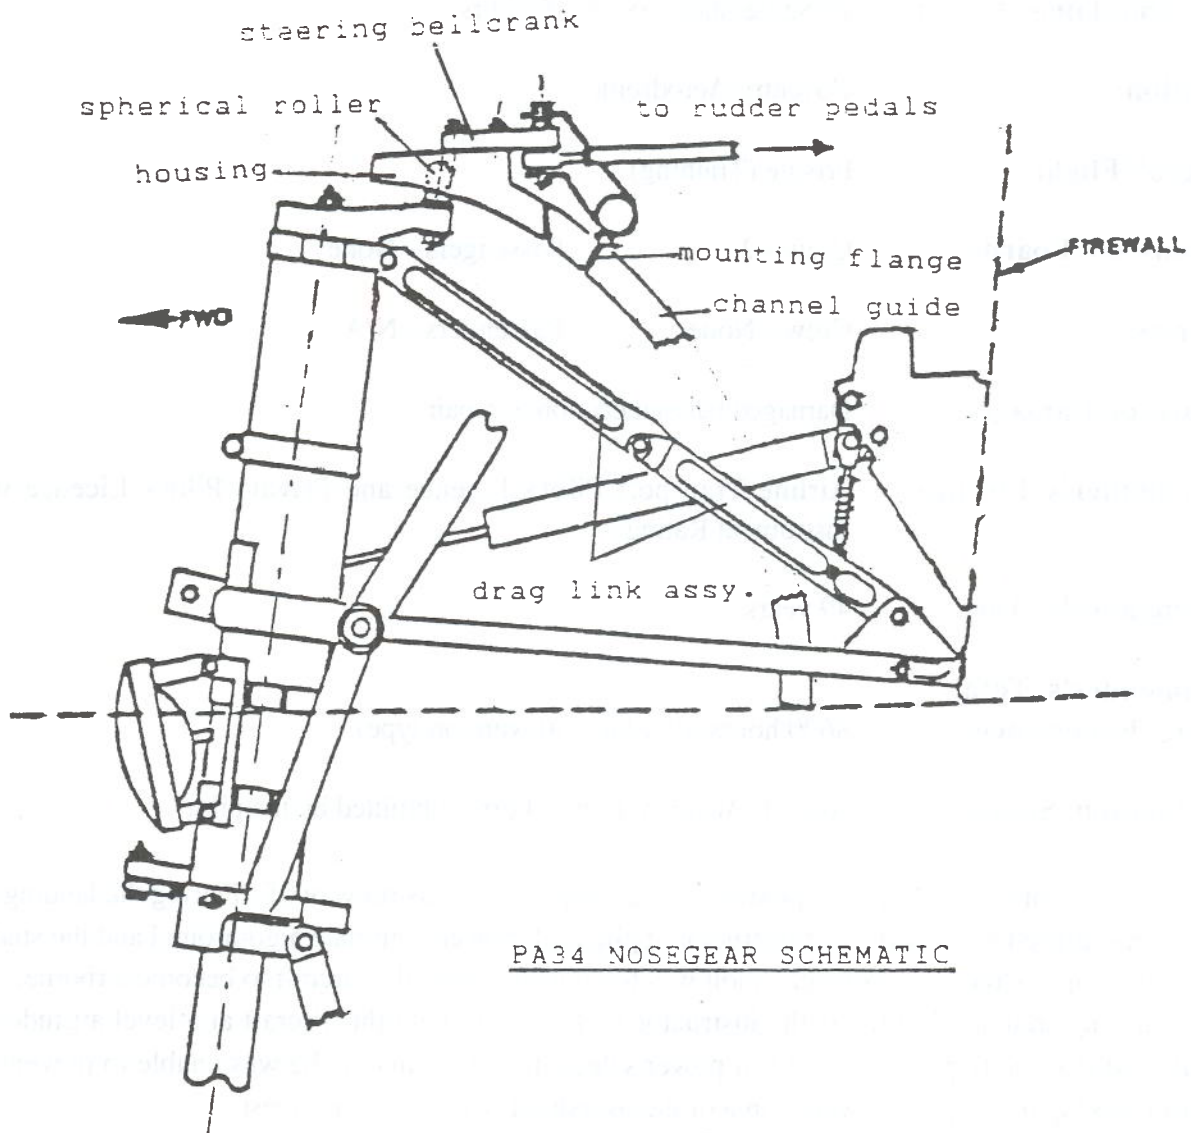
PA34 NOSEGEAR SCHEMATIC

Subsequent examination of the nose landing gear revealed that the spherical roller on the steering arm had not been running within the channel guide during the previous retraction cycle (see attached diagram). Nosewheel steering on this aircraft is effected by means of a housing, attached to the steering bellcrank, operating on the spherical roller. The housing (Piper Part No 95394-00) is fabricated from mild steel and its rear aperture is approximately the same section as, and positioned adjacent to, the top of the channel guide. Thus when the gear is retracted with deflected rudder (and hence nosewheel) the roller is fed into the channel guide in order to align the noseleg. It was apparent in this case that one of the welds had cracked allowing the sides of the housing to open out under the lateral pressures of the roller. The situation had eventually arisen where the rear of the housing had opened up sufficiently to allow the roller to miss the entrance to the channel, and to run instead along its right hand side. A

mounting flange, which attached the channel guide to a cross member, had clearly impeded the roller during the last retraction, and it was this that had caused the roller to jam at the next extension. This would have resulted in the nose leg remaining some 20° short of its locked down position, at which point the drag link assembly would not have over-centred.

It was evident that the crack in the housing had been present for some time. It is considered likely that it had resulted from a combination of heavy rudder pedal action (with the aircraft on the ground), nosewheel "shimmy", castoring forces and operation on rough ground.
