Aircraft Type and Registration:	Aero Vodochody L-39ZO Albatros, G-OTAF	
No & Type of Engines:	1 Ivchenko AI-25TL turbofan engine	
Year of Manufacture:	1982	
Date & Time (UTC):	2 August 2003 at 1421 hrs	
Location:	Field three miles south of Duxford Airfield, Cambridgeshire	
Type of Flight:	Private	
Persons on Board:	Crew - 1	Passengers - None
Injuries:	Crew - None	Passengers - N/A
Nature of Damage:	Nose gear collapsed, minor damage to wings and nose	
Commander's Licence:	Private Pilot's Licence	
Commander's Age:	59 years	
Commander's Flying Experience:	1,574 hours (of which 50 were on type) Last 90 days - 8 hours Last 28 days - 6 hours	
Information Source:	Aircraft Accident Report Form submitted by the pilot plus post-accident engine testing and further enquiries

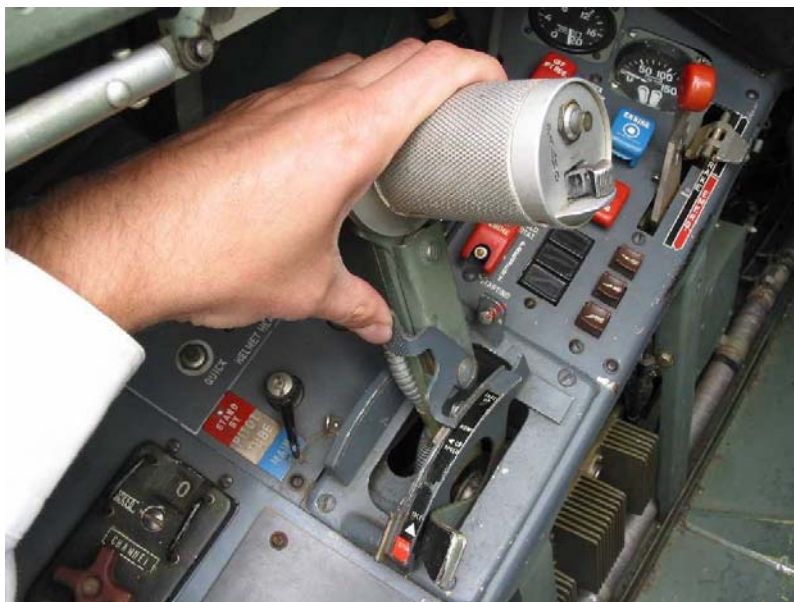
Throttle lever examination

The throttle lever has a thumb actuated latch that when depressed permits the lever to move aft of the IDLE stop and into the fuel shutoff region. Inadvertent application of this latch while slamming the lever back to IDLE could result in an inadvertent engine shutdown. However, normal positioning of a hand around the throttle grip with one's thumb close to the airbrake switch on the side would make it

extremely difficult to accidentally depress the latch. Multiple hard throttle slams were performed to check that the IDLE stop gate had not worn down and on no occasion did the throttle move aft of the IDLE stop. It is conceivable that a pilot might deliberately, albeit subconsciously, depress the latch while reducing the throttle to IDLE and thereby inadvertently shut the engine down. The German Air Force

had two incidents whereby a low-time student pilot inadvertently shut down the engine in this manner. The aircraft manufacturer provides an optional modification that requires the throttle to be retarded to IDLE before the latch becomes effective.

An inadvertent engine shutdown by the pilot was considered but the throttle lever latch operated normally, the IDLE stop gate was intact, and accidental operation of the latch appeared to be very difficult. It is possible that the pilot subconsciously depressed the latch during the throttle slam, but his subsequent reapplication of throttle would have resulted in unburned fuel being exhausted from the engine. However, the video footage of the aircraft's final moments did not show a fuel vapour trail and so this explanation seems unlikely.
