ACCIDENT

Aircraft Type and Registration:	AS355F1, G-XCEL
No & Type of Engines:	2 Rolls-Royce (Allison) 250-C20F turboshaft engines
Year of Manufacture:	1985
Date & Time (UTC):	2 December 2003 at 1438 hrs
Location:	Hurstbourne Tarrant, near Andover, Hampshire
Type of Flight:	Private
Persons on Board:	Crew - 1 Passengers - 2
Injuries:	Crew - 1 (Fatal) Passengers - 2 (Fatal)
Nature of Damage:	Helicopter destroyed
Commander's Licence:	Airline Transport Pilot's Licence
Commander's Age:	51 years
Commander's Flying Experience:	7,800 hours (of which 1,322 were on type) Last 90 days - 81 hours Last 28 days - 18 hours
Information Source:	AAIB Field Investigation

Synopsis

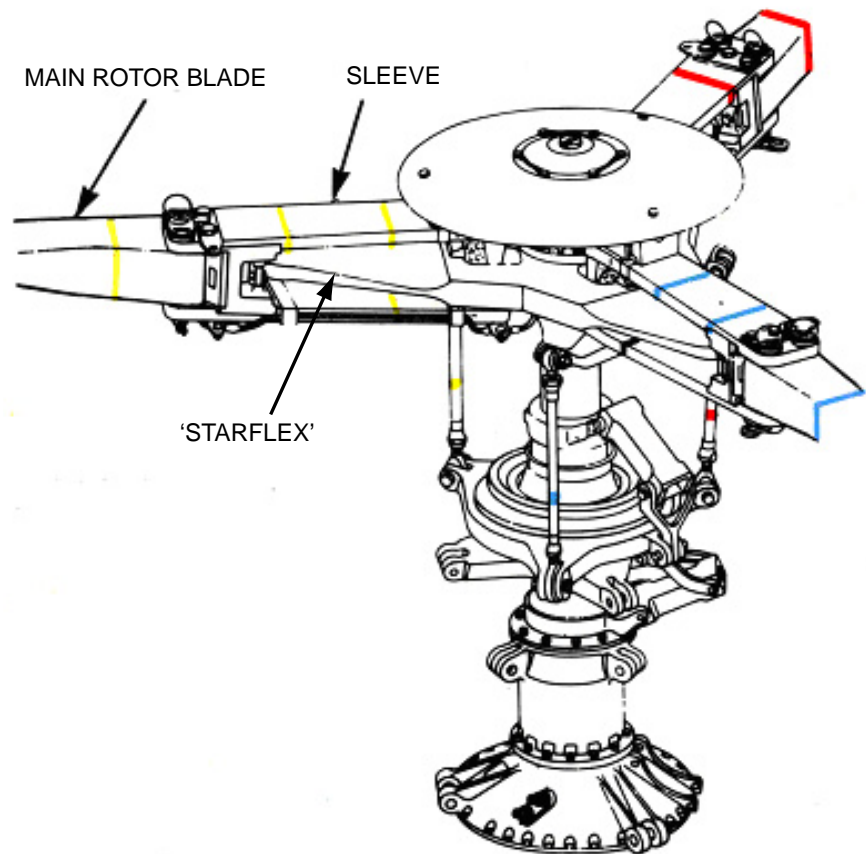
Figure 3
AS355 main rotor head

main rotor. These were found, in an unburnt condition, 20 m south-west of the fuselage. All three rotor blades were attached to the hub, although the blade sleeves had become delaminated. None bore evidence of significant leading edge damage indicating very little or no rotation at impact with the trees and ground. It was clear that the MRGB had detached shortly before the fuselage hit the ground due to failure of the four support struts. Both the fuselage and MRGB appeared to have cut vertical paths through the trees indicating little, if any, forward speed. The outboard, flexible, parts of two of the 'Starfex' arms were missing from the main rotor, whilst the third, although present, had also fractured.

The broken 'Starfex' was also examined. Eurocopter advised that the fracture faces, which ran roughly at 45° to the axis of the arm across half the section and at 90° across the other half, were indicative of a mixture of torque and vertical bending being involved in their failure. No further explanation of the reason for failure could be offered at that stage.

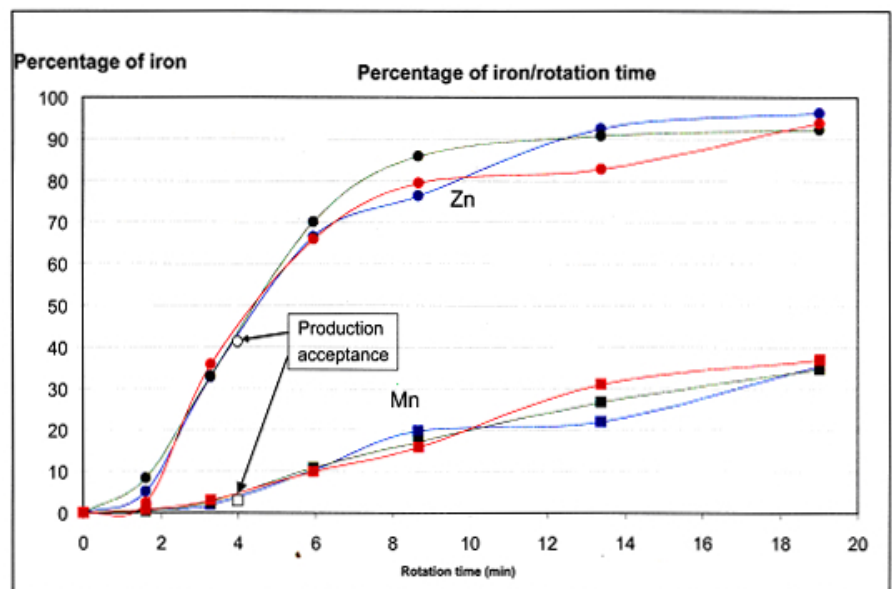
Figure 5

Accomplishing this many times enabled a graph to be produced showing how the ratio of the surface coating to the amount of base metal (Iron) on each type of roller varied with a number of typical duty cycles, translated into time for which the freewheels had rotated. This graph is reproduced in Figure 5. From this it can be seen that the zinc phosphate coating wears away very rapidly, reaching a figure of 35% visible iron after about 3 minutes of rotation time. The manganese phosphate coating wears much more slowly, reaching the same ratio after about 19 minutes.

It is Eurocopter's considered view that this figure of about 35% of base metal visible, *for either type*, is critical; above that figure, slippage under load is unlikely whilst below that figure it is possible. This percentage was reached after about 3.5 minutes of rotation time for the zinc-phosphated rollers but the manganese-phosphated rollers did not reach the 'critical percentage' until about 19 minutes. They also related these figures to the known history of slippage events, for which the precise operating times and sequences were recorded since the majority took place under their own flight test operations. This comparison enabled a chart to be plotted, relating slippage occurrences to time of freewheel operation since new. From this it was determined that the slippage events all took place within the range of about 100-700 seconds of freewheel rotation time once fitted in the helicopter.

Graph of results from rollers with Manganese and Zinc Phosphate coatings showing percentage of base metal (Iron) visible on the surface plotted against freewheel rotation time

Eurocopter factory. This was found to equate to four minutes of freewheel rotation time, at which time the percentage of Iron visible on the zinc-phosphated roller surface was measured to be about 40%; only some 4% was visible on manganese-phosphated items. From this it was concluded that, when the bench running time is added to the normal post-installation ground running before fight torques are applied, the surface iron/zinc phosphate ratio is comfortably above 35% and slippage will not occur. With manganese phosphate, however, slippage under load is possible for another 10 minutes or so of freewheel rotation time. Eurocopter calculations showed that this equated to about 3 hours of helicopter operation and that, after applying a safety factor of roughly 3, manganese-phosphated rollers, which had run for more than 10 fight hours, could remain in service.
