**ACCIDENT**

| <b>Aircraft Type and Registration:</b> | AS355F1, G-XCEL | |
| <b>Location:</b> | Hurstbourne Tarrant, near Andover, Hampshire | |

**Synopsis**

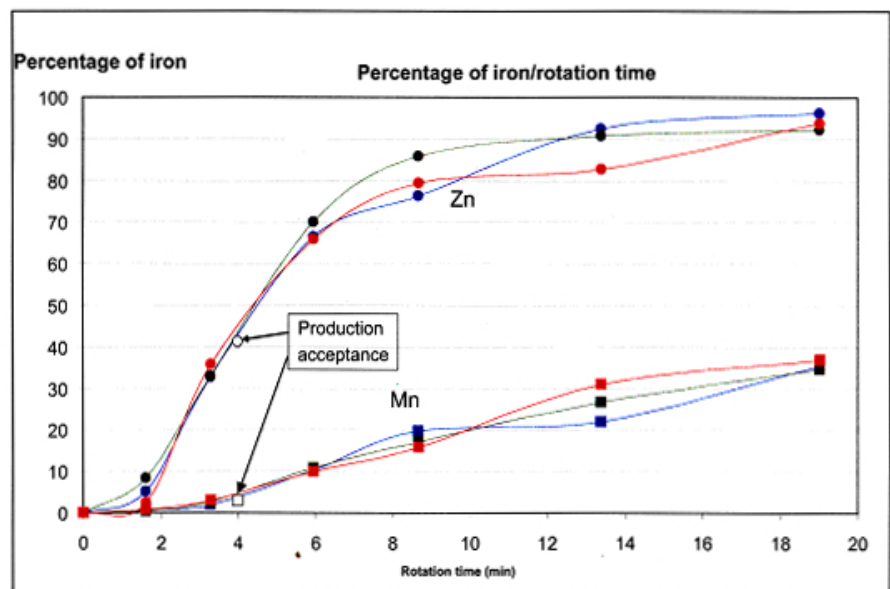
**Figure 5**

Accomplishing this many times enabled a graph to be produced showing how the ratio of the surface coating to the amount of base metal (Iron) on each type of roller varied with a number of typical duty cycles, translated into time for which the freewheels had rotated. This graph is reproduced in Figure 5. From this it can be seen that the zinc phosphate coating wears away very rapidly, reaching a figure of 35% visible iron after about 3 minutes of rotation time. The manganese phosphate coating wears much more slowly, reaching the same ratio after about 19 minutes.

It is Eurocopter's considered view that this figure of about 35% of base metal visible, *for either type*, is critical; above that figure, slippage under load is unlikely whilst below that figure it is possible. This percentage was reached after about 3.5 minutes of rotation time for the zinc-phosphated rollers but the manganese-phosphated rollers did not reach the 'critical percentage' until about 19 minutes. They also related these figures to the known history of slippage events, for which the precise operating times and sequences were recorded since the majority took place under their own flight test operations. This comparison enabled a chart to be plotted, relating slippage occurrences to time of freewheel operation since new. From this it was determined that the slippage events all took place within the range of about 100-700 seconds of freewheel rotation time once fitted in the helicopter.

Graph of results from rollers with Manganese and Zinc Phosphate coatings showing percentage of base metal (Iron) visible on the surface plotted against freewheel rotation time

Eurocopter factory. This was found to equate to four minutes of freewheel rotation time, at which time the percentage of Iron visible on the zinc-phosphated roller surface was measured to be about 40%; only some 4% was visible on manganese-phosphated items. From this it was concluded that, when the bench running time is added to the normal post-installation ground running before flight torques are applied, the surface iron/zinc phosphate ratio is comfortably above 35% and slippage will not occur. With manganese phosphate, however, slippage under load is possible for another 10 minutes or so of freewheel rotation time. Eurocopter calculations showed that this equated to about 3 hours of helicopter operation and that, after applying a safety factor of roughly 3, manganese-phosphated rollers, which had run for more than 10 flight hours, could remain in service.
