No: 5/89

Ref: EW/G88/12/04

Piper PA28-161 Warrior, G-BPBM

11 December 1988 at 1400 hours

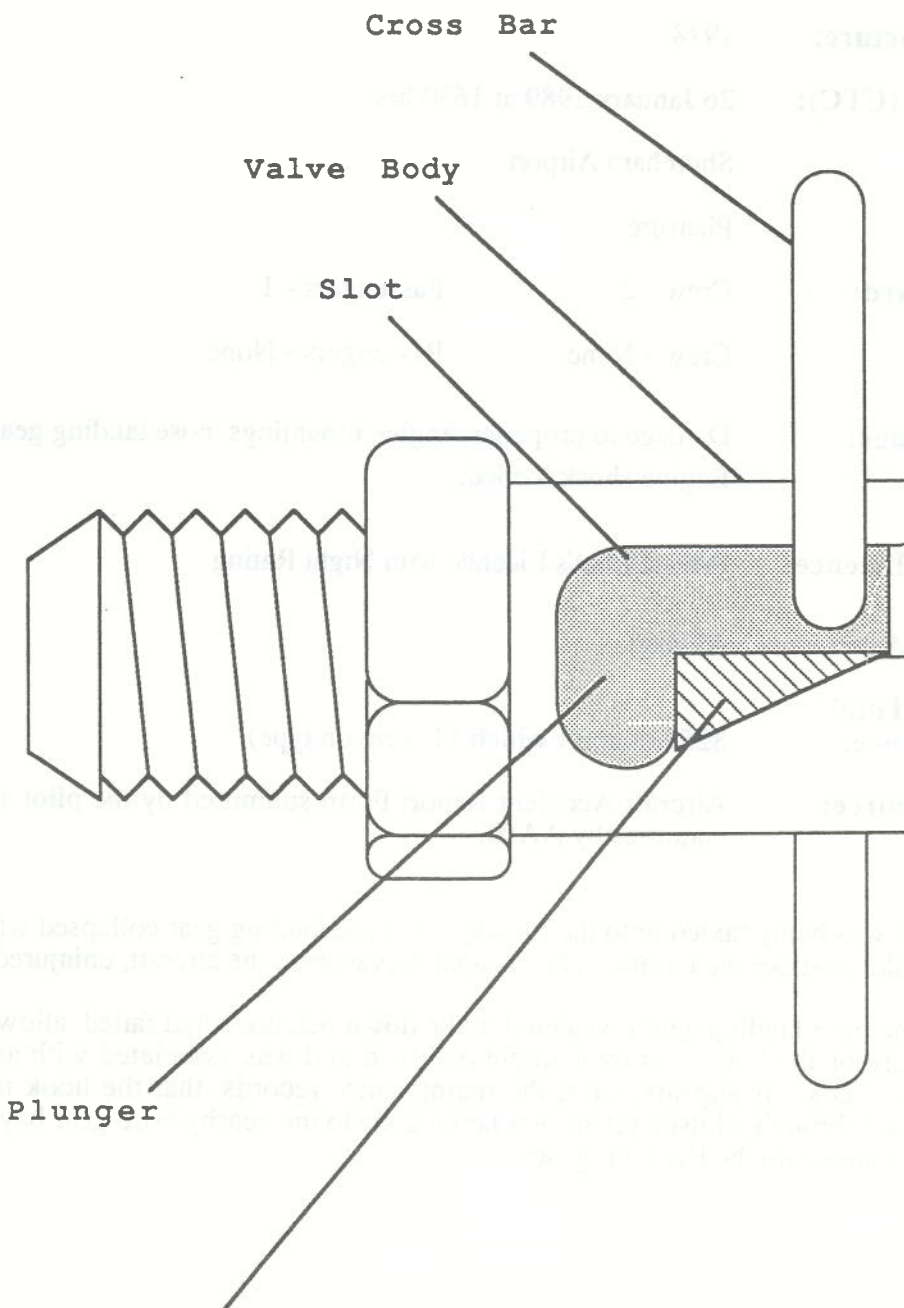
FIG 1

Inspection after the accident found that the fuel tanks were approximately $\frac{3}{4}$ full and that the electric fuel pump delivered fuel satisfactorily to the carburettor. It was also found that the engine had suffered no major pre-accident mechanical distress. However, it was reportedly noted during recovery of the aircraft that fuel was flowing from the fuel filter drain valve. This was a Curtiss type valve, (Fig 1) which is opened by manually pushing a plunger off its seat by means of a cross-bar and closed by spring pressure. The cross-bar travels in an L shaped slot in the valve body, which allows the plunger to be locked in the valve-open position.

The filter drain valve had been operated momentarily during pre-flight checks, in accordance with normal practice, to drain any water that might have collected in the filter. The evidence indicated that the drain valve had inadvertently been left locked open after this check, but that this had not been apparent because the fuel cock had been off and this had caused drainage to cease after a short time. Reportedly some initial fuel drainage from the filter may occur when the drain valve is opened even with the fuel cock off. Previous experience indicates that, after opening the fuel cock, the pressure loss associated with an open filter drain valve can be insufficient to prevent fuel from reaching the carburettor and feeding the engine normally until the pressure at the filter inlet is reduced somewhat by take-off and climb accelerations. Thus the engine can start and run, apparently normally, with the drain valve open but can experience starvation of fuel supply to the carburettor during take-off and climb.

The CAA commented in the GASIL that it had recommended, on numerous occasions, the removal of the locking feature on the Curtiss fuel cock, and reproduced CSE Service Bulletin 6/75 of Oct 1975 which accomplishes this by filing off of the shoulders on the valve body forming the angle of the L-shaped slot. (Fig 1) The Bulletin lists the models affected as All Piper Single and Twin Aircraft, and recommends compliance within the next 50 hours of operation or at the next inspection whichever occurs first. It was also noted, however, that the second case described in the GASIL related to a modified drain valve which had stuck open due to a fault.

Shaded area of slot for filing off in accordance with CSE Service Bulletin 6/75 (schematic only)

AAIB has recommended that the CAA requires the deletion of the drain valve locking feature on British registered aircraft that can be affected in the above way should the valve inadvertently be left open.
