**ACCIDENT**

<b>Aircraft Type and Registration:</b>	Eurocopter AS332L2 Super Puma, G-CHCG	
<b>No &amp; Type of Engines:</b>	2 Turbomeca Makila 1A2 turboshaft engines	
<b>Year of Manufacture:</b>	2003	
<b>Date &amp; Time (UTC):</b>	3 March 2006 at 1503 hrs	
<b>Location:</b>	104 nm north-east of Aberdeen VOR/DME	
<b>Type of Flight:</b>	Commercial Air Transport	
<b>Persons on Board:</b>	Crew - 2	Passengers -18
<b>Injuries:</b>	Crew - None	Passengers - None
<b>Nature of Damage:</b>	Lightning strike damage to one main rotor blade, one tail rotor blade and other components including all three main rotor servo-actuators	
<b>Commander's Licence:</b>	Airline Transport Pilot's Licence	
<b>Commander's Age:</b>	58 years	
<b>Commander's Flying Experience:</b>	Approximately 15,000 hours (of which about 2,500 hrs were on type) Last 90 days - 91 hours Last 28 days - 29 hours	
<b>Information Source:</b>	AAIB Field Investigation

**Synopsis**

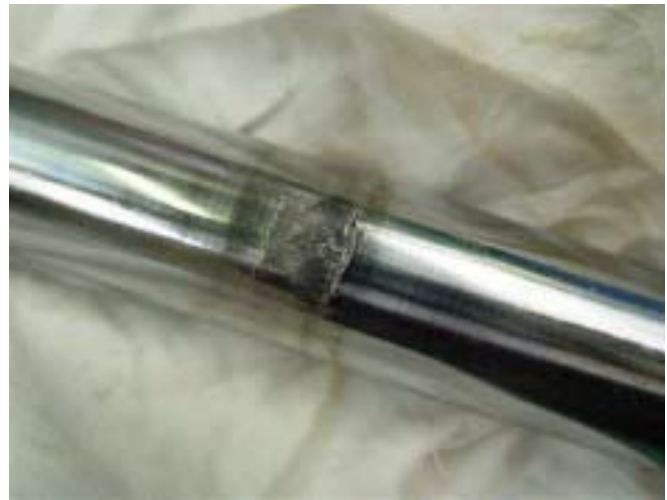
**Figure 1**

Other areas of localised overheating damage were found, principally on the pitch link spherical bearings but also on a bearing associated with the flying control circuit within the fuselage. Similar damage had also been found on the spherical bearings of the three main rotor hydraulic actuators and, significantly, on the external 'Fescolized'<sup>2</sup> portion of the ram of two of them (see Figure 1).

Outer rod showing externally visible arcing damage

This damage had the appearance of localised melting and erosion of the chromium plating and the surface of the steel underneath and was clearly the origin of the hydraulic leak from No 1 system. All three actuators were despatched for testing and laboratory examination by their manufacturer under AAIB supervision.

The examination commenced with a bench test of all three actuators. They were checked first at about 25 to 30 bar before full system working pressure of 175 bar was applied. The first actuator tested had visible evidence of metal erosion on the external portion of the Fescolized rod and, when tested at low pressure, a significant external leak was obvious such that it was decided not to continue to high pressure. Strip examination of this unit showed that the upper bearing seal had been perforated and it was concluded that this was responsible for the leak which had depleted No 1

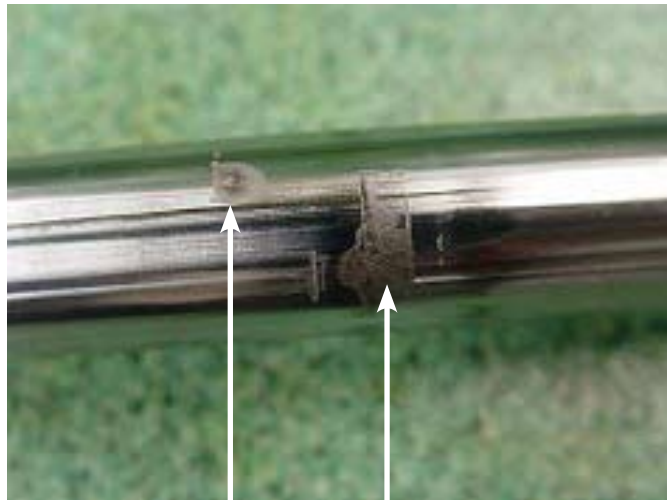
**Figure 3**

but no leakage from System 1. However, when dismantled there was significant erosion damage to the internal rod and it was noted that the damage appeared to have two distinct areas, (see Figure 3), suggesting two separate events occurring with the piston in slightly different extensions; this possibility is discussed below. There was also evidence of electrical tracking on one of the spherical bearings.

Damage to Fescolized portion of inner rod showing two distinct areas of arcing damage

leak which led to depletion of the No 1 system appears to have been damage to the seal, either from the strike itself or from rubbing against the rough, eroded area of the rod. It is conceivable that, in the absence of seal damage, there will be no leakage when the actuator is moved such that the eroded area no longer impinges on the seal, but when the seal is damaged, leakage could occur at all actuator extensions. It was noted that any slight leakage, indicating seal damage, tended to be evident at low pressure only, suggesting that checking for leaks would be more rigorous at these pressures. However, low pressure testing is not normally required because the seals are optimised for a working pressure of 175 bars. According to the helicopter manufacturer, leakage at low pressure should not necessarily be considered as a malfunction because it would be difficult to define leakage criteria appropriate to low-pressure testing.

the non-metallic seals and cause localised melting of the steel. Of particular concern is the observation on the internal rod of one actuator that it had experienced two separate strikes. G-CHCG had suffered a lightning strike three days prior to this incident which resulted in a main rotor blade replacement. It is likely that one of the internal damage indications occurred as a result of this strike but it was not detected at the time.

Eurocopter have stated that they will be producing a Service Letter to operators which will include the following:

- a) Research of arcing mark on ball joint, power rod and body.*
- b) Research any evidence of leakage.*

*If any of these anomalies will lead (sic), the servo control must be sent to a repair station for detailed inspection and repair.*
