#### ACCIDENT

Aircraft Type and Registration:	Eurocopter AS332L2 Super Puma, G-CHCG	
No & Type of Engines:	2 Turbomeca Makila 1A2 turboshaft engines	
Year of Manufacture:	2003	
Date & Time (UTC):	3 March 2006 at 1503 hrs	
Location:	104 nm north-east of Aberdeen VOR/DME	
Type of Flight:	Commercial Air Transport	
Persons on Board:	Crew - 2	Passengers -18
Injuries:	Crew - None	Passengers - None
Nature of Damage:	Lightning strike damage to one main rotor blade, one tail rotor blade and other components including all three main rotor servo-actuators	
Commander's Licence:	Airline Transport Pilot's Licence	
Commander's Age:	58 years	
Commander's Flying Experience:	Approximately 15,000 hours (of which about 2,500 hrs were on type) Last 90 days - 91 hours Last 28 days - 29 hours	
Information Source:	AAIB Field Investigation

#### **Synopsis**

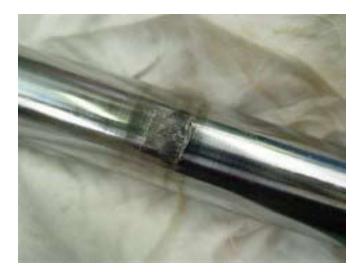
Other areas of localised overheat damage were found, principally on the pitch link spherical bearings but also on a bearing associated with the flying control circuit within the fuselage. Similar damage had also been found on the spherical bearings of the three main rotor hydraulic actuators and, significantly, on the external 'Fescolized'<sup>2</sup> portion of the ram of two of them (see Figure 1).

**Figure 1** Outer rod showing externally visible arcing damage

This damage had the appearance of localised melting and erosion of the chromium plating and the surface of the steel underneath and was clearly the origin of the hydraulic leak from No 1 system. All three actuators were despatched for testing and laboratory examination by their manufacturer under AAIB supervision.

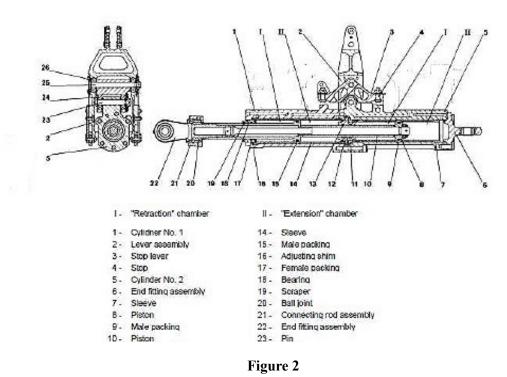
AS332L main rotor servo actuator

its own but, of course, they normally work together. It can be seen that the Fescolized portion of one piston extends out of the body of the actuator (No 1, or Left system) and is therefore visible externally, but the piston of the other system (No 2, or Right) remains completely hidden internally. A drain hole between the intermediate bearings of No 2 system should provide witness of any internal leakage past the Fescolized rod.

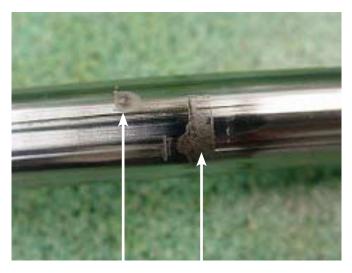
## Figure 3

Damage to Fescolized portion of inner rod showing two distinct areas of arcing damage

leak which led to depletion of the No 1 system appears to have been damage to the seal, either from the strike itself or from rubbing against the rough, eroded area of the rod. It is conceivable that, in the absence of seal damage, there will be no leakage when the actuator is moved such that the eroded area no longer impinges on the seal, but when the seal is damaged, leakage could occur at all actuator extensions. It was noted that any slight leakage, indicating seal damage, tended to be evident at low pressure only, suggesting that checking for leaks would be more rigorous at these pressures. However, low pressure testing is not normally required because the seals are optimised for a working pressure of 175 bars. According to the helicopter manufacturer, leakage at low pressure should not necessarily be considered as a malfunction because it would be difficult to define leakage criteria appropriate to low-pressure testing.

Eurocopter have stated that they will be producing a Service Letter to operators which will include the following: 'To ensure that servo-controls damaged by a lightning strike do not remain in service, the EUROCOPTER documentation will be modified in order to specify the type of checks to be carried out following a lightning strike.
