ACCIDENT

Aircraft Type and Registration:	Christen Eagle II, G-EGUL	
No & Type of Engines:	1 Lycoming AEIO-360-A1A piston engine	
Year of Manufacture:	1980	
Date & Time (UTC):	29 October 2008 at 1349 hrs	
Location:	Seething Airfield, Norfolk	
Type of Flight:	Private	
Persons on Board:	Crew - 1	Passengers - 1
Injuries:	Crew - 1 (Fatal)	Passengers - 1 (Fatal)
Nature of Damage:	Aircraft destroyed, structural damage to spraying vehicle	
Commander's Licence:	Private Pilot's Licence	
Commander's Age:	49 years	
Commander's Flying Experience:	2,500 hours (of which 0 were on type) Last 90 days - 40 hours estimated Last 28 days - 13 hours estimated	
Information Source:	AAIB Field Investigation

Synopsis

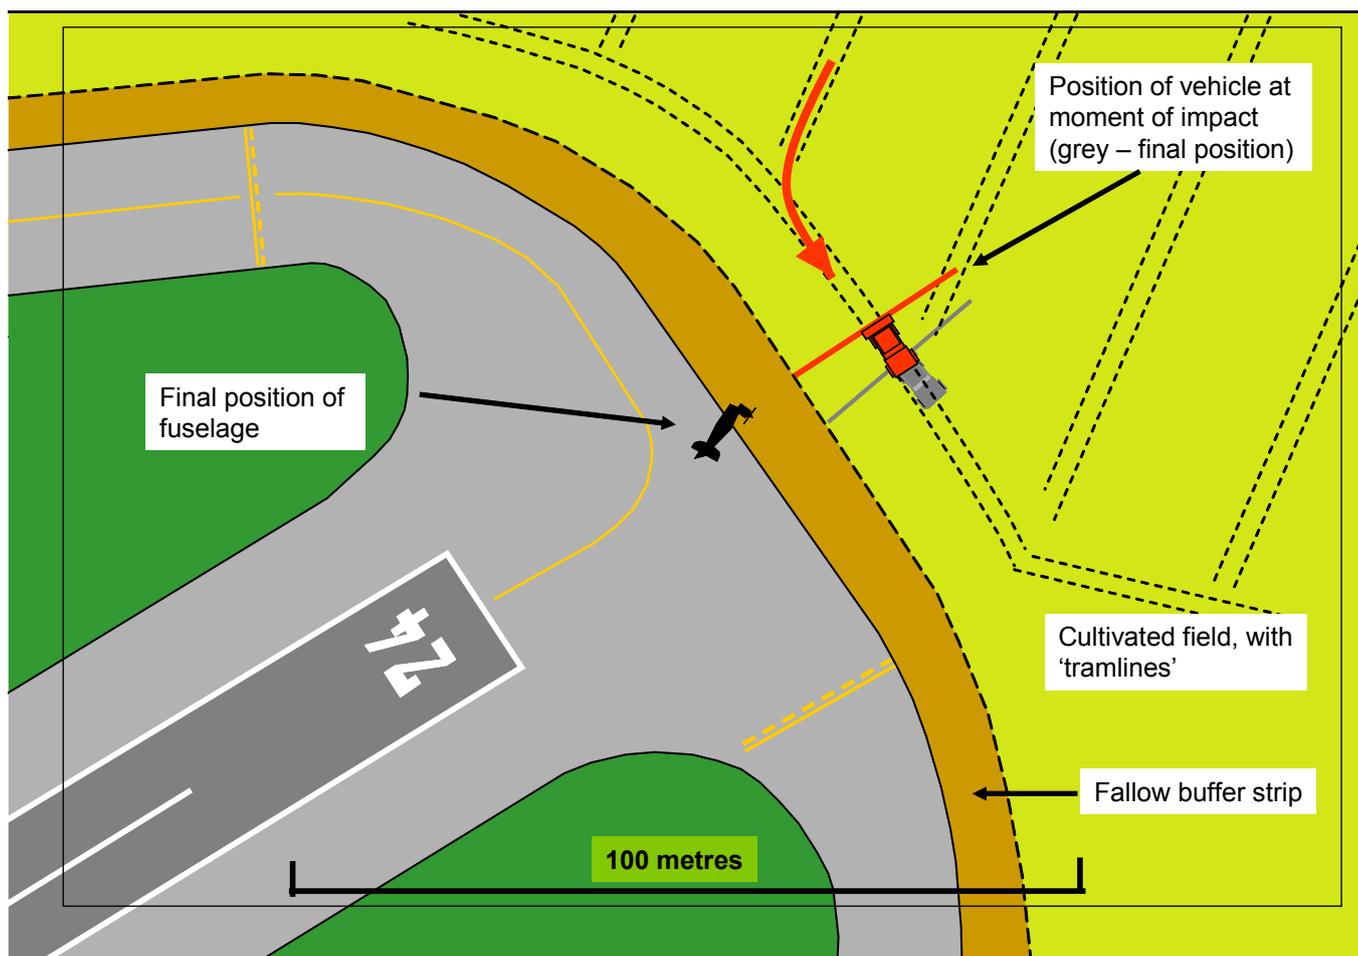
Plan of accident area, showing positions of spray vehicle and aircraft fuselage

manoeuvrability of his vehicle. Similarly, as Figure 1 indicates, the decision to go to the replenishment bowser was not a factor. Had the vehicle continued spraying, it would still have been in about the same position, although probably at a different aspect because it would have been turning onto the next tramline.

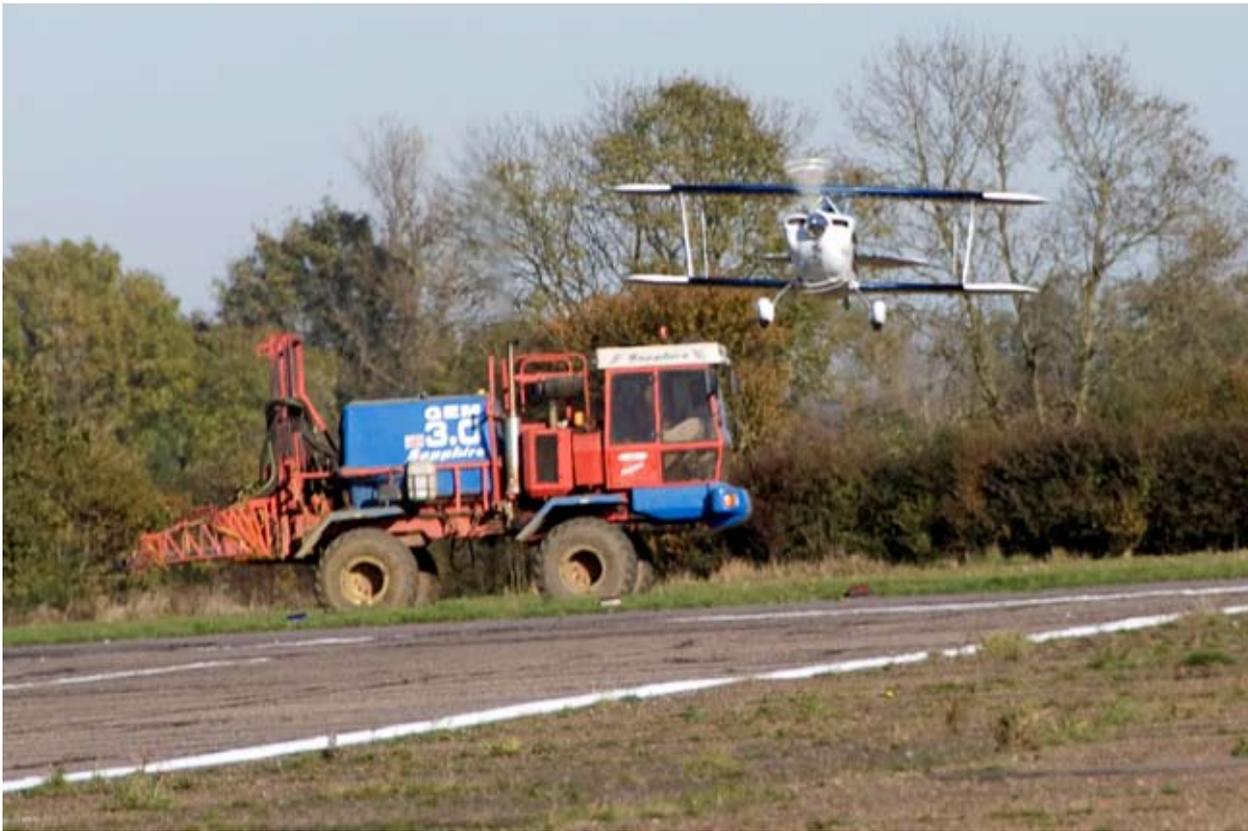
Figure 2 shows a photograph of the aircraft and vehicle shortly before the impact, taken from the photographer's position beside the runway. The crop-sprayer was a

Long focal length view of aircraft and spray vehicle shortly before impact

In Figure 2, the blur of the rotating propeller is clearly apparent, and this enabled the angular arc of a propeller blade leading edge to be measured. Together with knowledge of the camera shutter speed, this led to the determination of an engine speed of approximately 1,960 rpm. Potential errors in the measurement process

mean that this calculated value would be subject to an estimated tolerance of $\pm 10\%$. Bearing in mind the as-found positions of the propeller and throttle controls, an engine speed of around 1,960 rpm appears credible, with the low power setting resulting in the speed falling below the governed range.

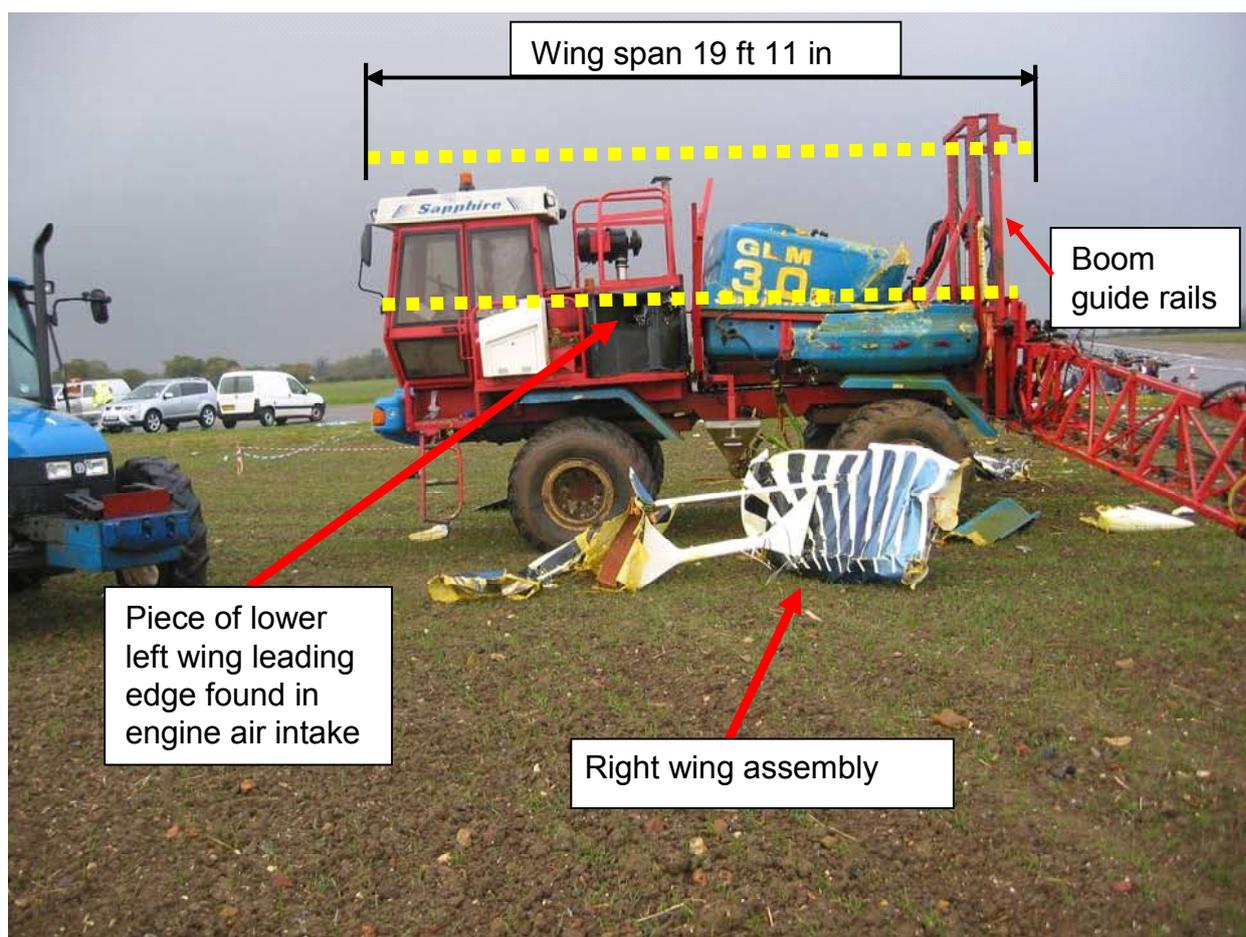
Figure 3 shows the vehicle with the likely impact positions of the wing leading edges. The right wings were torn off in the impact and came to rest by the side of the vehicle. The left wings mostly disintegrated, but the larger fragments remained attached to the bracing wires and were carried to the main impact area along with the fuselage.

The nose and engine of the aircraft passed through the vehicle, disrupting the relatively insubstantial tank structure, although, as can be seen from Figure 3, the landing gear would have impacted the vehicle chassis. It was clear that the main wheels had detached at this point, with the vehicle running over one of them during the estimated 4 to 5 metres it took to come to a halt. The fuselage had 'nosed over', striking the ground some

Probable wing impact positions on vehicle
