## ACCIDENT

<b>Aircraft Type and Registration:</b>	Cirrus SR22, N147KA	
<b>No &amp; Type of Engines:</b>	1 Continental IO-550-N piston engine	
<b>Year of Manufacture:</b>	2006 (Serial no: 1944)	
<b>Date &amp; Time (UTC):</b>	21 July 2013 at 1200 hrs	
<b>Location:</b>	English Channel	
<b>Type of Flight:</b>	Private	
<b>Persons on Board:</b>	Crew - 1	Passengers - None
<b>Injuries:</b>	Crew - 1 (Fatal)	Passengers - N/A
<b>Nature of Damage:</b>	Aircraft destroyed	
<b>Commander's Licence:</b>	Private Pilot's Licence	
<b>Commander's Age:</b>	36 years	
<b>Commander's Flying Experience:</b>	192 hours (of which 76 were on type) Last 90 days - 2 hours Last 28 days - 2 hours	
<b>Information Source:</b>	AAIB Field Investigation

## Synopsis

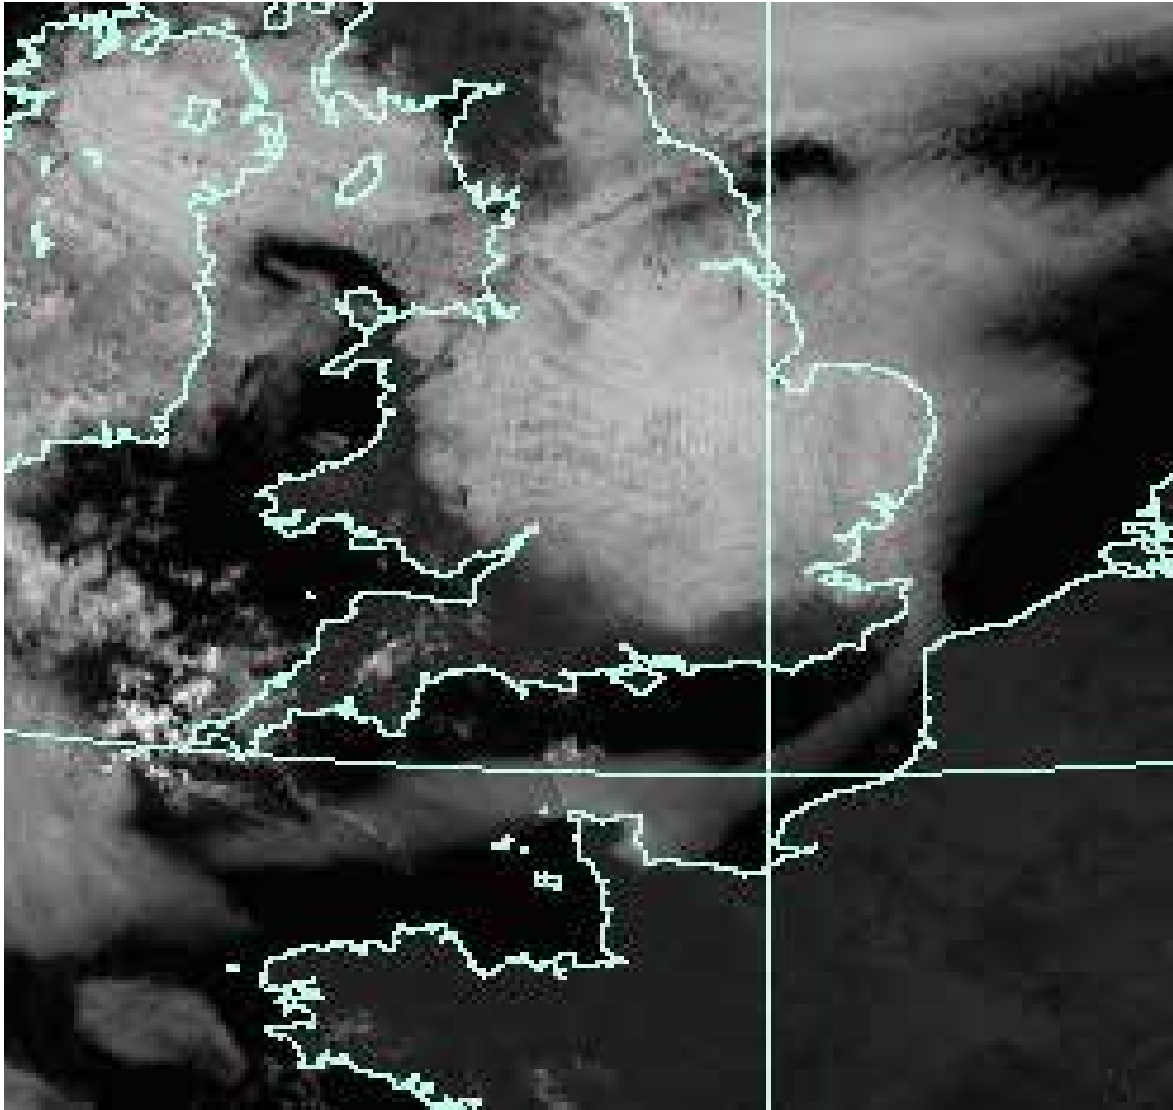
**Figure 1**

A Met Office report, at the time the aircraft was carrying out circuits, gave the cloudbase at Farnborough as broken at 1,400 ft with visibility greater than 10 km. Visual satellite images show less cloud further south and large clear areas around the coast. Figure 1 shows a visual satellite image of the area of low cloud or sea fog. The Shoreham 0950 hrs and 1020 hrs weather reports indicated few clouds at 2,000 ft. Weather reports for Lydd Aerodrome for the same times indicated CAVOK and temperature 22°C. However, satellite images showed a band of low cloud or fog extending through the Dover Straits and into the English Channel across the route of the aircraft. Weather reports for Le Touquet for 1030 hrs and 1100 hrs indicated visibility greater than 10 km, no significant cloud, temperature 27°C and dewpoint 28°C. The forecast for Le Touquet between 0900 hrs and 1800 hrs indicated wind from 090° at 7 kt and CAVOK.

Visible satellite image valid at 1030 hrs on 21<sup>st</sup> July 2013 showing a band of fog or low cloud extending into the English Channel

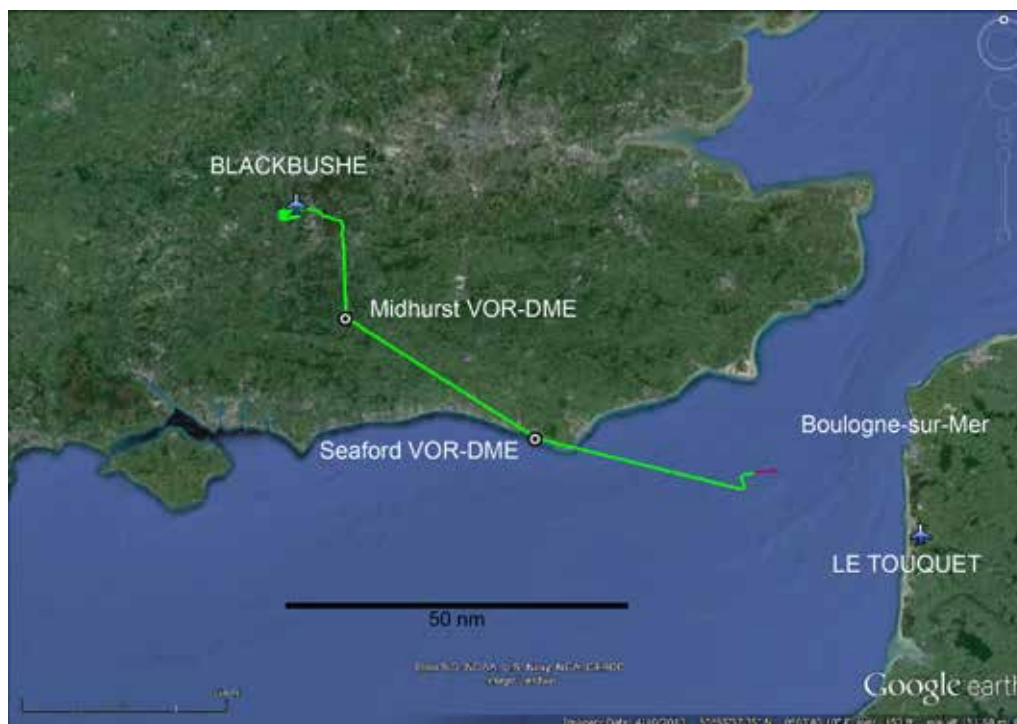
**Figure 2**

The ground track of N147KA is illustrated in Figure 2 (Pease Pottage in green and the last 21 returns of Boulogne in red) and shows the aircraft in the circuit at Blackbushe before tracking towards the Midhurst and Seaford VORs and crossing the coast at Beachy Head.

Overview of the accident flight radar tracks

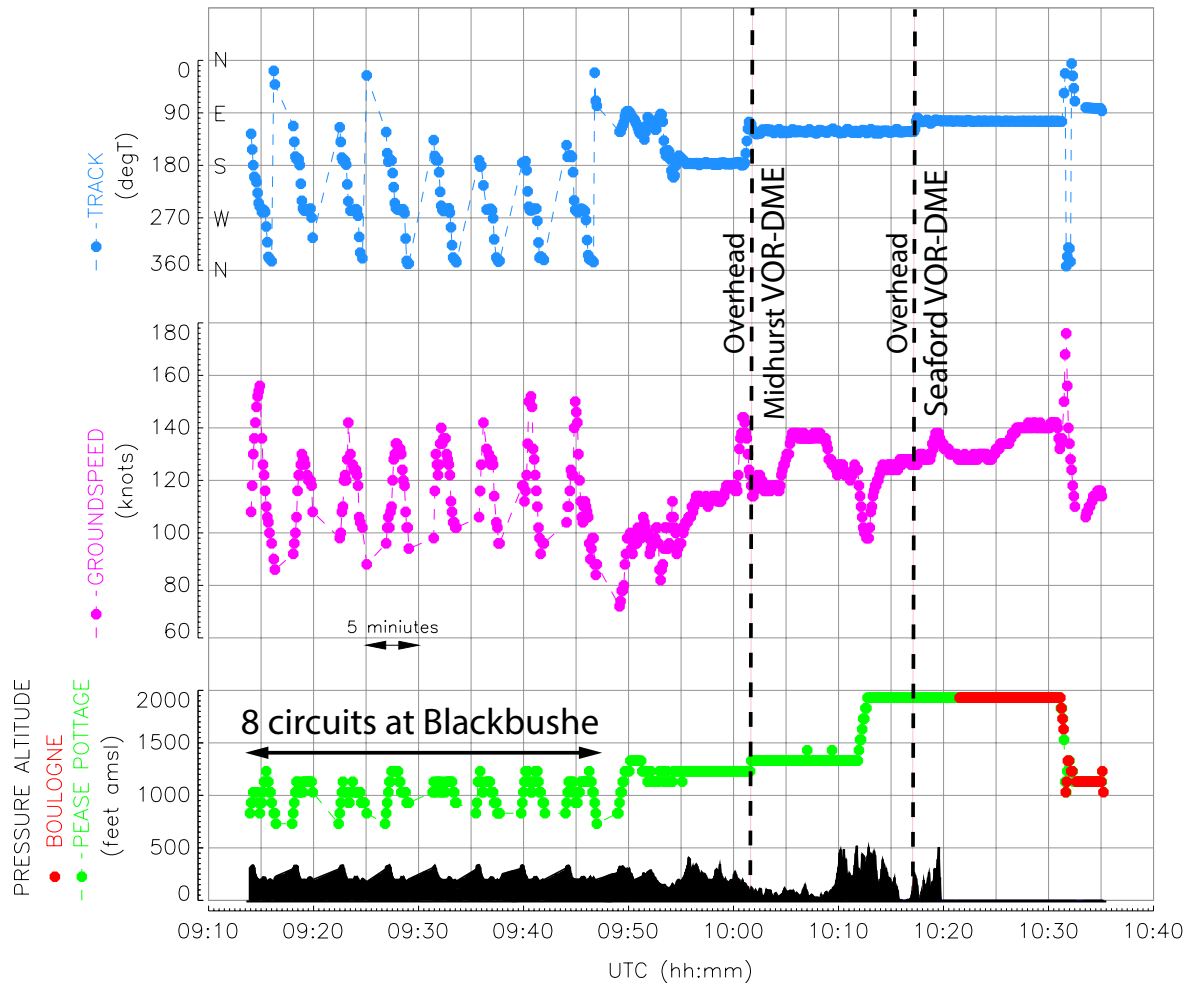
**Figure 3**

Figure 3 shows the groundspeed, true track and altitude (adjusted to 1018 hPa) from the aircraft. The figure shows it in the circuit at Blackbushe where eight circuits were flown and then flying towards the Midhurst VOR at approximately 1,230 ft. It then climbed to approximately 1,930 ft amsl before flying overhead the Seaford VOR and turning toward Le Touquet, crossing the coast at 1019:29 hrs.

Radar Mode C & S recorded data for accident flight with terrain height below flight path

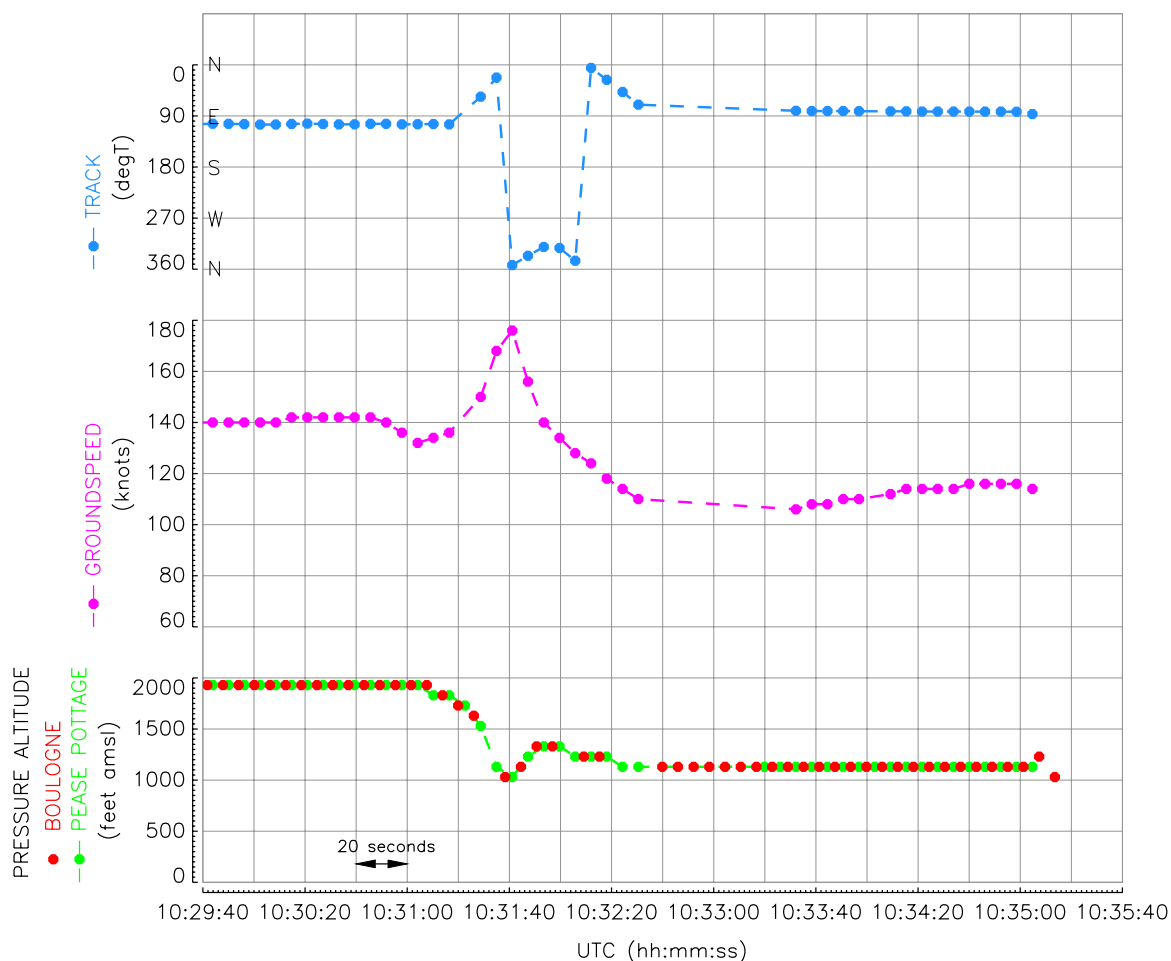
**Figure 4**

At 1030:45 hrs, about 25 nm from Beachy Head, the groundspeed began to reduce from a nominal 140 kt. Shortly afterwards the aircraft began to descend and, at 1031:16 hrs, turned left from a track of 105°T. The minimum altitude recorded in the turn was 1,030 ft amsl on a track of 22°T. The aircraft continued the turn to about 320°T before turning back to the right onto a track of 81°T towards Boulogne-sur-Mer. The descending turn is illustrated in Figure 4.

Recorded data showing the track, groundspeed and altitude of the aircraft during the descending turn through to the last contact.
