Aircraft Type and Registration:	DH82A Tiger Moth, G-APAO	
No & Type of Engines:	1 Gipsy Major 1C piston engine	
Year of Manufacture:	1940	
Date & Time (UTC):	29 July 2004 at 1132 hrs	
Location:	Duxford Aerodrome, Cambridgeshire	
Type of Flight:	Training	
Persons on Board:	Crew - 1	Passengers - 1
Injuries:	Crew - None	Passengers - None
Nature of Damage:	Damage to right main landing gear, wing tip, elevator, and aileron control arm	
Commander's Licence:	Commercial Pilot's Licence with Instructor rating	
Commander's Age:	35 years	
Commander's Flying Experience:	2,327 hours (of which 115 were on type) Last 90 days - 220 hours Last 28 days - 67 hours	
Information Source:	AAIB Field Investigation

Synopsis

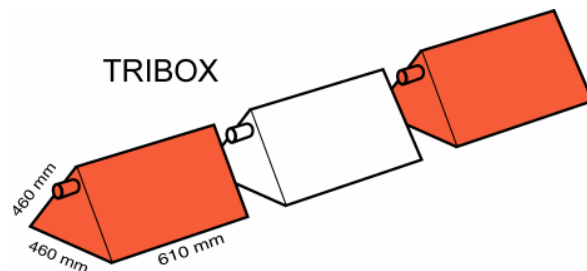
The Tribox

Each triangular 'Tribox', constructed of strong medium-density polythene, is 610 mm long, with sides measuring 460 mm in length and standing 398 mm high. Individual boxes may be locked together by means of spigots that locate into holes in an adjoining box.

The 'Triboxes' used were of a design intended for use on airfields. Their design however, does not satisfy the CAP 168 criteria for use as runway markers within the cleared and graded area as they stand more than 360 mm high. Furthermore, although no testing was carried out, it is clear by inspection that the combination of the structurally-strong triangular-sectioned design, the thickness

of the walls and the dense plastic material makes them unlikely to distort or yield when struck. Indeed, the manufacturer describes them as '*virtually indestructible*'.

The manufacturer states that 'Triboxes' may be partially filled with water but does not specify how much water should be used and it is possible that, had the Tribox in this case contained significantly less water, the consequences of the collision may have been less severe.

regarding height and frangibility specified in CAP 168 and was made significantly heavier than its empty weight by being filled with a quantity of water.

It is recommended that the United Kingdom Civil Aviation Authority Aerodrome Standards Department publish advice to aerodrome operators to ensure that obstacles placed within a runway's Cleared and Graded Area are genuinely lightweight and frangible taking into account the types of aircraft that commonly use the runway.

'We intend advising new buyers of TRIBOX in future that whilst a small volume of water can usefully be used to weight TRIBOX to prevent it from 'blowing away' one must always consider the frangibility of this or any other product in relation to moving aircraft in Cleared and Graded areas'.
