No: 1/92

Ref: EW/G91/10/14

Aircraft Type and Registration: Falco F8L Series 2, G-OCDS

Location: Gransden Airfield, Sandy, Bedfordshire

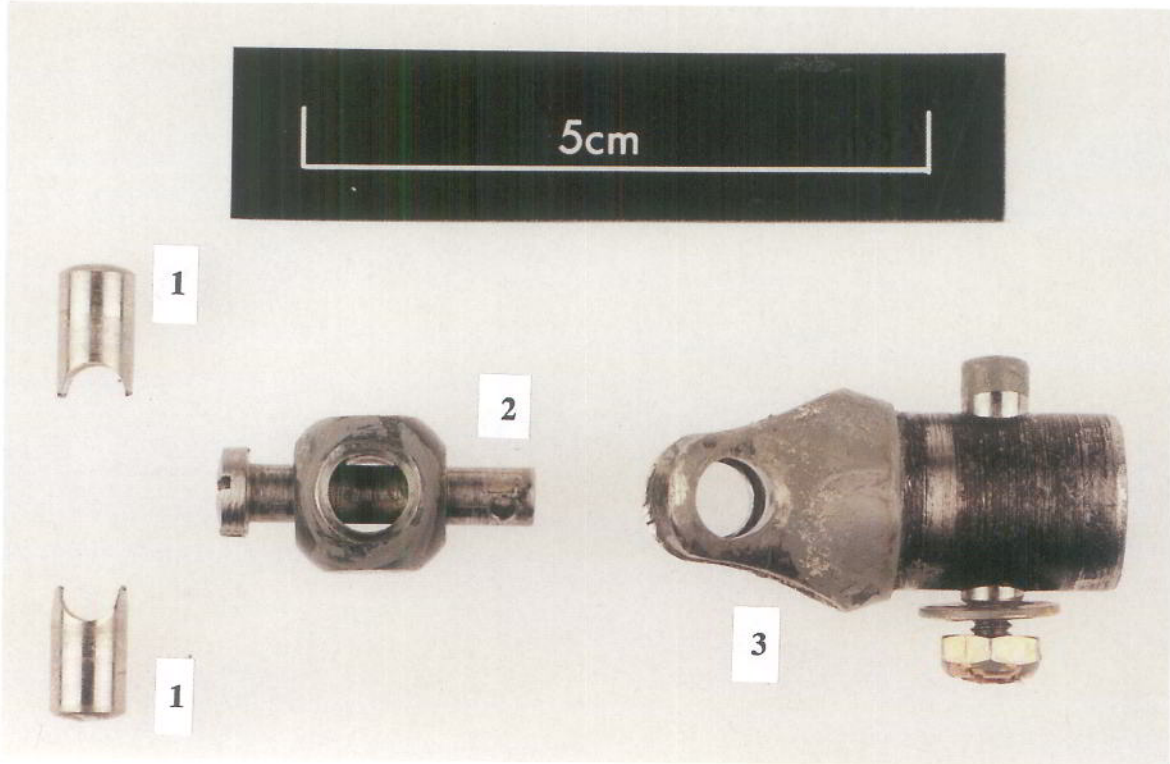
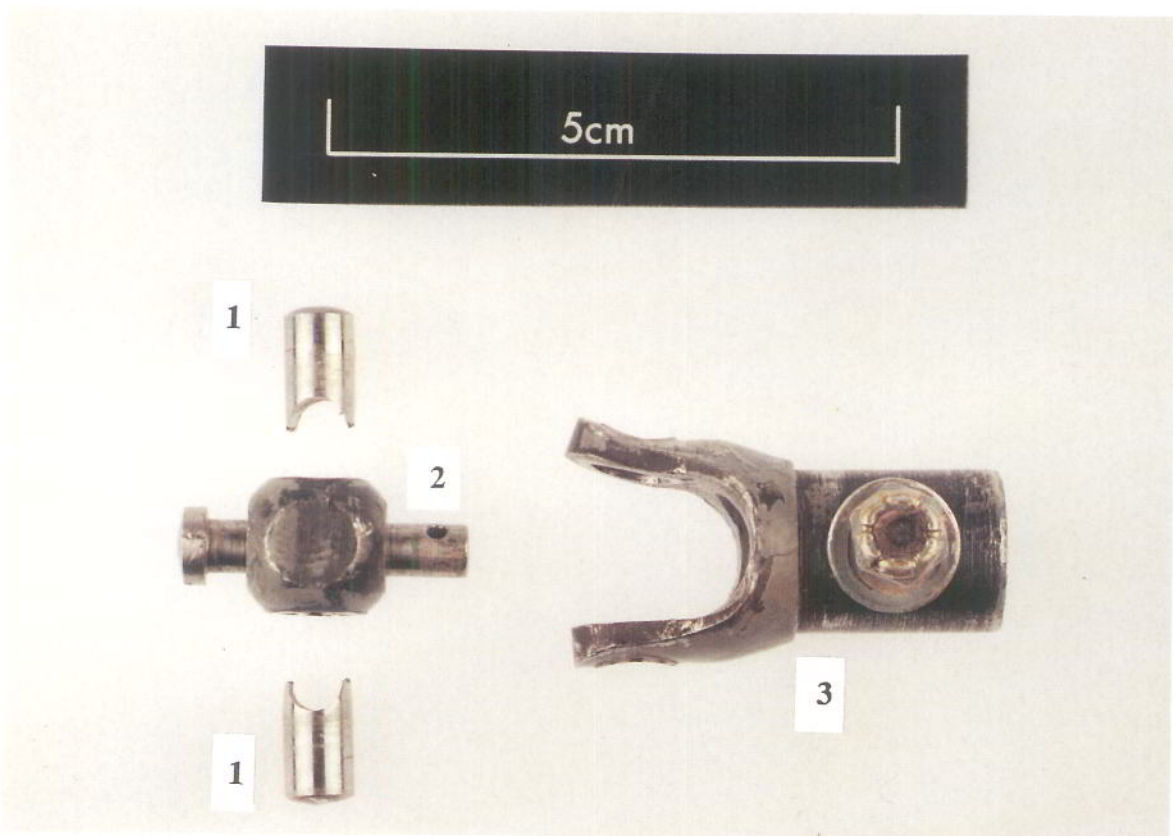
COMPONENTS FROM FAILED UNIVERSAL JOINT

On subsequent examination, the aircraft was found to have suffered failure of a universal-joint in the drive between the landing gear motor and the nose-leg operating screw-jack. Four such universal-joints are utilised in the total landing-gear operating system of this aircraft type, one on each main-leg drive and two on the nose-leg drive. Motion is transmitted through the universal-joints during retraction and extension, both when the the gear is operated in the normal electrical mode and when the emergency manual system is used.

It was found that in the failed joint, the larger diameter pin had fractured at this mid-length drilling. This had permitted its two ends to separate and come out of the block. The diameter of the drilling was such that it left a minimal material cross-section linking the two ends of the pin. The fracture faces were thus too small to readily establish the precise mode of failure.

The company considers that the drive comes under load during take-off and landing runs on rough fields. This appears to occur because the degree of over-centring of the nose-leg mechanism is minimal when the gear is fully extended. The geometric lock appears as a consequence to break occasionally during such rough field operation. This has the effect of applying the ground-loading forces to the operating mechanism as well as releasing the limit micro-switch on the nose-leg. The landing gear motor then operates to restore the leg to its correct position. Repeated motor operation is not unusual on rough surfaces. This sequence of events thus places non-design loads on the operating mechanism, including the universal joint in question.

A failure of the larger diameter pivot-pin will not necessarily manifest itself at once; it will only become evident when one of the ends of the failed pin disengages from the central block. Although the point of the failure is theoretically unloaded even when transmitting high torques, in practice, wear, manufacturing inaccuracy and distortion under applied torque may all contribute to causing significant loading to be placed on that point, as will any applied end loading.

- 1** Fractured rivet pin. **2** Central block (approximately cube shaped) with small diameter pivot pin.
3 Distorted fork connection to drive shaft. (Second similar fork connection not shown).

The maintenance company is proposing to seek CAA approval to carry out a modification to replace the universal joint with a standard aeronautical joint of similar dimensions but greater mechanical strength.
