ACCIDENT

Aircraft Type and Registration:	Piper PA-38-112 Tomahawk, G-TOMS	
No & Type of Engines:	1 Lycoming O-235-L2C piston engine	
Year of Manufacture:	1979	
Date & Time (UTC):	26 November 2010 at 1125 hrs	
Location:	Brecon Beacons, Wales	
Type of Flight:	Private	
Persons on Board:	Crew - 1	Passengers - None
Injuries:	Crew - None	Passengers - N/A
Nature of Damage:	Severe damage to airframe and engine	
Commander's Licence:	Private Pilot's Licence	
Commander's Age:	66 years	
Commander's Flying Experience:	266 hours (of which 100 were on type) Last 90 days - 4 hours Last 28 days - 1 hour	
Information Source:	Aircraft Accident Report Form submitted by the pilot

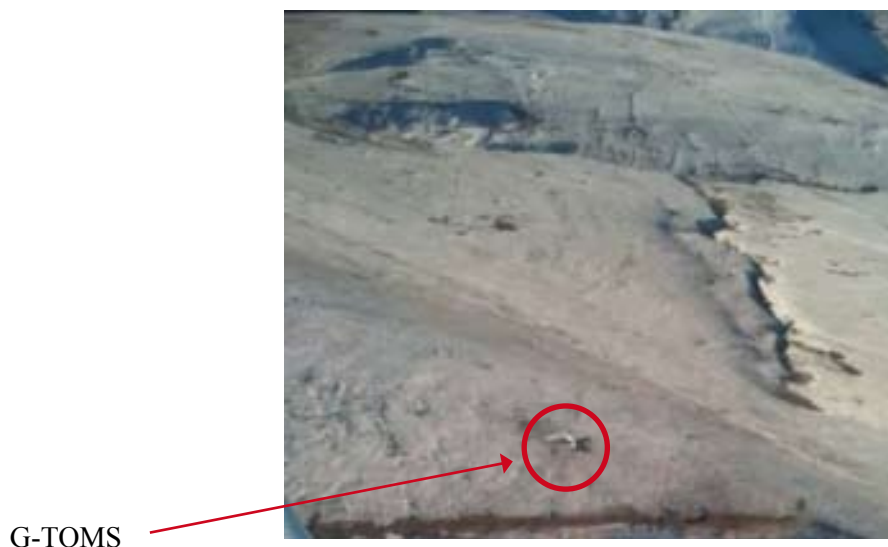
Figure 1

The pilot reported that the aircraft approached the ground “steeper than would have been normal for a landing” and that the aircraft tipped over onto its nose on contact with the ground and came to rest inverted (Figure 1). The pilot was wearing a full harness and exited the aircraft through the cabin side window.

G-TOMS inverted on hillside
(photograph courtesy of Cambrian Flying Club)
