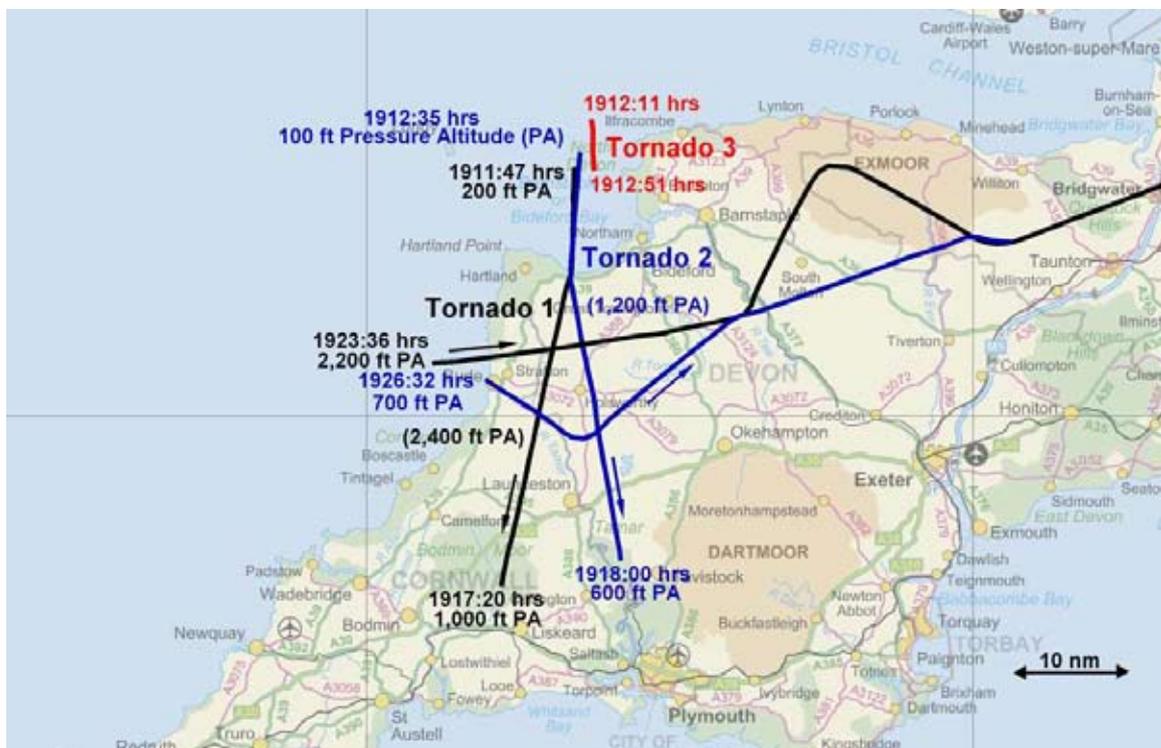
Figure 1

The radar and on-board recordings were compared. They agreed with each other and also confirmed the routings which had been planned before the three Tornados took off. The radar recordings are shown on Figure 1. The first and second Tornado aircraft tracks near to the balloon's landing site, which were reconstructed from the on board equipment recordings, are shown at Figure 2. The more westerly and lead aircraft passed 1.9 nm to the north-west of the balloon's landing site, south bound, at approximately 450 ft agl, at 1917:35 hrs, before turning away to the west. The second aircraft passed 0.6 nm to the north of the balloon landing site, west bound, at 1919:39 hrs, at about 350 ft agl and approximately 420 kt. The third aircraft was reported as being 2 nm astern of the second aircraft and slightly to the north of its track. On that basis, this third aircraft would have passed about 0.6 nm to the north of the landing site, at a similar height and speed to the second aircraft, at approximately 1919:56 hrs.
