**Aircraft Type and Registration:** Sportavia RF5B Sperber, G-SSWV

**Date & Time (UTC):** 3 August 1993 at 1925 hrs

**Location:** Netherthorpe Airfield, Nottinghamshire

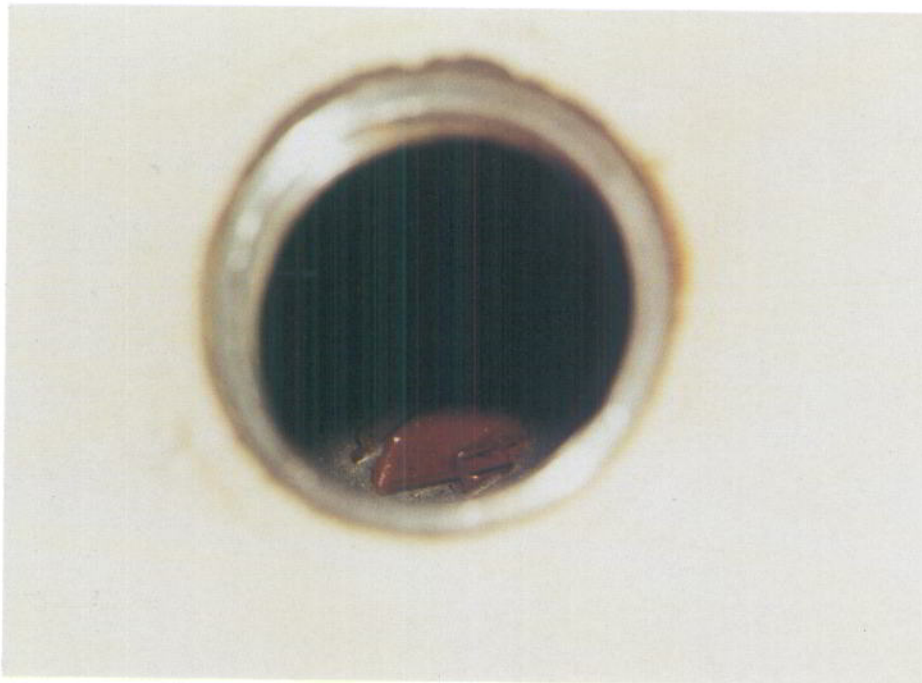
The fuel flow rate to the engine was checked on the following day and was found to be normal. The aircraft was recovered for repair and, once the fuselage had been supported and secured, the engine, at the second attempt, was successfully started and run. However, when the fuel was being removed from the tank by suction pump, the pump inlet became blocked with large flakes of red paint. Six large flakes were found in the tank with dimensions typically ½ inch to 1 inch (See photograph). One small paint flake was also found in the neck of the tank outlet pipe. The paint resembled that commonly found lining jerrycans.

The engineer who carried out the investigation pointed out that the outlet pipe in the fuel tank was flush with the floor of the tank. Without a thimble strainer over the outlet or some other protective arrangement this would have allowed the flat flakes of paint to be sucked down onto the orifice, blocking it completely.

**Paint flakes seen through filler cap**

Item No 4 in the August 93 edition of the General Aviation Safety Information Leaflet refers to a case where large paint flakes were found in fuel which had been stored in new jerrycans and notes the importance of always using a suitable filter when refuelling from such containers.
