# **BAC 167 Strikemaster MK83, G-BXFX, 9 December 2000 at 1318 hrs**

**AAIB Bulletin No: 8/2001 Ref: EW/C2000/12/4 Category: 1.2**

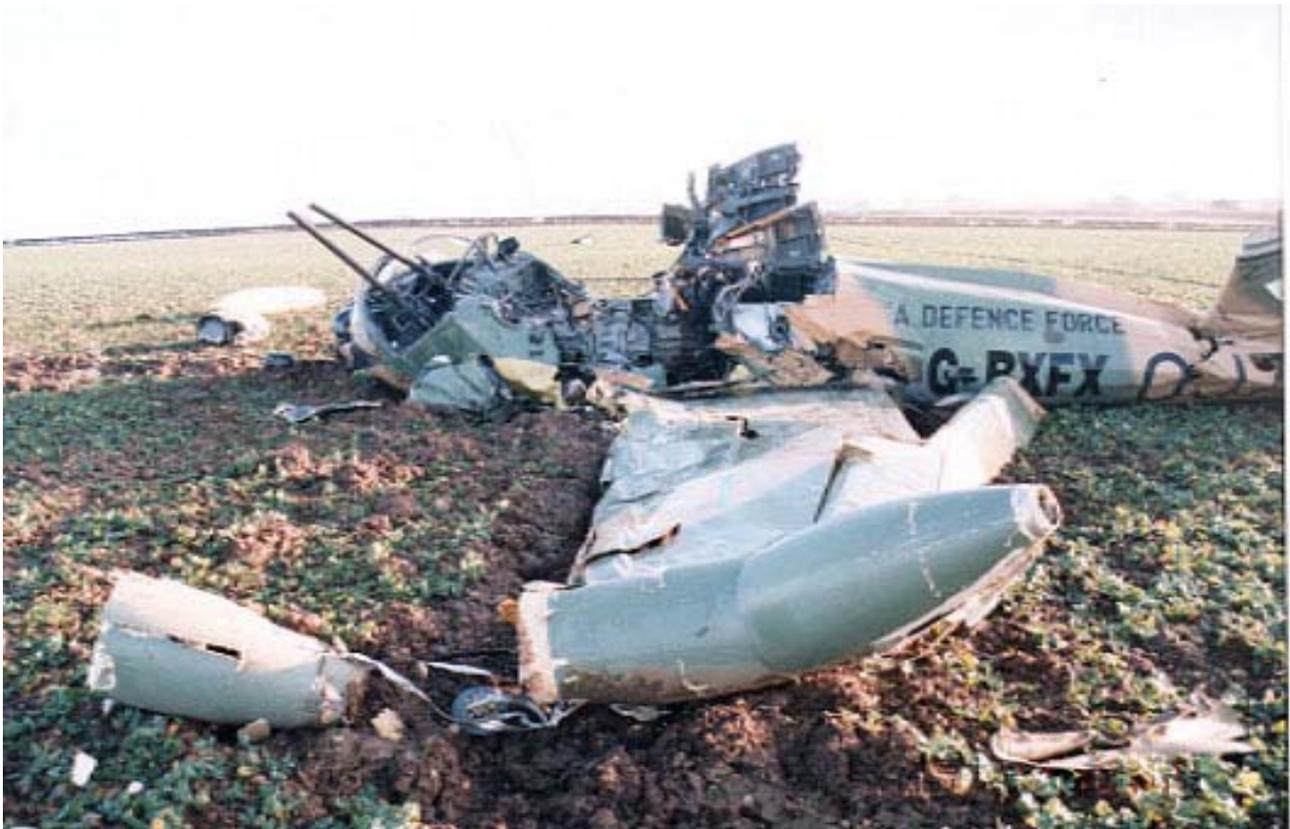
The aircraft had come to rest on a northerly heading in a level field approximately 400 feet amsl. There was no ground-slide, indicating zero forward speed. Marks made by the wing leading edges indicated that the aircraft had been rotating to the left at impact. The right hand tip tank had become detached at impact and thrown forwards, again indicating rotation to the left. Severe crushing damage on the underside of the nose together with structural failure of the fuselage aft of the cockpit indicated a nose down attitude at impact. The inboard weapon pylon on the right wing was found embedded in the earth at an angle of 20°. Thus the evidence was consistent with the aircraft having struck the ground whilst in a spin to the left, with a high descent rate and a 20° nose down attitude. A photograph of the wreckage is shown at Figure 1.

**Figure 1.** General view of aircraft wreckage

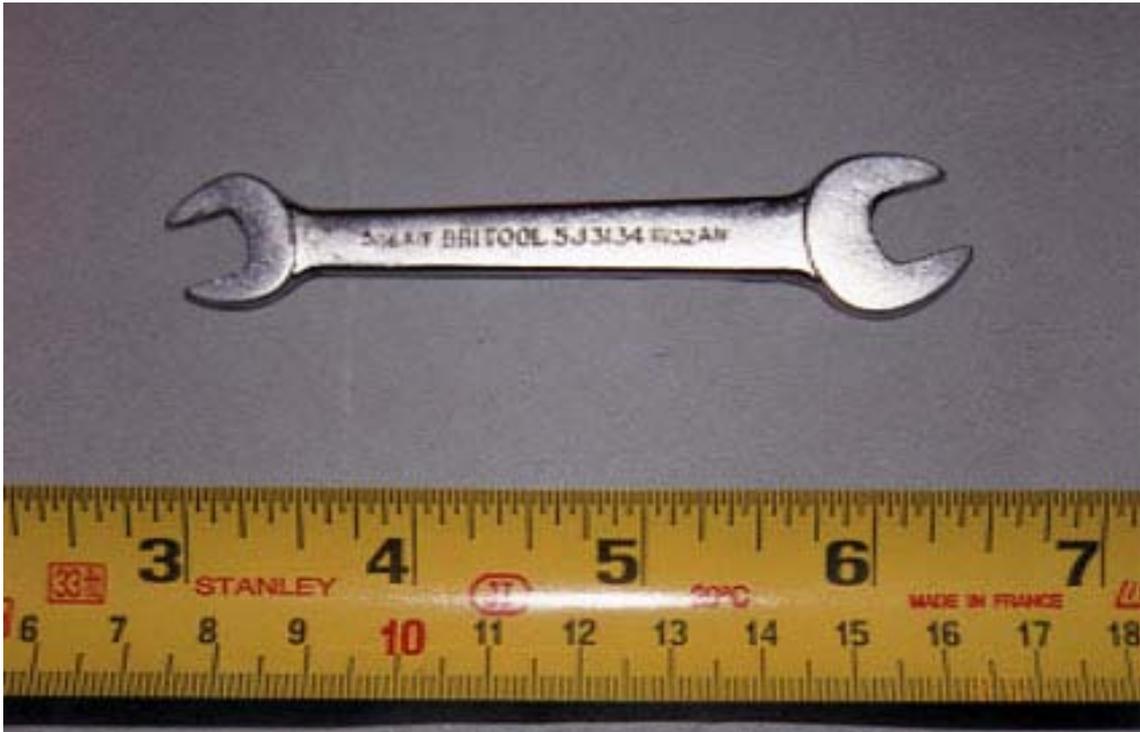
The wreckage was recovered to the AAIB's facility at Farnborough for a detailed examination. During the recovery process, a spanner was found on the ground in the area beneath the mid to aft fuselage. Whilst this appeared to come from the aircraft, it was not possible to define its location or how it came to be in the aircraft, although it was thought that it was unlikely to have come from the cockpit area. Close examination of the spanner did not reveal any witness marks to indicate its interference with any part of the aircraft. A photograph of the item is shown at Figure 2.

The primary flying controls on this type of aircraft are conventional, manually operated, with the dual control columns connected to the control surfaces via cables, pulleys, push-rods and bellcranks. Some scope appeared to exist for a loose article, such as the spanner, to cause a control jam at the rear of the fuselage, where the elevator and rudder controls ran in close proximity. No witness marks were found on any of the components that might have suggested that such an event had occurred however. Elsewhere in the fuselage, the control runs were located alongside the engine and jet pipe and presented little opportunity for being jammed.

**Figure 2.** Spanner found in fuselage
