MD-80 series Main Landing Gear oleo strut

# G-DEVR Accident - Time history of relevant recorded parameters

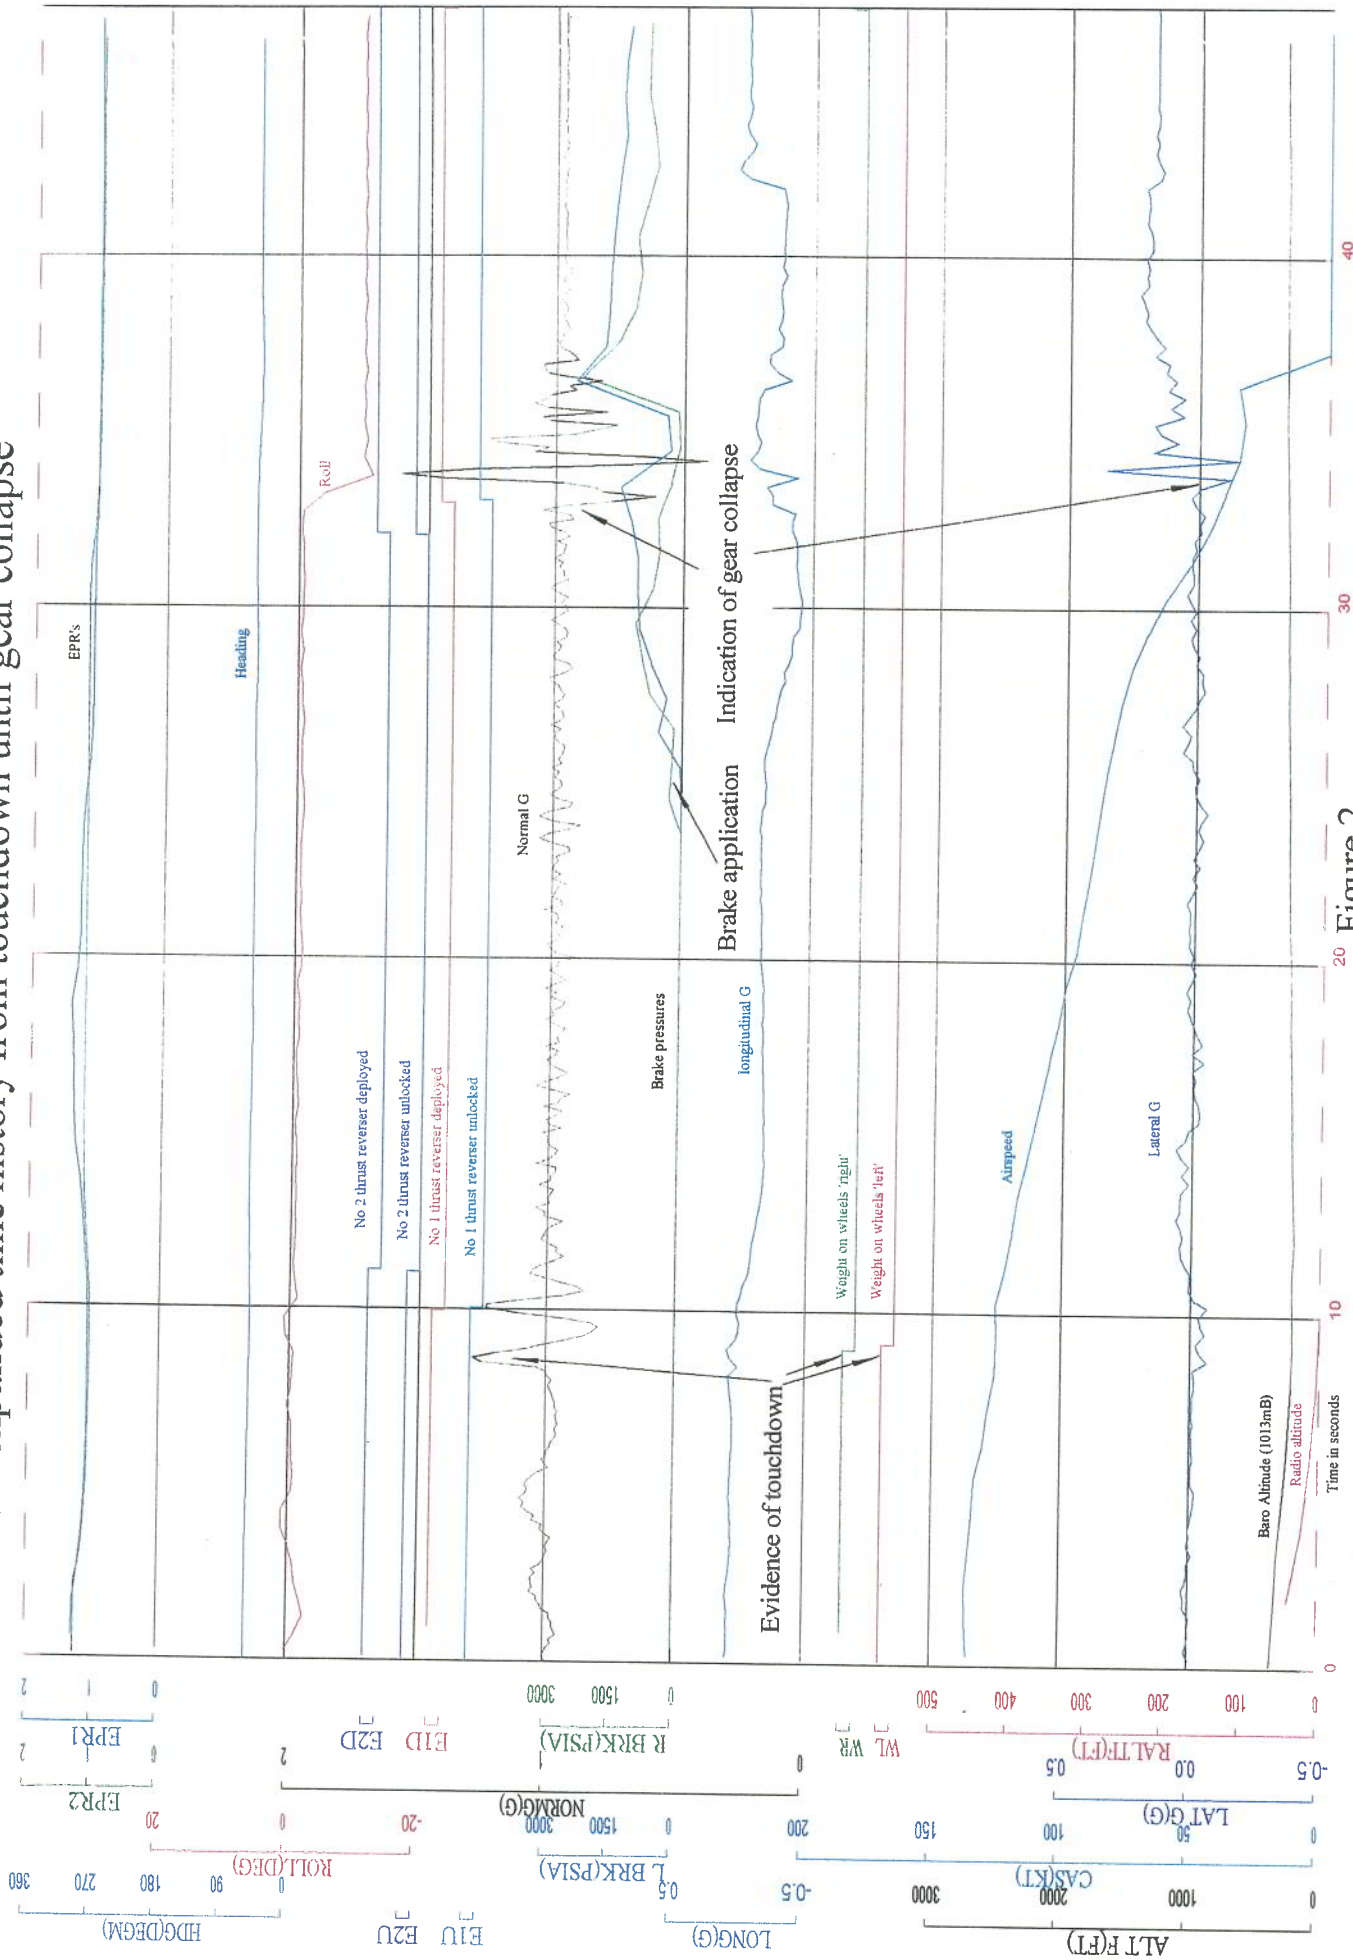
Figure 2

# G-DEVR expanded time history from touchdown until gear collapse

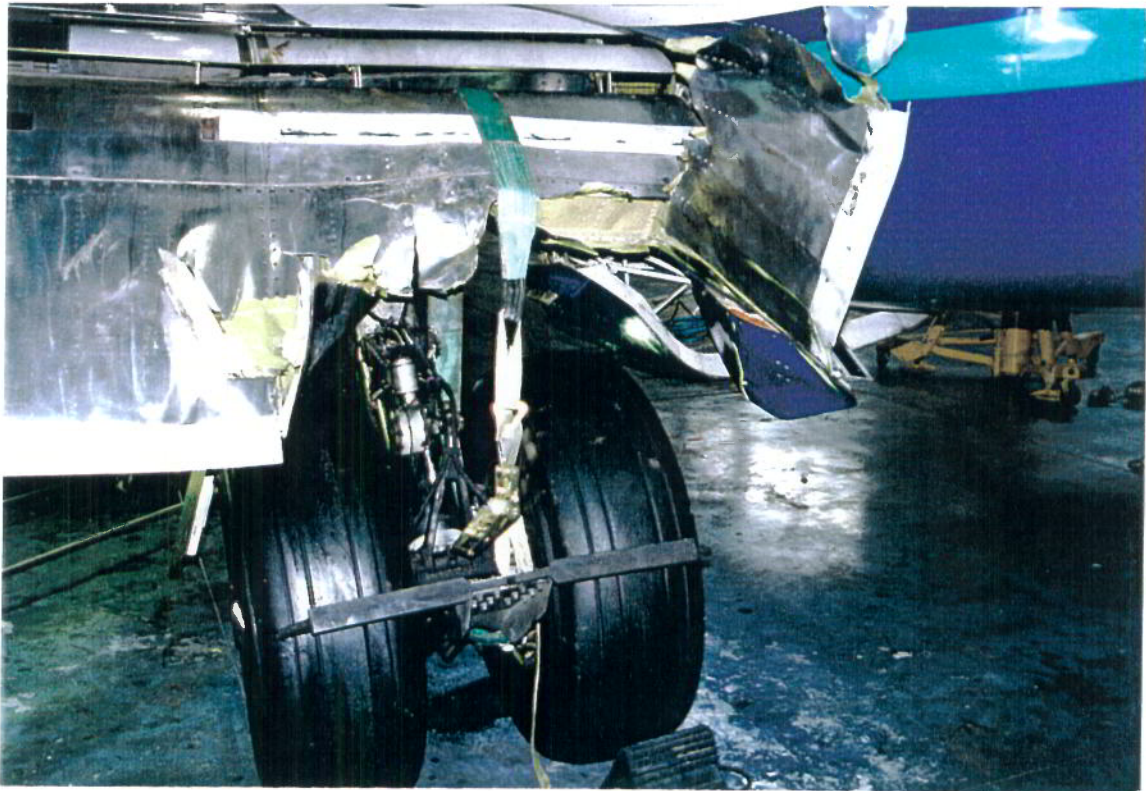
G-DEVR on jacks post-accident. View of left MLG from aft looking forward showing damage to trailing edge flaps

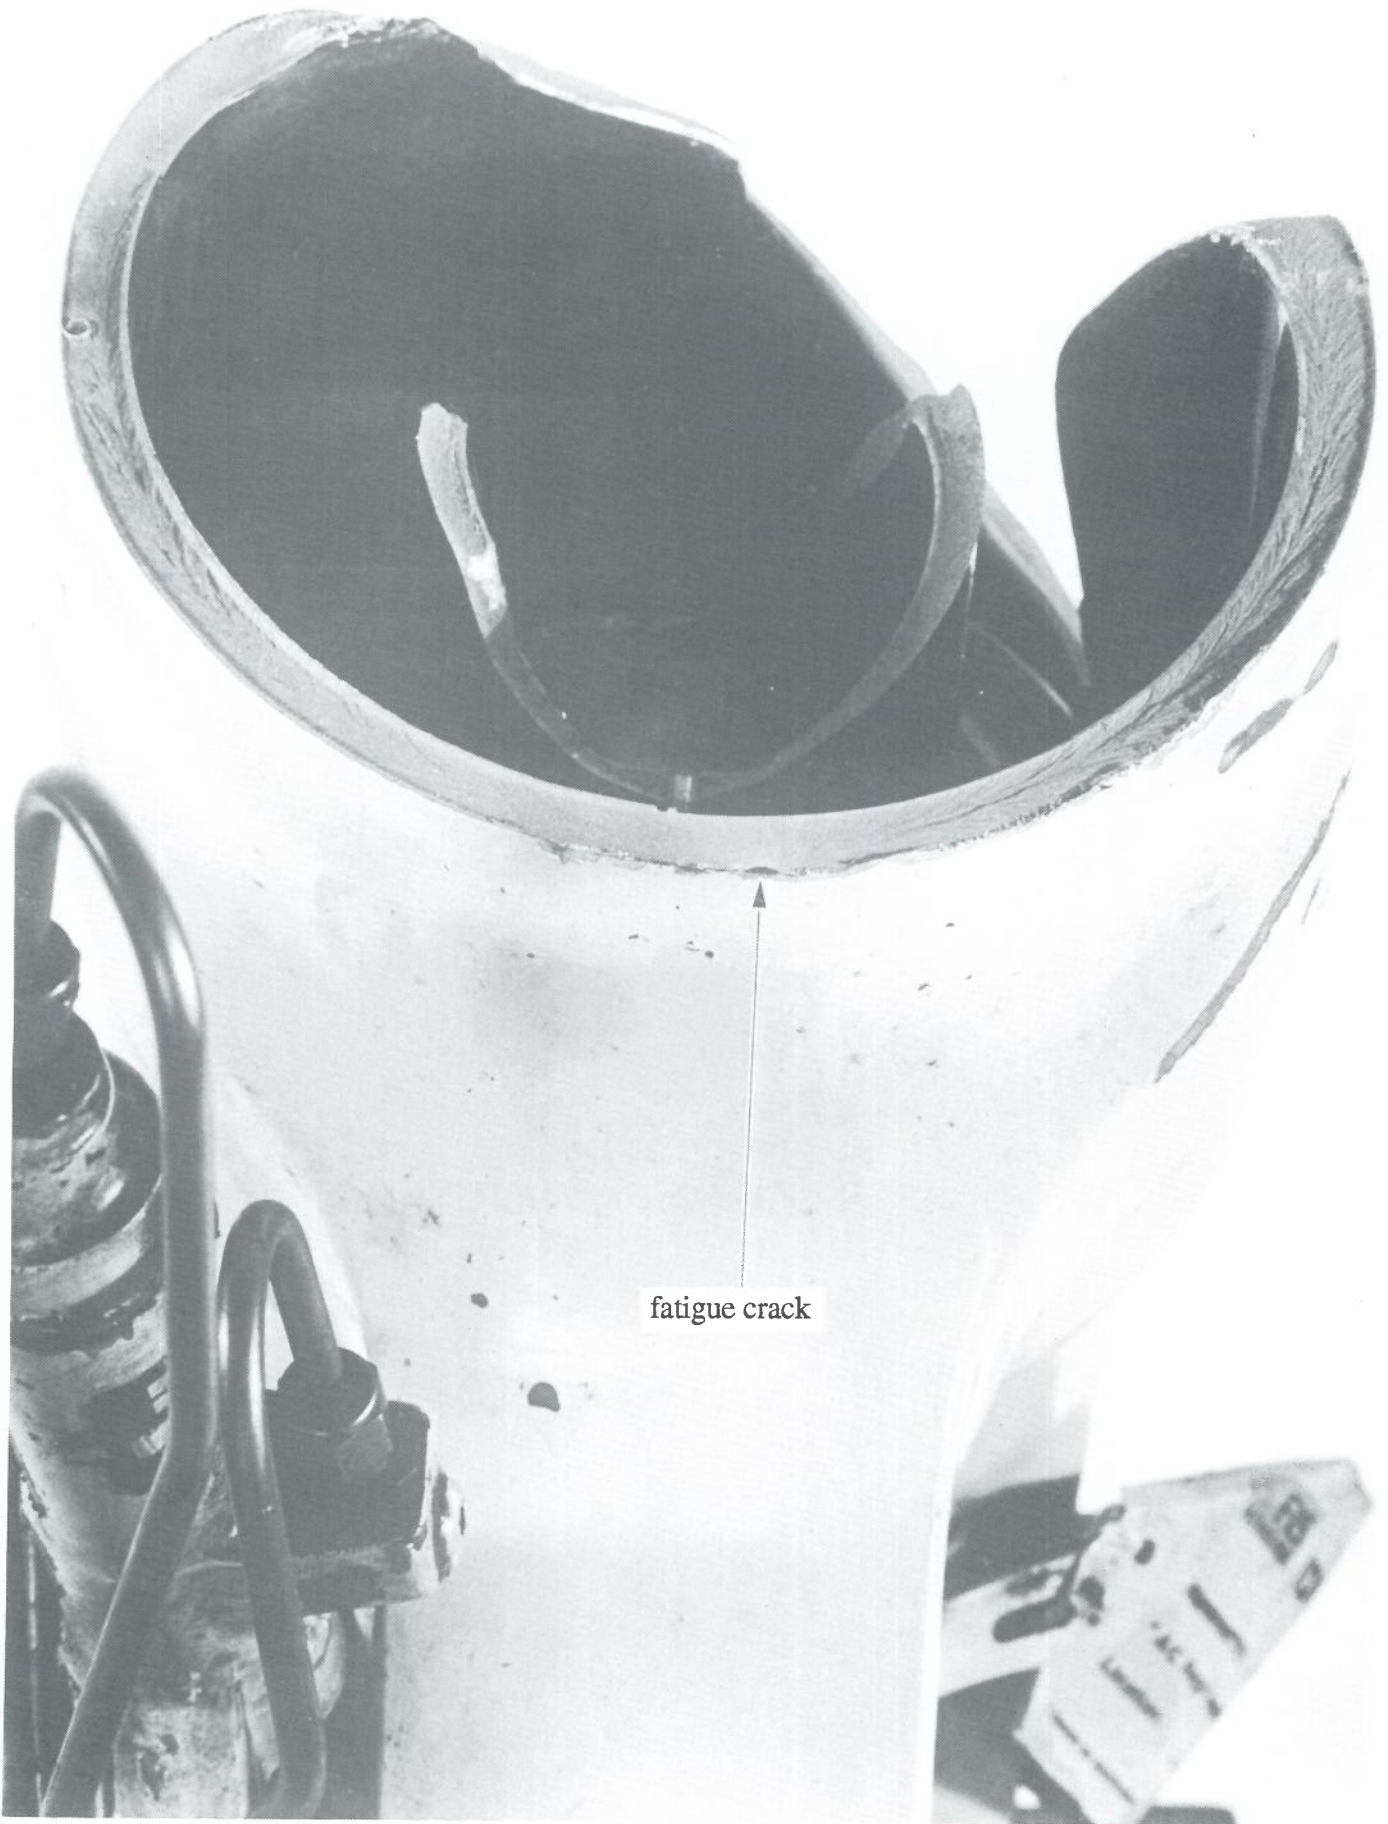
View of lower half of failed MLG cylinder fracture face showing location of pre-existing fatigue crack (arrowed)

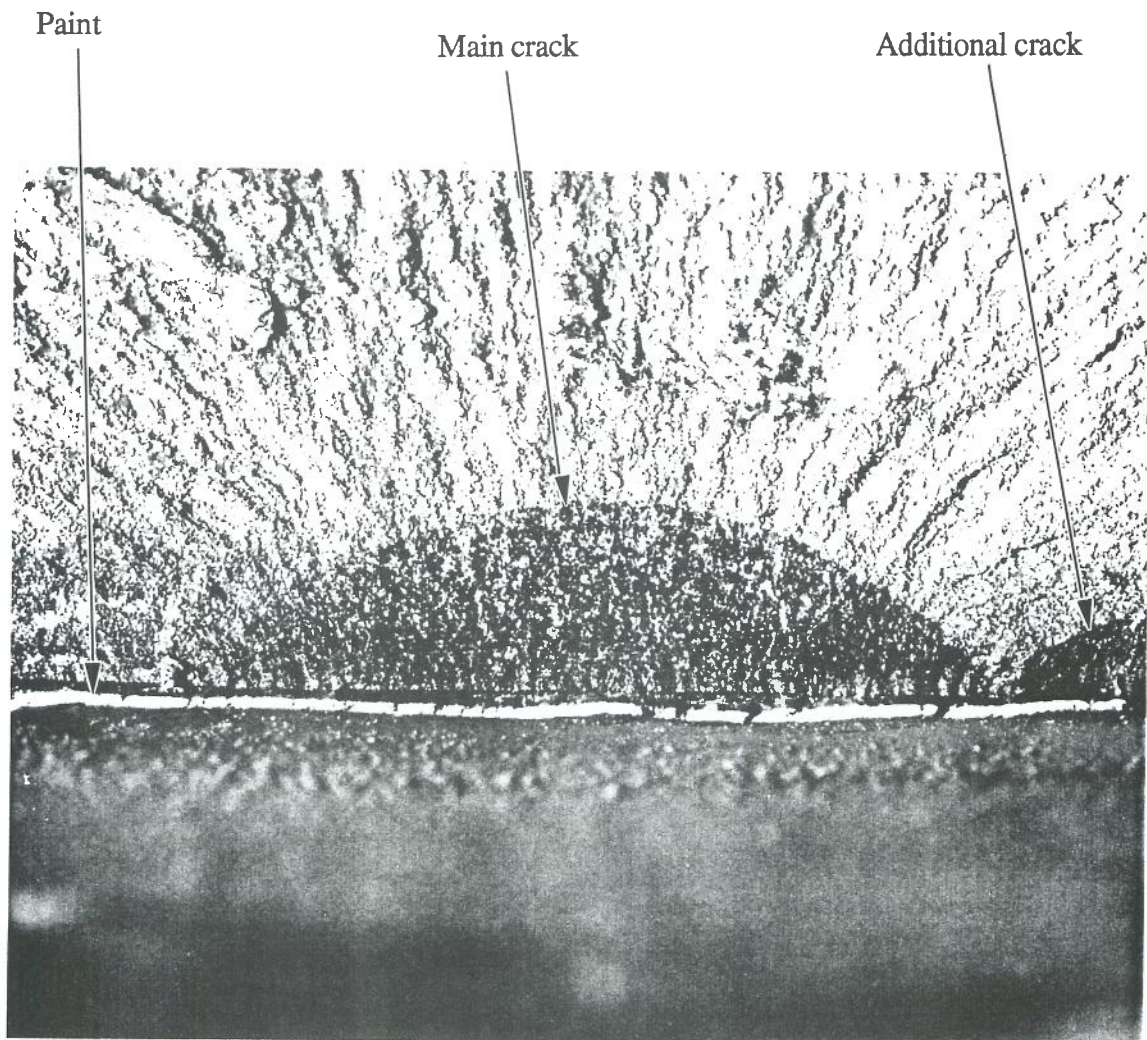
Optical microscope view of major fatigue crack (magnification approx x20)

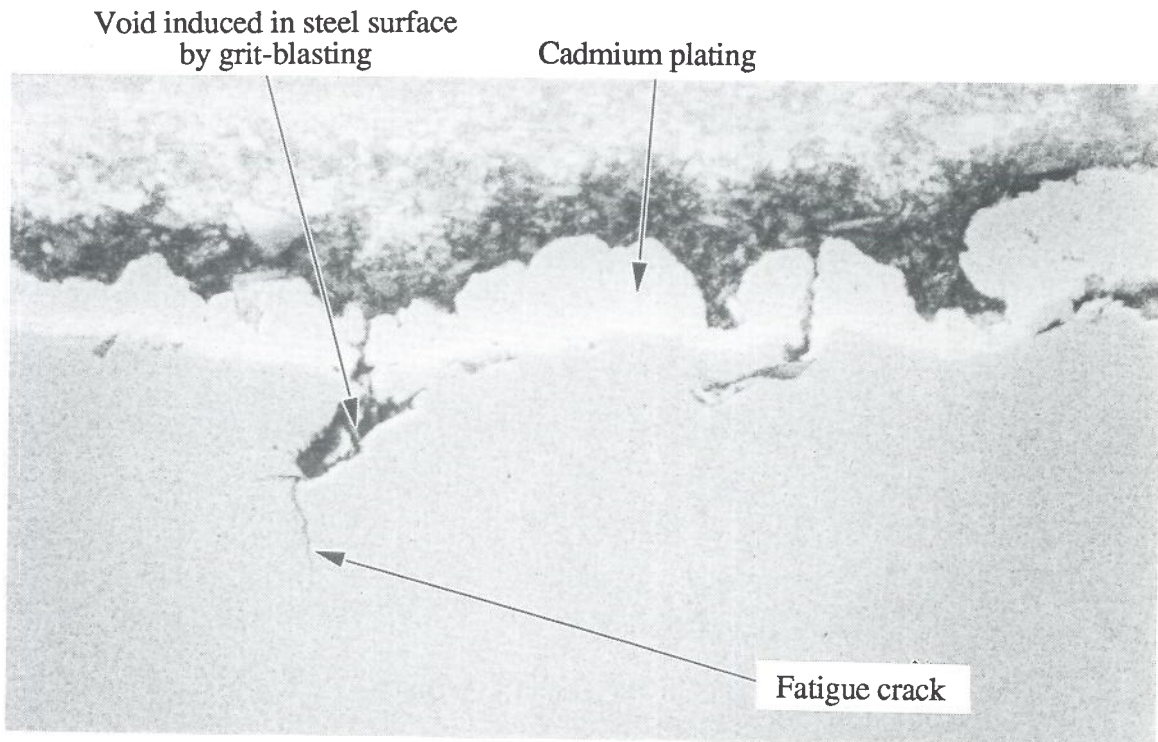
Scanning Electron Microscope view of fatigued area showing irregular surface finish and 'lumpy' appearance of Cadmium plating. Note embryonic fatigue crack growing from larger fold (magnification x1000)

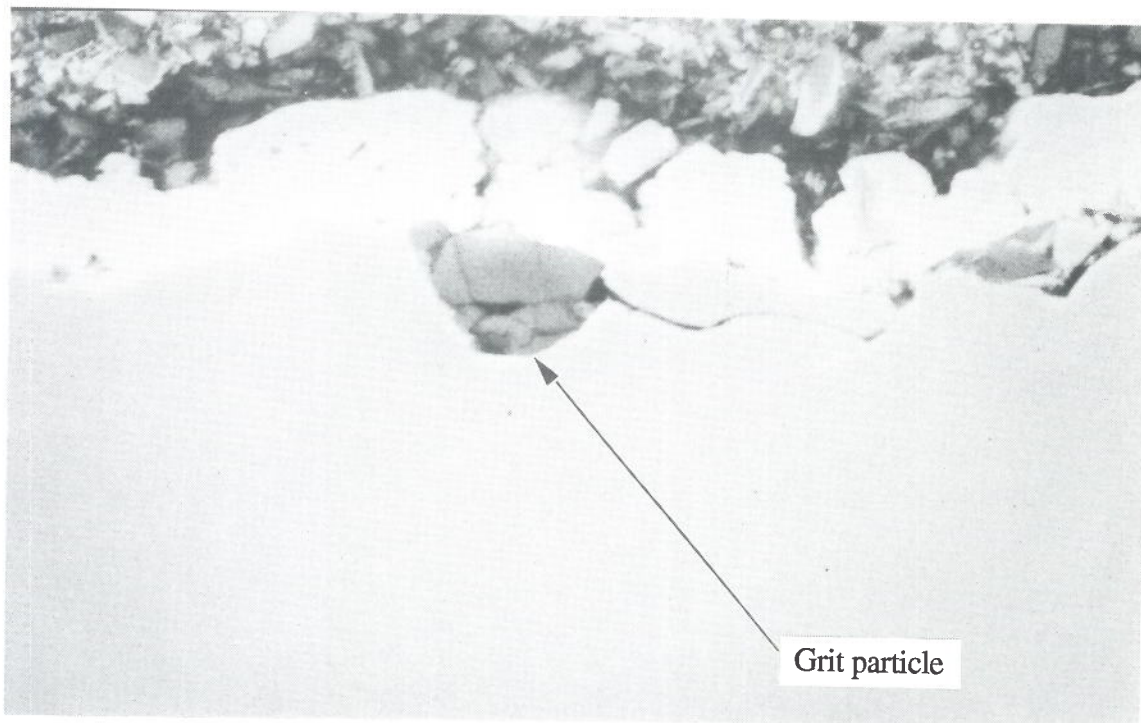
Scanning Electron Microscope view of surface showing particle of alumina grit trapped beneath Cadmium plating (magnification x1900)

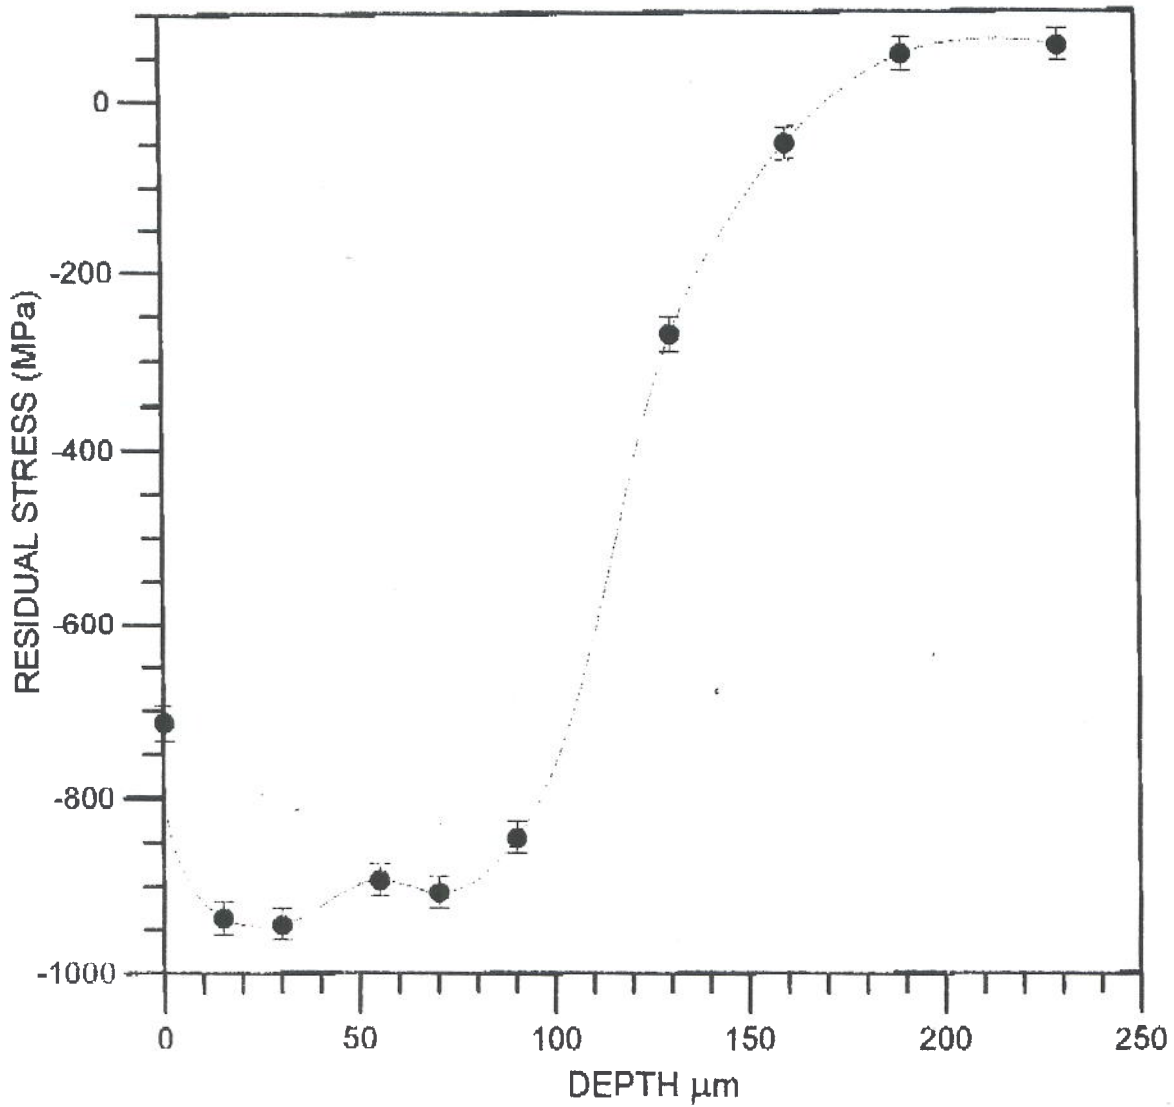
Chart showing results of X-ray diffraction test to measure residual stress in the surface of the cylinder induced by shot peening.

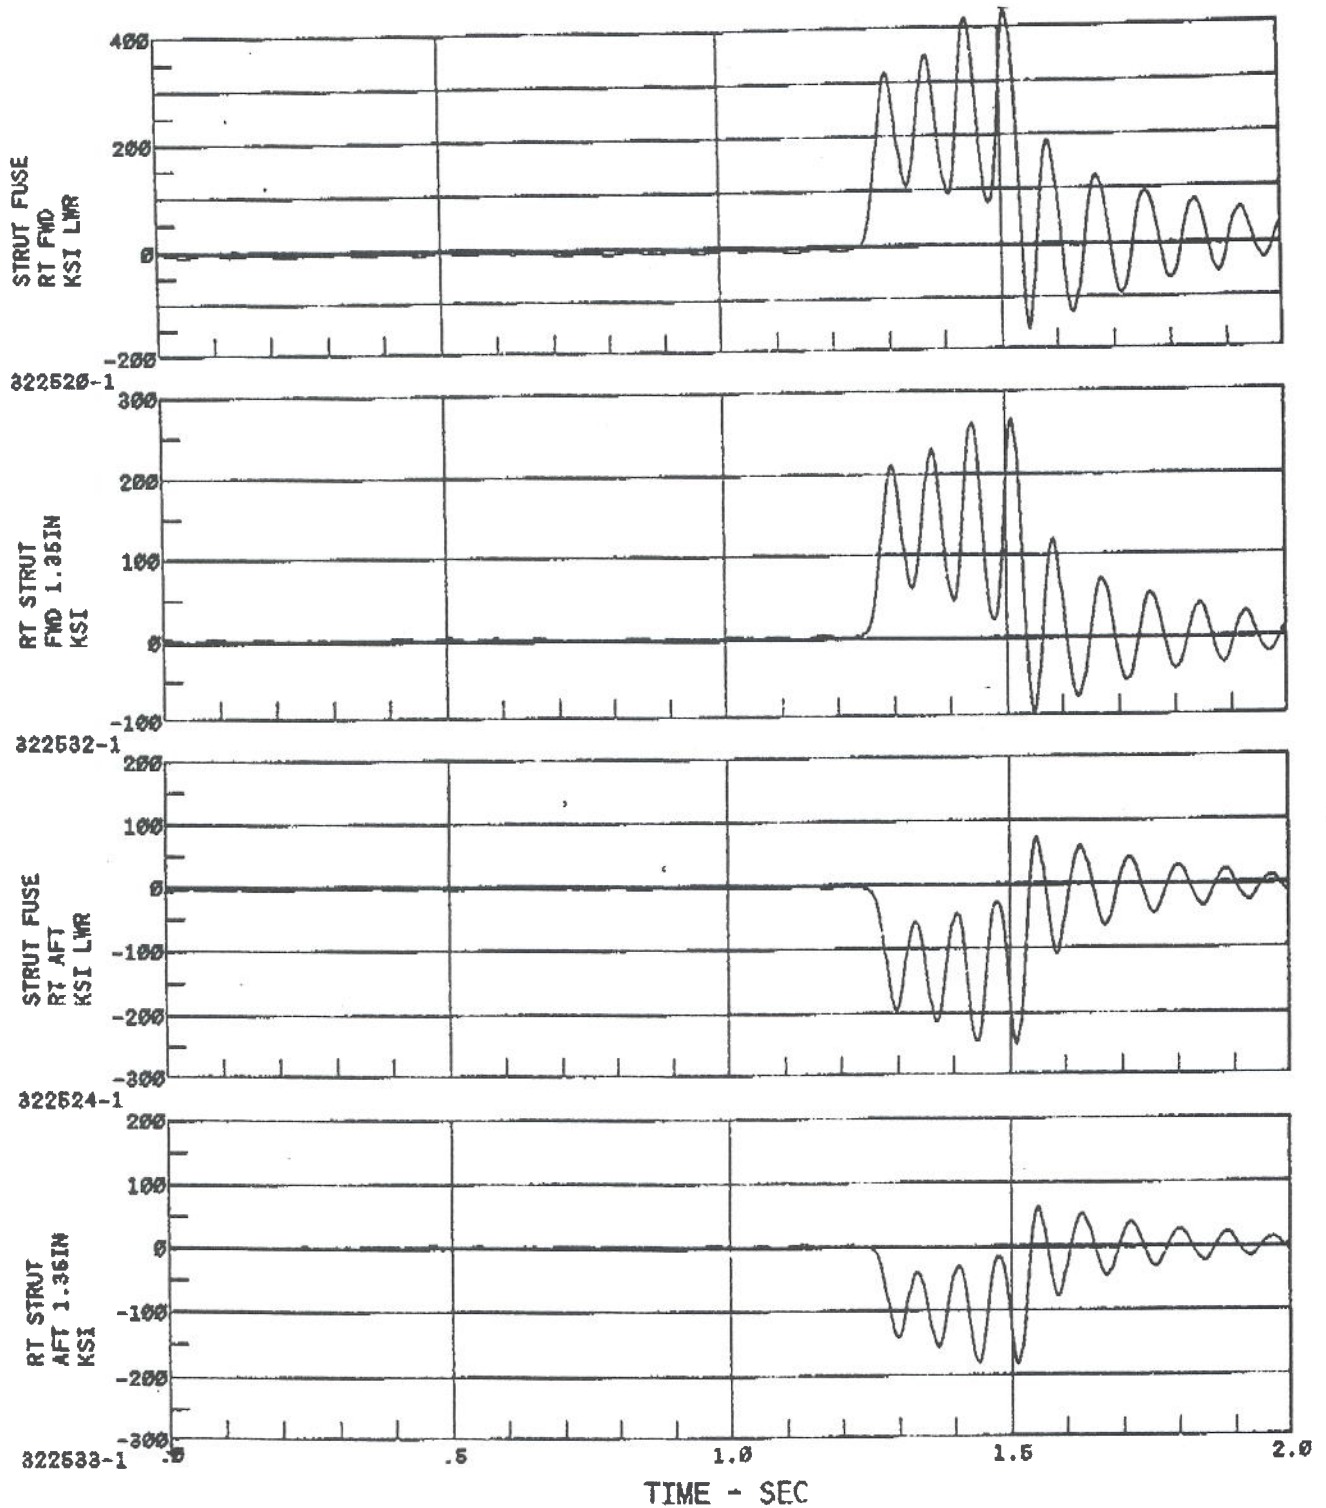
Strain gauge charts showing stresses measured during DAC tests which deliberately induced 'gear walking' on the right main landing gear of a Company MD-87 aircraft.

The first two charts record stress (in KSI) against time (secs) for gauges on the front of the leg both on the critical area and slightly displaced from it.

The second two charts record the same information measured on the rear of the leg

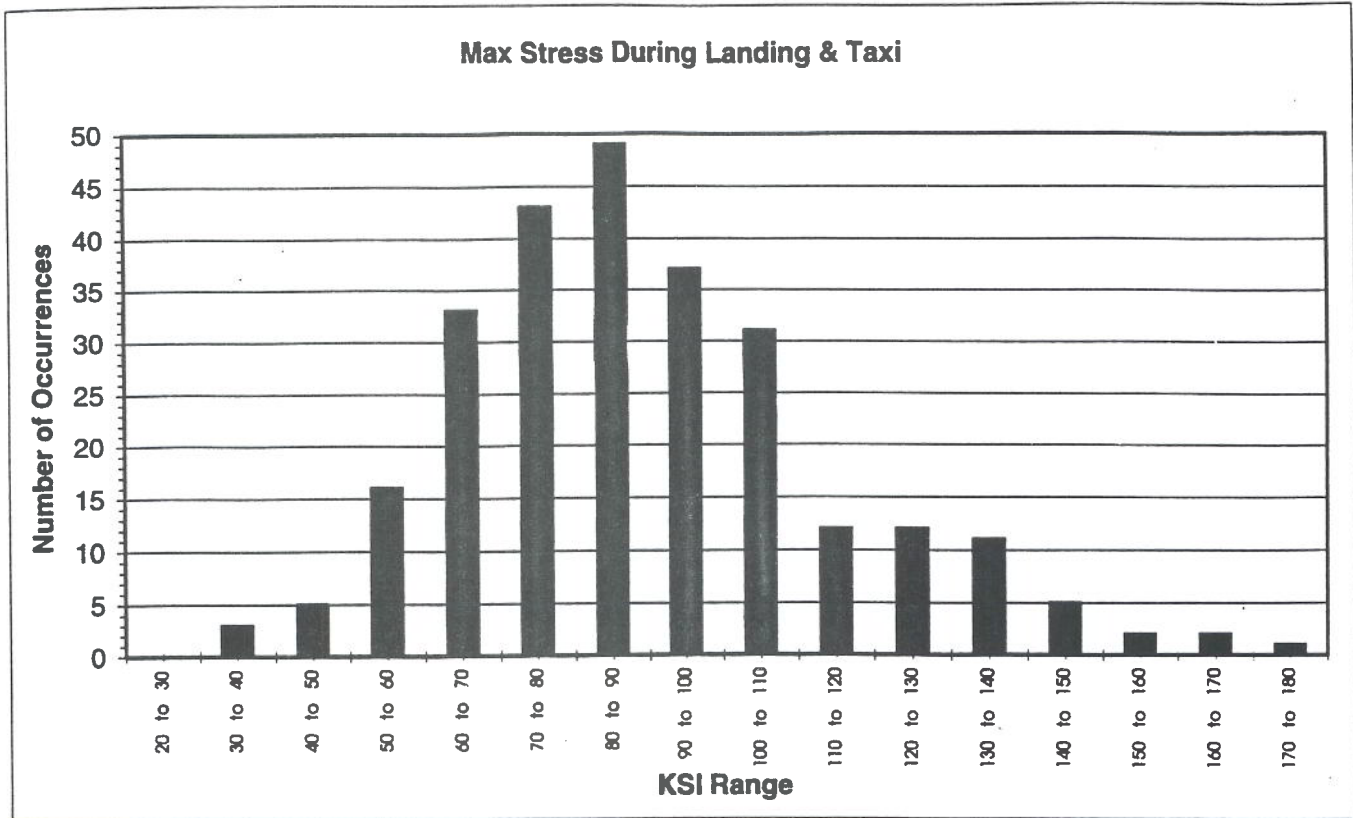
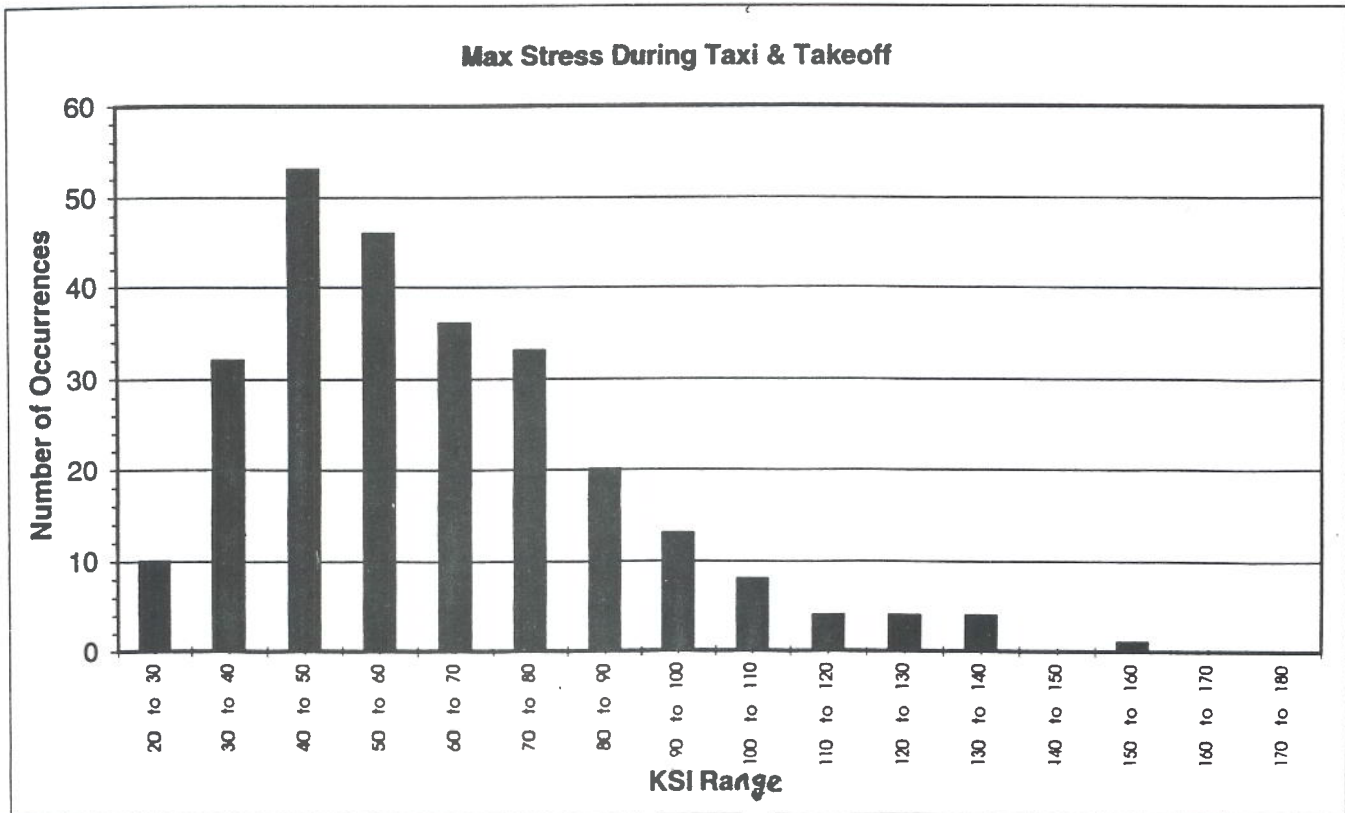
Results of in-service landing gear stress measured by strain gauges fitted to left MLG of G-DEVR after repair
