AAIB Bulletin No: 8/95

Ref: EW/C95/3/3

Aircraft Type and Registration: North American Aviation T-6G Harvard, G-BHTH

Date & Time (UTC): 13 March 1995 at 1630 hrs

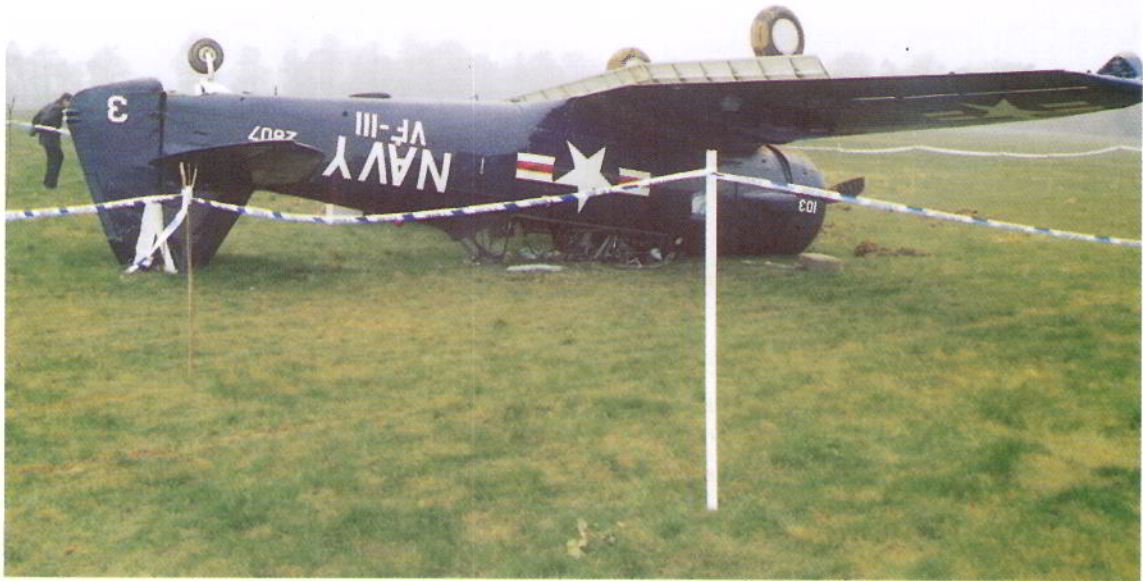
between the ground and the side of the fuselage. The aircraft owner went to fetch a tractor to lift the tail of the aircraft whilst other people attended to the pilot and passenger. After a short while the pilot stopped talking and became very still. The owner returned to the aircraft with the tractor but he was unable to lift the aircraft's tail with the tractor's lifting gear. A photograph of the accident site is shown at Figure 1.

The ground marks indicated that the aircraft touched down heavily in the undershoot area where there was an uphill slope of 4.5°. The disposition of the marks showed that contact was made initially by the tailwheel, followed respectively by the right and left mainwheels. The right wheel made an impression in excess of one foot deep, which was sufficient to submerge it as far as the axle. It was apparent that the aircraft then bounced (although light contact was maintained by the left wheel) for approximately 6 metres, when propeller chop marks were observed in the ground. The mainwheel marks at this point were relatively shallow, and had torn the turf in a manner which suggested that the wheels were skidding as a result of brake application. The distance between successive propeller blade strikes progressively lengthened as the engine RPM reduced, and there was a large scar made by the lower part of the engine cowling before the aircraft nosed over onto its back. The aircraft came to rest approximately 70 metres from the initial impact point.

Figure 1. View of accident site

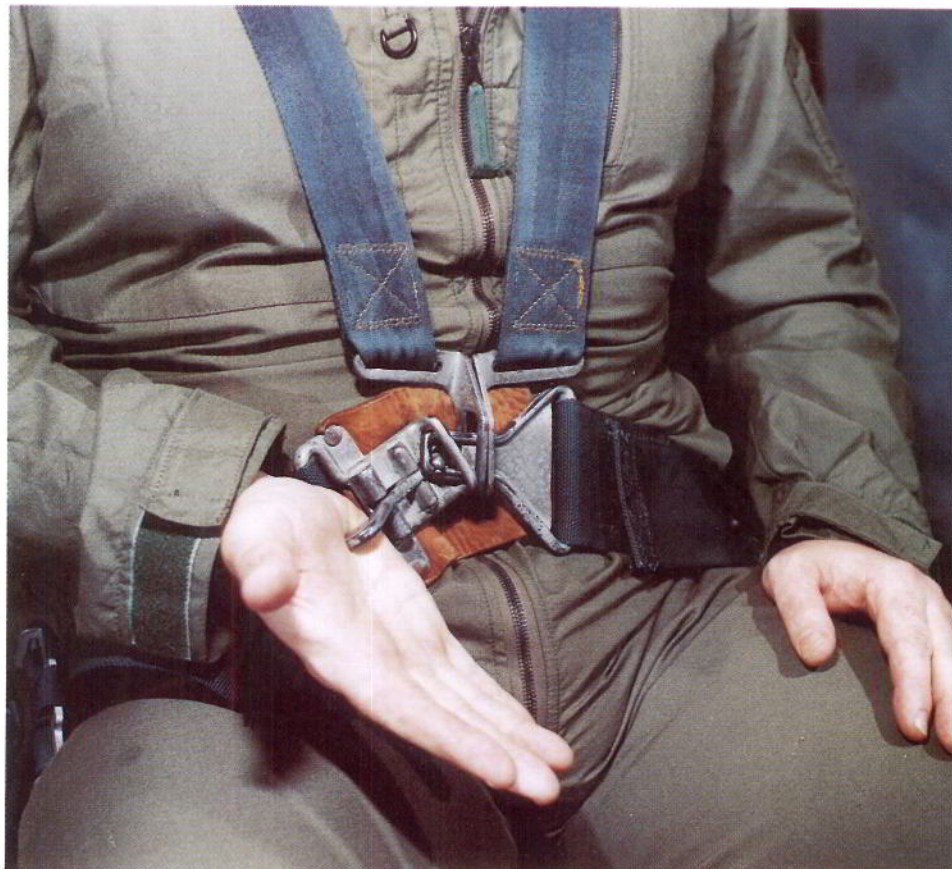
The seat harnesses were of the four-point type comprising a lap strap and two shoulder straps which were attached to a spring loaded reel mounted on the rear of the seat. The reel could be locked by means of a lever mounted on the left side of the seat. The lap strap webbing was stiff and appeared to be original; however the shoulder straps seemed to be of more recent manufacture. None of the components bore any manufacturer's identification marks. Eyes in lugs attached to the shoulder straps are passed over a hasp on one of the lap straps which engages with a hook and locking lever assembly on the other lap strap. It was noted that when the lap strap assembly was adjusted so that it was loose, the shoulder straps pulled on each lap strap half so that they formed an inverted 'V'. This altered the geometry of the hasp in the hook such that releasing the harness, by means of operating the locking lever, became difficult and sometimes impossible to achieve. This feature was apparent on both front and rear harnesses. A photograph of the harness with the connector in the potentially jammed position is shown at Figure 2. Long term wear patterns could be discerned on the mating areas of the hooks and hasps with the lap strap in the inverted 'V' noted above. It could not be established whether the pilot had remained strapped in his seat through an inability to release the harness.

The inversion tests using the mannikin involved flexing the torso forwards to reproduce the as-found position of the pilot. It was observed that the harness connector adopted the angle as described earlier such that its release was extremely difficult. The test was repeated using the human volunteer: with the rig inverted and the torso of the subject flexed forward, the overlap of the thighs onto the abdomen resulted in it being virtually impossible to reach and release the harness. The test had to be abandoned after a few minutes due to distress experienced by the subject.

Figure 2. View of harness with buckle in potentially jammed position
(Photo: RAF School of Aviation Medicine)

It is recommended that the Civil Aviation Authority publicise, for example, by means of an article in GASIL, the potential difficulties of releasing this type of harness if the aircraft is inverted, and emphasising the importance of correct adjustment of the harness.
