No: 9/89

Ref: EW/G89/01/04

Aircraft Type and Registration: DHC-6 Twin Otter 310, G-JEAC

Location: Southend Airport

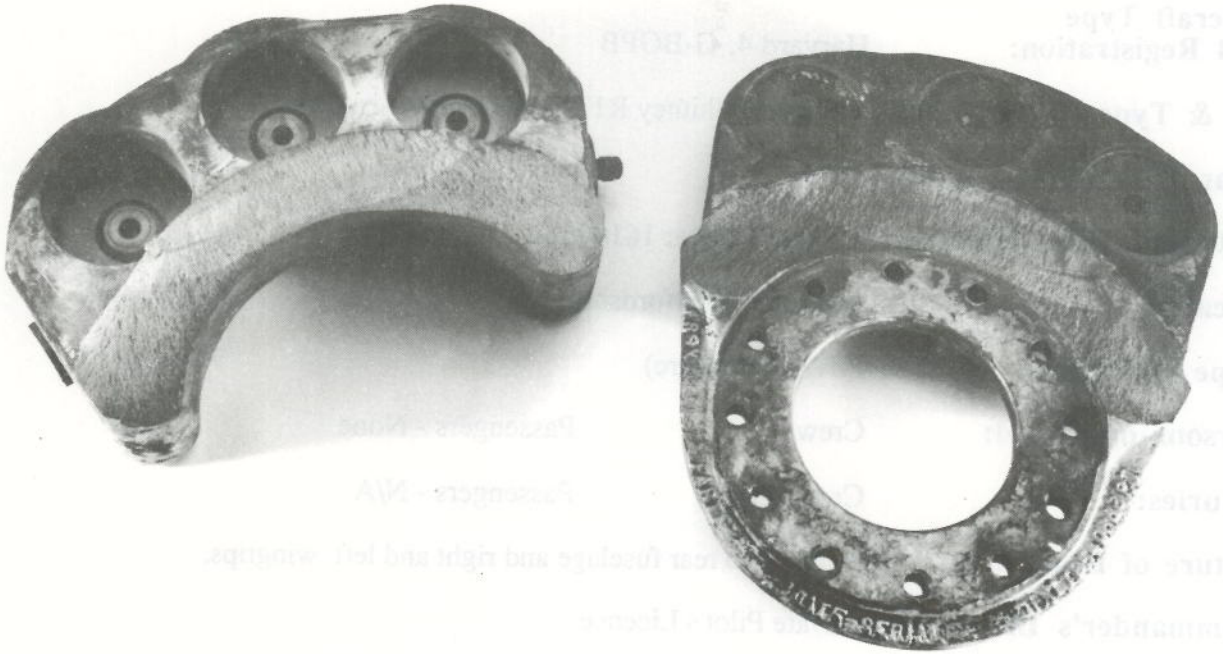
Figure 1. Failed brake calliper from G-JEAC

A photograph of the failed calliper, which is manufactured from magnesium alloy, is shown at Fig. 1. The fracture surfaces were examined by the Materials and Structures Department of the Royal Aerospace Establishment at Farnborough. This examination revealed that the failure had occurred from

a fatigue crack, with multiple origins located around a 158 mm length of the blending radius, on one side of the calliper slot. Cracks were also found in the blending radius on the other side of the slot. In both cases the crack origins had initiated from corrosion attack on the horizontal surface of the slot. During manufacture, the component should have been corrosion protected in accordance with a process specification that included a chromate treatment. Qualitative X-ray analysis of the surface confirmed the presence of chromium, and also other elements which most probably resulted from brake wear debris. In particular there was a high level of iron, which is likely to have helped promote the corrosion process. Thus, although there was evidence that some corrosion protection had been applied, it was apparent that it had not remained effective.

The unit had a serial number which indicated that it had been manufactured in 1978. According to the operator, it was fitted to G-JEAC in November 1986 and had achieved a total life estimated at 8000 hrs/8000 landings. The brake unit was maintained 'on condition', ie there was no requirement for periodic maintenance.
