BULLETIN ADDENDUM

AAIB File:	EW/G2004/10/06
Aircraft Type and Registration:	Gulfstream AA-5B Tiger, G-BFZR
Date & Time (UTC):	15 October 2004 at 1545 hrs
Location:	1 mile west of Oxford Kidlington Airport, Oxfordshire
Information Source:	Report submitted by maintenance organisation

AAIB Bulletin No 2/2005, page 57 refers

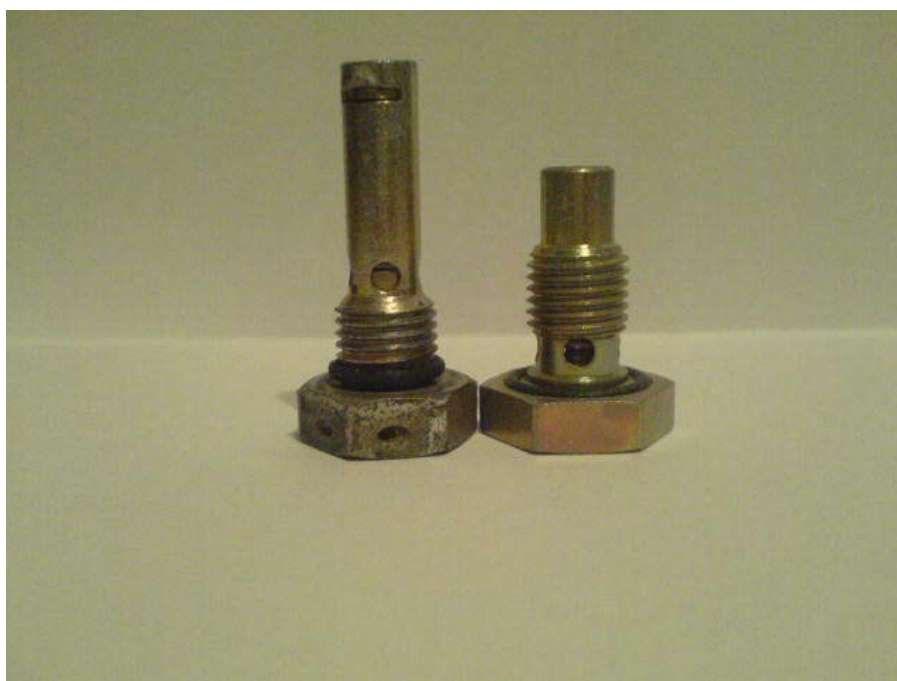
Figure 1

During a recent inspection of this aircraft an incorrect type of fuel drain was found fitted to its left wing. The sampling holes of this drain were located higher up the body of the fitting than on the correct type such that a greater depth of fluid in the wing remained unchecked during its operation (Figure 1). This might account for the significant amounts of water found in the fuel

system after the accident which were not detected in samples taken during preflight checks.

Image showing difference between the fuel drains

Each type of fuel drain can be identified by its part number which is visible on the outside (bottom) face of the drain.
