No: 1/92

Ref: EW/G91/10/03

Aircraft Type and Registration: Cessna 421C Golden Eagle, G-TELL
No & Type of Engines: 2 Continental GTSIO-520-L piston engines
Year of Manufacture: 1980
Date & Time (UTC): 4 October 1991 at 1030 hrs
Location: Southampton (Eastleigh) Airport, Hampshire
Type of Flight: Private
Persons on Board: Crew - 1 Passengers - 4
Injuries: Crew - None Passengers - None
Nature of Damage: Damaged aileron trim tab
Commander's Licence: Private Pilot's Licence with Instrument rating
Commander's Age: 58 years
Commander's Flying Experience: 2,780 hours (of which 310 were on type)
Information Source: Aircraft Accident Report Form submitted by the pilot and AAIB examination of failed component

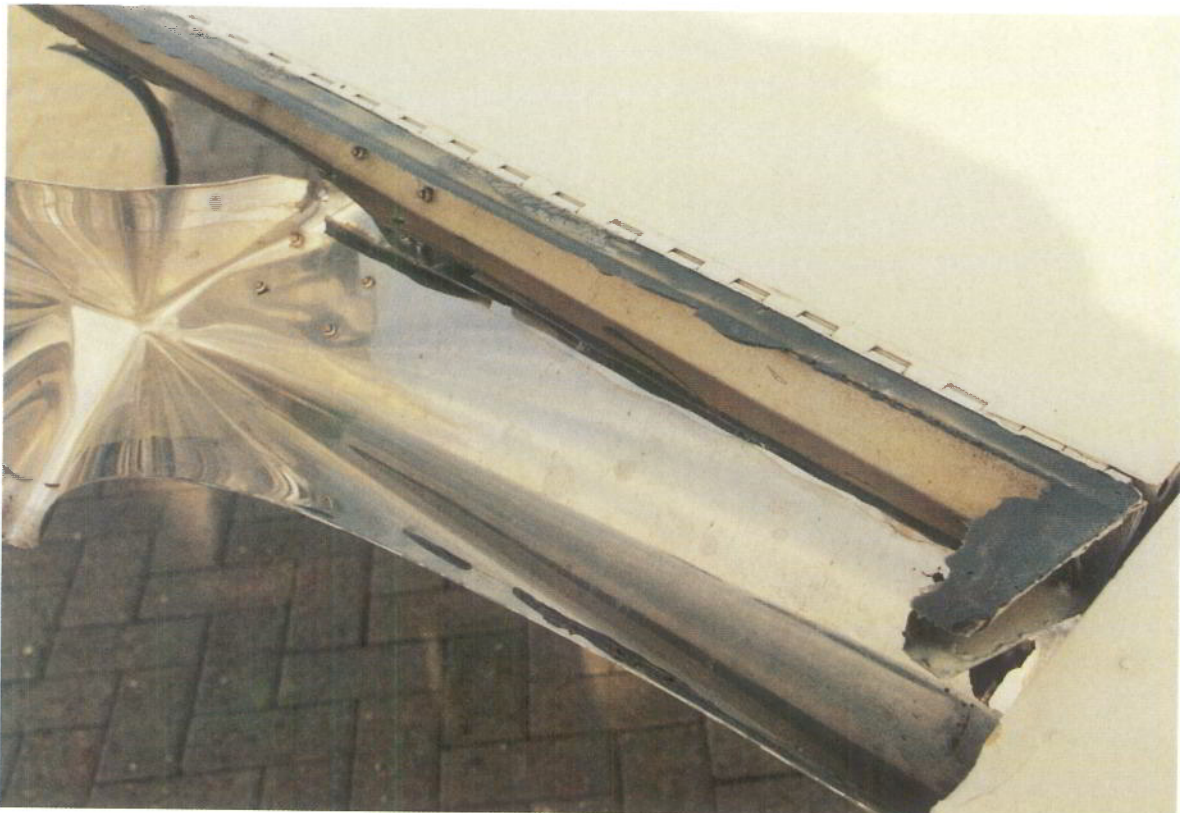
Subsequent inspection revealed that the trim tab on the left aileron had become disbonded. The tab is of lightweight construction, consisting of two end ribs joined to a spanwise spar that incorporates the 'piano' hinge. A single piece of alloy skin, folded at the trailing edge, is bonded to the ribs and spar. It was apparent that there had been a complete bond failure, as can be seen in the accompanying photograph. The tab skin was prevented from becoming detached from the aircraft only by the operating arm attachment bracket which was rivetted to the underside of the tab. The tab was examined by the Materials and Structures Department of the Royal Aerospace Establishment, and the aircraft manufacturer assisted by providing constructional details. It was noted that:-

The adhesive, which was in a soft and rubbery state, was not of the specified type.

Although there was a yellow tint consistent with bond primer having been applied to the spar and ribs, no such treatment was evident on the skin.

There were large areas of voids in the adhesive, which would have weakened the joint and rendered it more susceptible to degradation by moisture.

Adhesive could be peeled off the skin very easily, indicating a very weak bond. By contrast, the adhesive could not be peeled from the spar assembly.

The skin did not have the visual appearance of having been etched; however, it would have been necessary to carry out additional work involving etching samples of the alloy actually used, in order to confirm this.

No part numbers or inspection stamps were visible anywhere on the assembly.

The trim tab's source of manufacture could not thus be identified. The aircraft manufacturer has requested that the component be returned to them for additional investigation. A UK Cessna dealer has ventured the opinion that a replacement skin had been bonded to the original spar/end rib assembly.

Aileron trim tab on G-TELL showing disbonding between skin, ribs and spar
