ACCIDENT

| Aircraft Type and Registration: | Nord NC854S, G-BGEW | |
| Date & Time (UTC): | 20 September 2009 at 1130 hrs | |
| Location: | Whistlers Farm, Tangley, Hants (Approx 4 miles North of Andover) | |

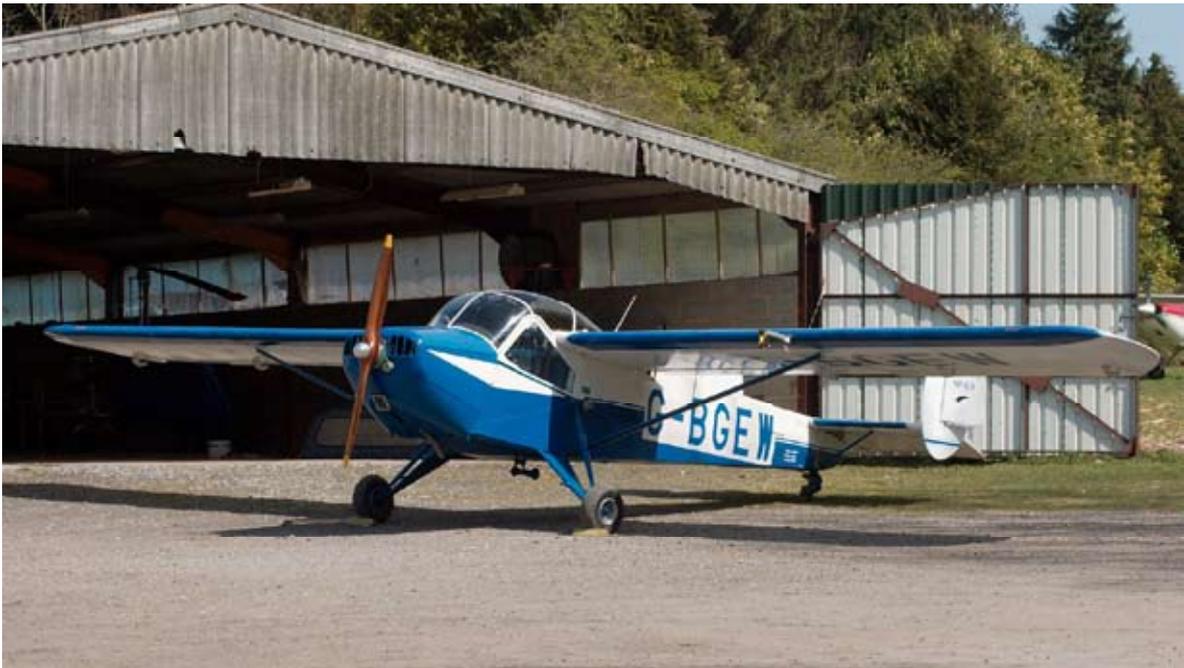
Figure 1

The Nord NC.850 (originally produced as the Aérocentre NC.850), from which the NC854S was developed, was a light aircraft developed in France in the late 1940s for use by French aeroclubs but which also saw military use as an airborne observation post. It is a high-wing, strut-braced monoplane with a fully enclosed two seat cabin (side by side configuration). The landing gear is fixed and of tailwheel configuration. The fuselage construction is welded tubular steel, the wings have a metal structure and the entire aircraft is skinned in fabric (Figure 1). A brief history of the type is shown below:

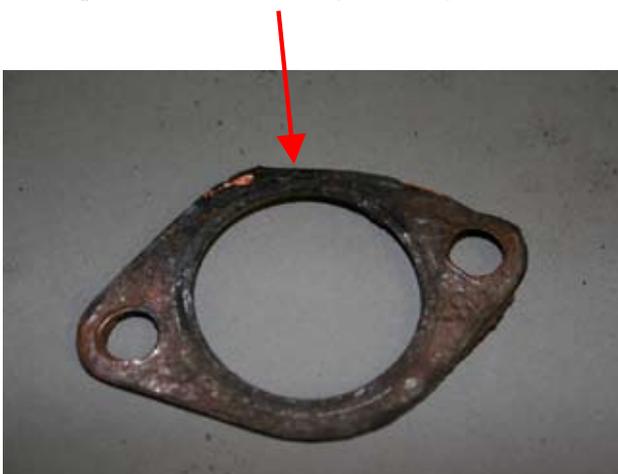
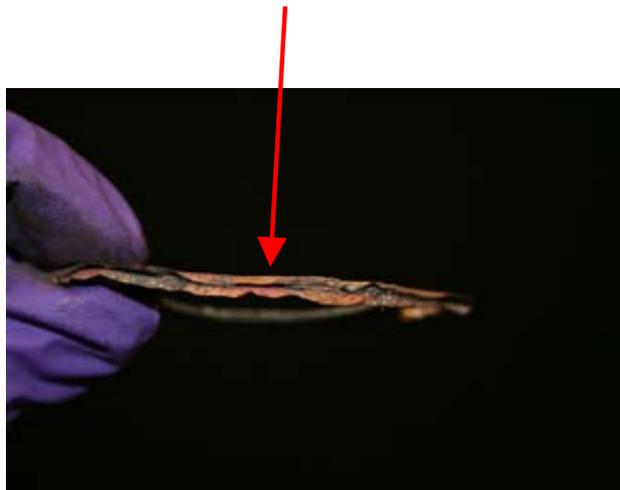
Figures 2 & 3
Exhaust gaskets removed from the accident aircraft

Post-accident disassembly of the exhaust system revealed significant deterioration and de-lamination of the four gaskets at the exhaust pipe/engine cylinder interface on each cylinder. The surfaces adjacent to the gaskets did not appear to have been exposed to the intense post-impact fire. Some gaskets displayed evidence of carbon deposits consistent with ‘blow-by’, indicating that exhaust gases may have been escaping whilst the engine was operating, Figures 2 and 3.

Flange curvature will prevent a gasket from making an effective seal, exposing it to the high temperatures of the exhaust gas stream. This may explain why the exhaust gaskets were found to be in such a poor condition. It is not known how long these particular gaskets had been fitted to the aircraft.

Notable area of carbon deposited which could indicate significant pre-accident exhaust gas leakage

Significant gasket de-lamination

Although it cannot be ruled out that the carbon monoxide found in both occupant's blood originated from another source, it is likely that it originated from an exhaust leak, or leaks, at the exhaust pipe/engine cylinder interface, where all four gaskets and three of the pipe flanges were found to be in very poor condition. It is possible that the exhaust gasses may have passed from the engine bay into the cockpit by either mixing with the slipstream around the cockpit, or by passing through various small apertures in the firewall. It was the opinion of the pathologist that a COHb level of 24.7% in the pilot would have resulted in a severe headache, nausea and a feeling of grogginess to the

‘Exhaust systems must give complete sealing; flanges, gaskets and air intake sealing must be regularly examined and maintained...Should a component be inaccessible for a thorough visual inspection or hidden by non-removable parts, remove the component and check for possible leaks.’

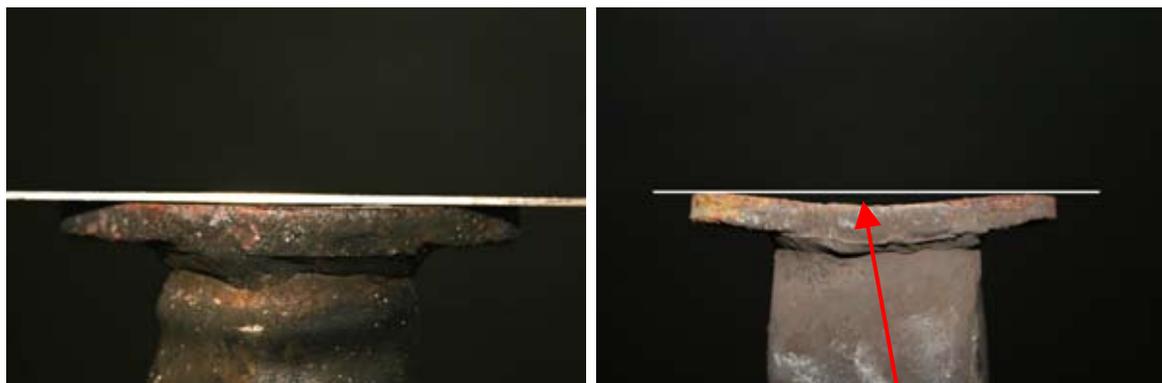
Further inspections revealed deformation of three of the four engine cylinder exhaust pipe flanges. The deformation observed seemed inconsistent with impact damage when the aircraft’s attitude and orientation in the final moments of flight were taken into consideration, and it is possible that such deformation may have been introduced by over-tightening of the joints during routine maintenance.

Figures 4 & 5 display exhaust pipe flanges from the aircraft wreckage from two separate engine cylinders, showing the flange without deformation, and one of the three with deformation, respectively.

Notable gap

Two of the exhaust flanges removed from the accident aircraft
