INCIDENT

Aircraft Type and Registration:	Boeing 757-2K2, G-LSAN	
No & Type of Engines:	2 Rolls-Royce RB211-535E4 turbofan engines	
Year of Manufacture:	1994 (Serial no: 26635)	
Date & Time (UTC):	7 August 2012 at 1535 hrs	
Location:	Over the North Sea, approximately 85 nm north-east of Newcastle Airport	
Type of Flight:	Commercial Air Transport (Non-Revenue)	
Persons on Board:	Crew - 2	Passengers - 1
Injuries:	Crew - None	Passengers - None
Nature of Damage:	None	
Commander's Licence:	Airline Transport Pilot's Licence	
Commander's Age:	51 years	
Commander's Flying Experience:	8,058 hours (of which 6,017 were on type) Last 90 days - 136 hours Last 28 days - 41 hours	
Information Source:	Aircraft Accident Report Form submitted by the pilot and further enquiries by the AAIB

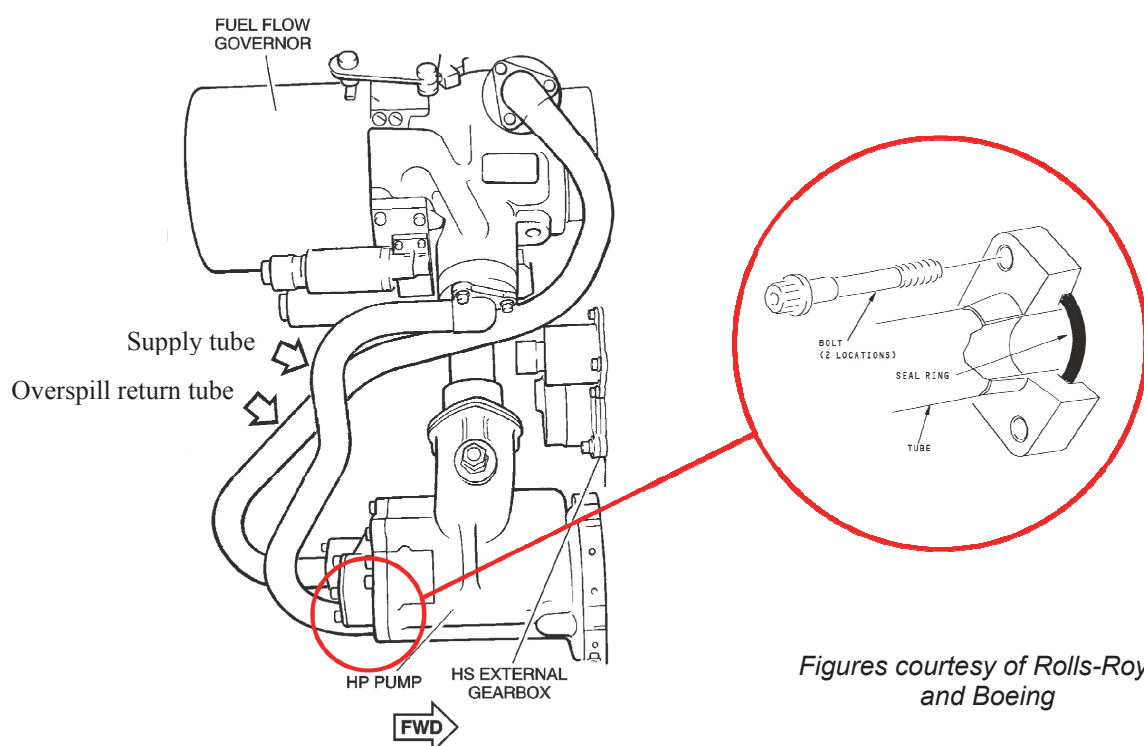
Figure 1

Inspection of the right engine's fuel system revealed that the source of the fuel leak was the pump-end flanged joint of the fuel supply tube running between the high pressure (HP) fuel pump and the fuel flow governor (Figure 1). This fuel tube had been installed during the C-check as part of a recommended Service Bulletin, RB.211-73-G230. This Service Bulletin recommends the replacement of earlier standards of fuel tube that were the source of previous fuel leaks; the AAIB report on G-TCBA, published in AAIB Bulletin 4/2011, refers to one such incident.

Location of the supply and overspill fuel tubes between the HP fuel pump and fuel flow governor, including detail of the supply tube's flanged end fitting

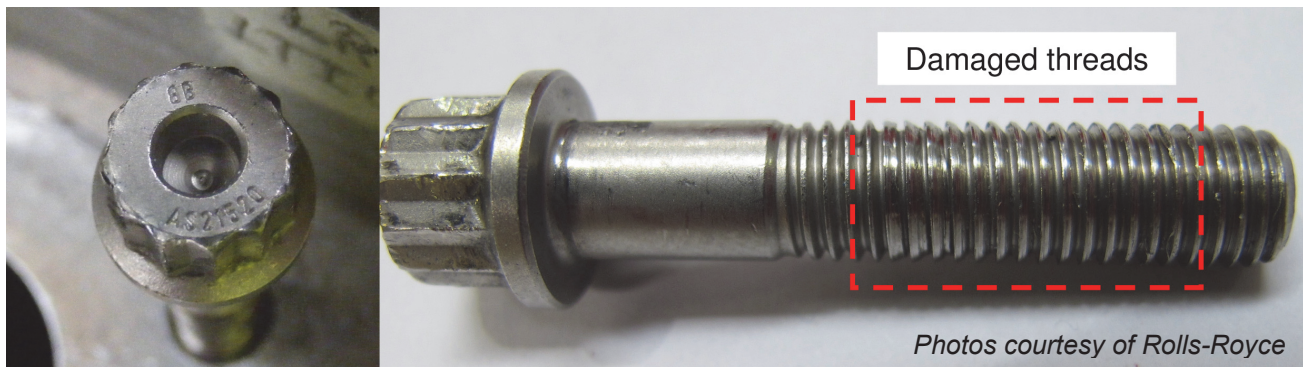
Figure 3

The threads on the lower bolt were found to be damaged, as was the start thread of the wire-thread insert in the pump body which had been displaced upwards slightly, and metallic debris was present on the insert's threads.

Examination of the damaged thread forms showed that the bolt had not been cross-threaded, rather that the start thread of the wire-thread insert had 'picked up' during insertion of the bolt, causing a progressive rounding-over of the bolt's threads as the bolt was tightened. A subsequent trial at the HP fuel pump manufacturer's overhaul facility, using a new bolt in the same hole, showed that whilst similar damage occurred to the bolt threads, the bolt torque specified in the Service Bulletin, 102 lbf-in, was only achieved when the flanged joint was fully fastened. It is therefore unlikely that the damaged wire-thread insert caused the lower bolt to remain only

Lower bolt showing damaged threads and galling marks on head

The galling damage observed on the lower flange bolt and pump body, together with the damaged wire-thread insert suggests that difficulties were experienced
