INCIDENT

Aircraft Type and Registration:	Boeing 737-800, TC-JGR	
No & Type of Engines:	2 CFMI CFM56-7B26 turbofan engines	
Year of Manufacture:	2006	
Date & Time (UTC):	16 October 2006 at 1101 hrs	
Location:	On departure from London Stansted Airport, Essex	
Type of Flight:	Commercial Air Transport (Passenger)	
Persons on Board:	Crew - 6	Passengers - 93
Injuries:	Crew - None	Passengers - None
Nature of Damage:	None	
Commander's Licence:	Airline Transport Pilot's Licence	
Commander's Age:	44 years	
Commander's Flying Experience:	10,500 hours (of which 7,000 were on type) Last 90 days - 230 hours Last 28 days - 82 hours	
Information Source:	AAIB Field Investigation

Synopsis

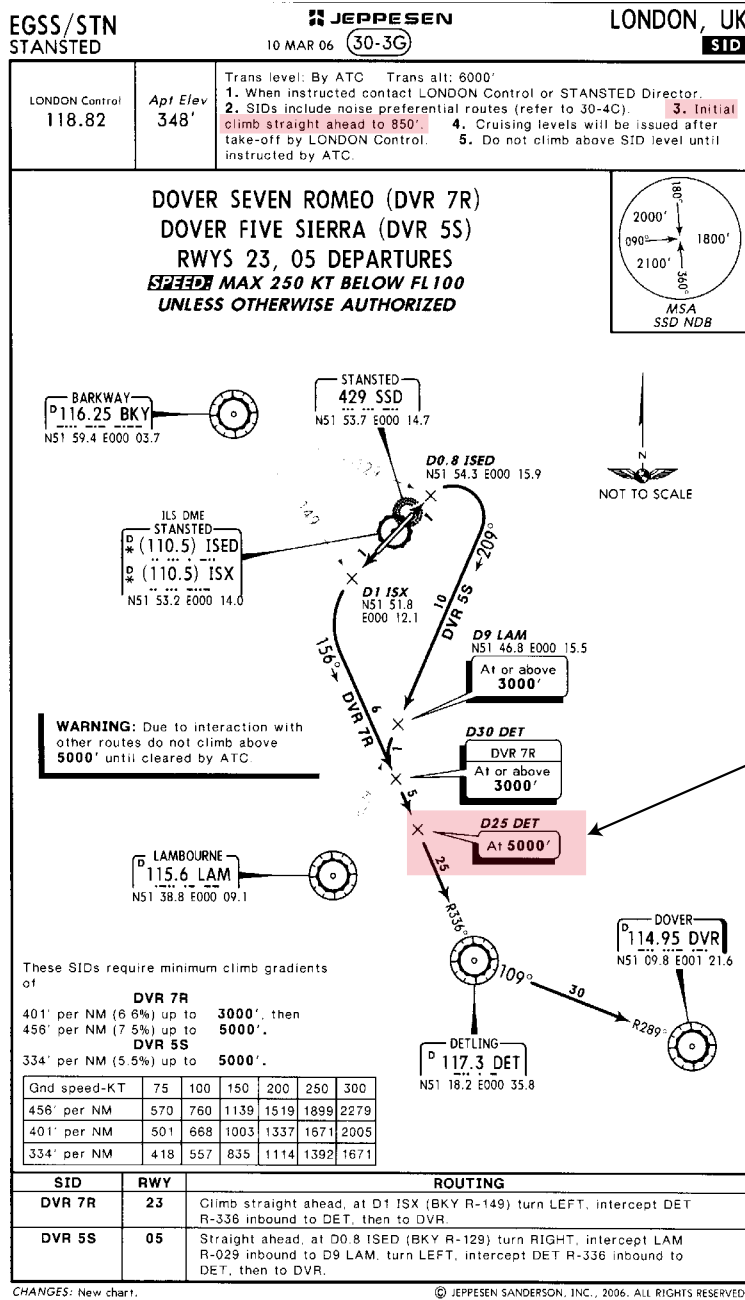
Figure 1

DVR 5S SID plate used by the crew

After the incident the commander realised that he and the co-pilot had not registered the exact meaning of the ‘Initial climb’ note on the SID plate and thought this might have been due to a language issue. He added that the format of the plate was also “unsuitable” compared to those of the other major European airports into which he operates, where the initial level-off altitude is displayed more conspicuously.

The commander commented that there might be a language issue with the *'Initial climb'* note on the plate. His initial doubt, during the co-pilot's brief, should have alerted him to seek clarification from ATC before takeoff. As he had operated out of other major UK airports before on "numerous occasions", he either interpreted the meaning of the note correctly or failed to notice it on the previous departures.

To ensure the safety of the aircraft, the crew must ensure that they fully understand the meaning of all notes on any airport plate. If there is any doubt, clarification must be sought.

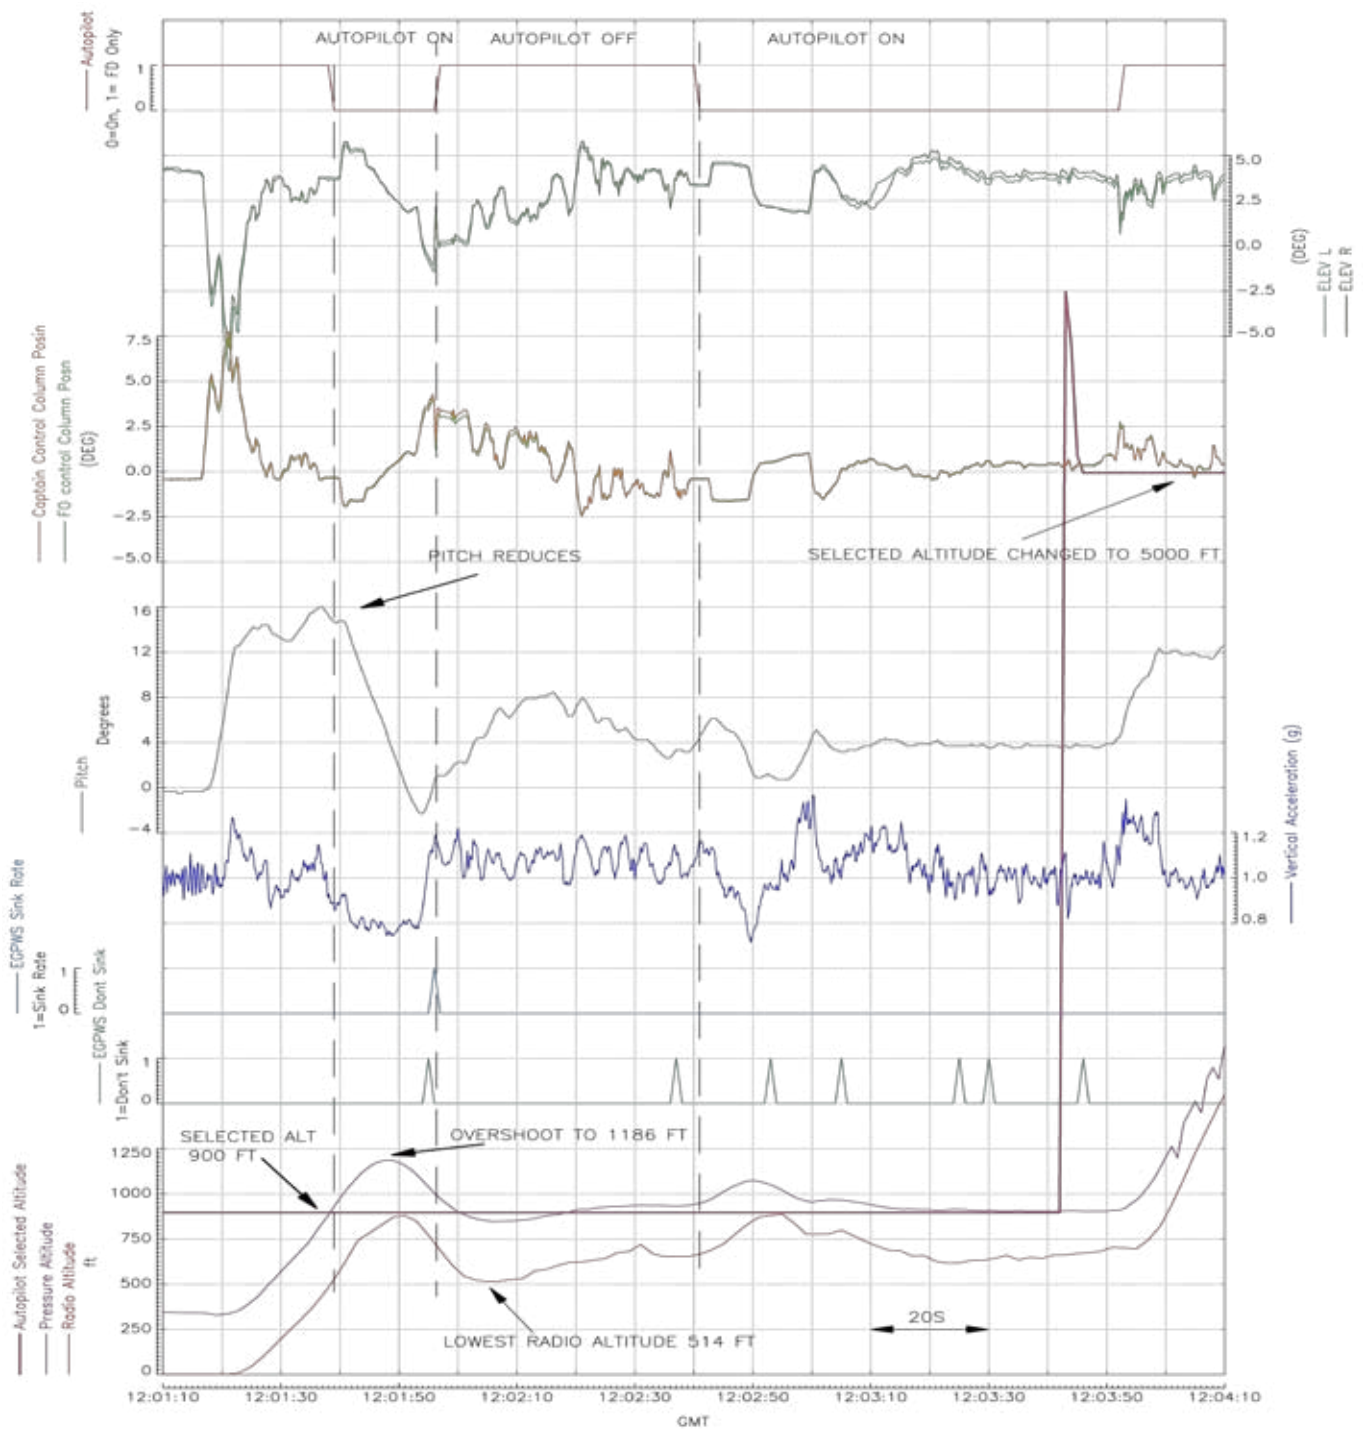
Figure 3

The FDR contained data covering just over 26 hours of operation. Takeoff occurred at 11:01:23 and around 16 seconds later, at a pressure altitude of around 882 ft, the autopilot was selected ON (see Figure 3). The autopilot selected altitude was 900 ft and 'Altitude Acquire' was immediately engaged. A pitch-down command was signalled by the autopilot but, due to the rate of climb and late acquire, TC-JGR overshot the selected altitude. It climbed to a maximum of 1,186 ft before descending towards 900 ft. The pilot then commanded a nose-down attitude, selected autopilot OFF and flew the aircraft manually, from around 974 ft.

At this point, the first EGPWS "DON'T SINK" alert was triggered. This alert is triggered when a significant altitude loss is detected with the landing gear or flaps not set in a landing configuration. The alert includes an audio message and EGPWS warning lights. The amount of altitude loss permitted is dependent on the height above the terrain (radio altitude). Data downloaded by the EGPWS manufacturer indicated a recorded altitude of 737 ft radio altitude at the time of the alert. From the FDR, this constitutes a 143 ft altitude decrease from the peak of 880 ft recorded just after takeoff.

One second after the "DON'T SINK" alert, an EGPWS "SINK RATE" alert was triggered. Unlike "DON'T SINK", this alert monitors for excessive descent rates with respect to radio altitude, in all phases of flight. At the time of the alert, the EGPWS recorded a descent rate of 2,029 ft/min at an altitude of 694 ft agl.

Flight data recorder (FDR) - TC-JGR

of 514 ft agl. A steady increase in altitude to 719 ft agl (938 ft pressure altitude) ensued, followed by an additional altitude decay, triggering a second “DON’T

SINK” alert at 655 ft agl (932 ft pressure altitude). Pitch attitude was increased to 6° and the aircraft began to climb again.

Following this alert, the autopilot was re-engaged and, following an overshoot to 1,070 ft pressure altitude, the selected altitude of 900 ft was achieved. However, due to this overshoot and subsequent reduction to the selected altitude, five more “DON’T SINK” alerts were recorded by the EGPWS. At 11:03:42, the selected altitude was changed to 5,000 ft and 11 seconds later the aircraft began to climb. The remainder of the flight was uneventful.

The aircraft manufacturer analysed the behaviour of the autopilot system during the events detailed above and concluded that it had performed as expected, with the overshoot to 1,186 ft explained by the ‘late acquire’ by the autopilot just after takeoff. Further simulations indicated that, had the autopilot remained engaged, only a slight undershoot below the selected altitude of 900 ft would have occurred.
