Aircraft Type and Registration:	Cessna T310R, N6834L	
No & Type of Engines:	2 Teledyne Continental TSI0-520-BB piston engines	
Year of Manufacture:	1981	
Date & Time (UTC):	30 March 2004 at 0840 hrs	
Location:	Near Laneshaw Bridge, Colne, Lancashire	
Type of Flight:	Private	
Persons on Board:	Crew - 1	Passengers - None
Injuries:	Crew - 1 (Fatal)	Passengers - N/A
Nature of Damage:	Aircraft destroyed	
Commander's Licence:	Private Pilot's Licence and FAA Private Pilot's Certificate issued on basis of UK Licence	
Commander's Age:	57 years	
Commander's Flying Experience:	627 hours (of which 403 were on type) Last 90 days - 3 hours Last 28 days - 0 hours	
Information Source:	AAIB Field Investigation

Synopsis

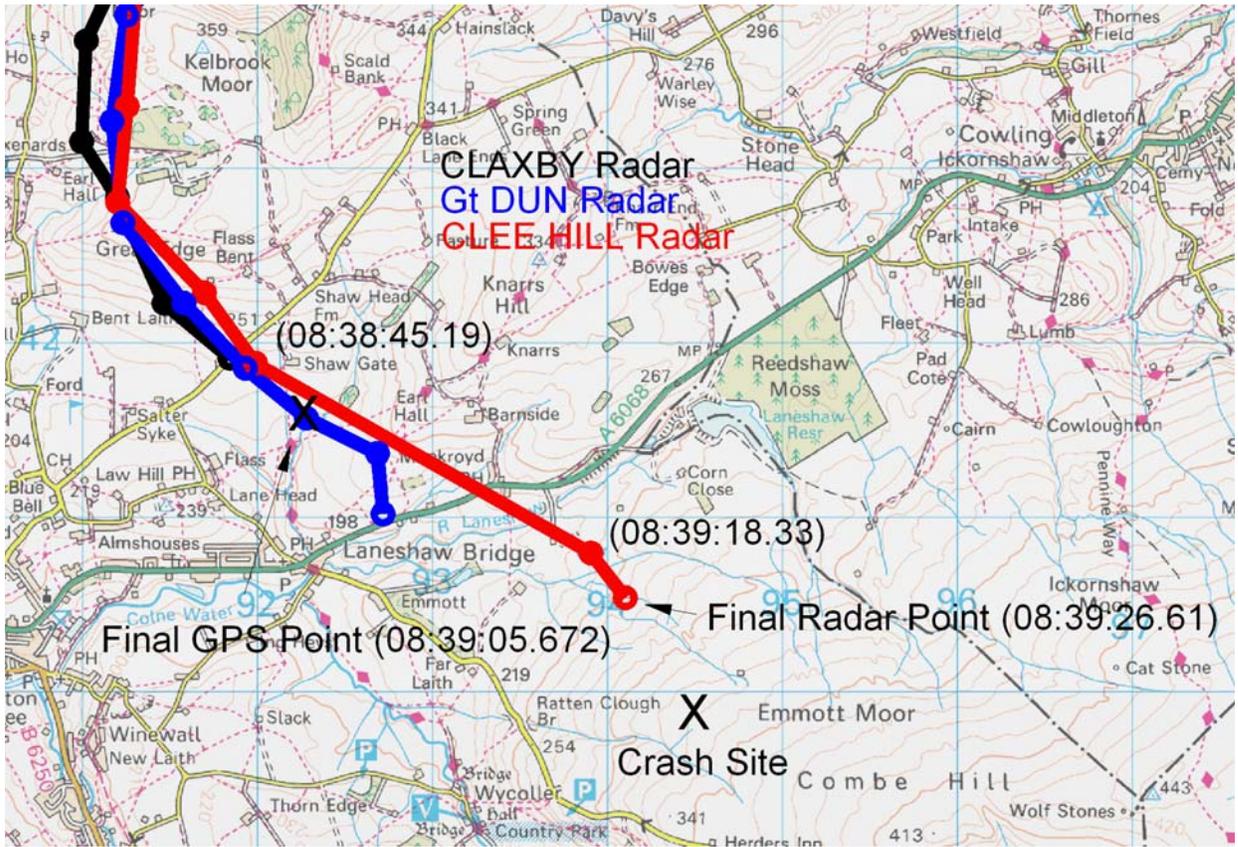
Figure 1

The aircraft was fitted with a panel-mounted Trimble TNL 2000T GPS unit that sustained damage in the accident. This unit has a limited memory only capable of recording a position fix of the 'last known point', date and time when electrical power is removed from the unit (Figure 1).

The date and time that power was removed from the unit was recorded as 30 March 2004 at 0839:05.672 hrs UTC; very close to the time and position at which transmissions were no longer received from the aircraft's radar transponder. The recorded GPS altitude at the last fix (3,187 feet amsl) was close, within the unit's tolerance of ± 900 feet, to the aircraft's reported altitude of 3,400 feet. At this stage the sequential positions recorded from the Clee Hill radar indicated a track of approximately 120°M, towards the airport.

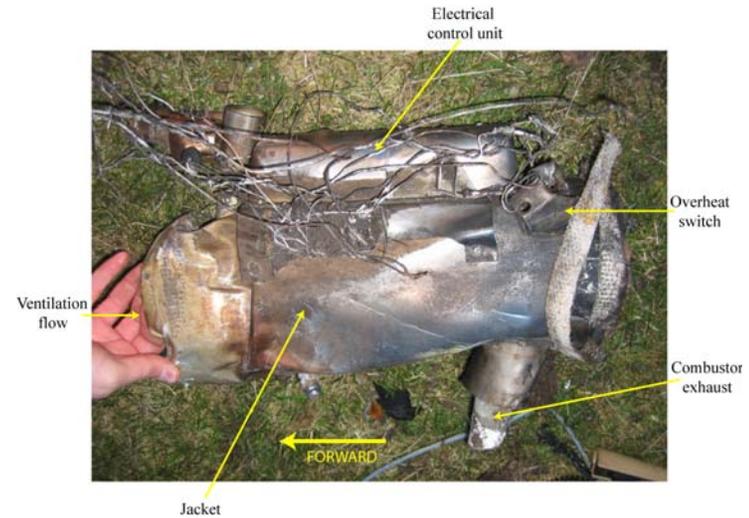
Figure 7 - Combustion heater, N6834L - left side

The combustion heater, examined in detail by the AAIB with a representative from the heater manufacturer present, showed extensive external heating damage (Figure 7).

The outer casing (or 'jacket') showed that the fire within the nose compartment was predominantly under the heater, towards the aft end. This is the area of the assembly closest to the fuel line from the aircraft to the fuel pump assembly, the fuel line attaching the fuel pump to the heater and the fuel drain line from heater itself. The connection in the leading edge of the right wing showed that the fuel supply line had not been replaced by the stainless steel line as provided for in the Cessna Service Bulletin MEB95-9.

Disassembly of the heater showed a normal pattern of internal combustion, with no leaks of the burner assembly other than an anomalous hole (approx $\frac{3}{8}$ " across) on the aft end plate. This hole had been made with considerable force and there was no mechanism that would have created it other than the aircraft's impact with the ground. It was also noted that there had been no recent maintenance in this area of the aircraft.

Therefore, all the mechanical damage to the heater was found to be consistent with the ground impact and all the heat damage was found to be consistent with an external fire, centred in the area immediately below the heater, while the aircraft was still in the air.

This external fire had, in particular, badly affected the electrical wires which provide the control system harness for the heater. Expert examination of the ruptured and melted ends of these wires indicated that there may have been some electrical arcing but there was no indication that this initiated the fire.

It is recommended that the FAA introduce inspection and maintenance requirements for combustion heaters in Part 23 aircraft to ensure that adequate detailed inspections are carried out at specified calendar intervals.
