SC7 Skyvan 3A Variant 100, G-PIGY

AAIB Bulletin No: 8/2003	Ref: EW/G2003/01/17	Category: 1.1
Aircraft Type and Registration:	SC7 Skyvan 3A Variant 100, G-PIGY	
No & Type of Engines:	2 Garrett Airesearch TPE331-2- 201A turboprop engines	
Year of Manufacture:	1975	
Date & Time (UTC):	22 January 2003 at 1030 hrs	
Location:	South Cerney Airfield, Gloucestershire	
Type of Flight:	Military (parachute training)	
Persons on Board:	Crew - 2	Passengers - 4
Injuries:	Crew - None	Passengers - None
Nature of Damage:	Damage to left main landing gear	
Commander's Licence:	Airline Transport Pilot's Licence	
Commander's Age:	57 years	
Commander's Flying Experience:	8,916 hours (of which 933 were on type) Last 90 days - 37 hours Last 28 days - 4 hours	
Information Source:	Aircraft Accident Report Form submitted by the pilot and additional AAIB inquiries

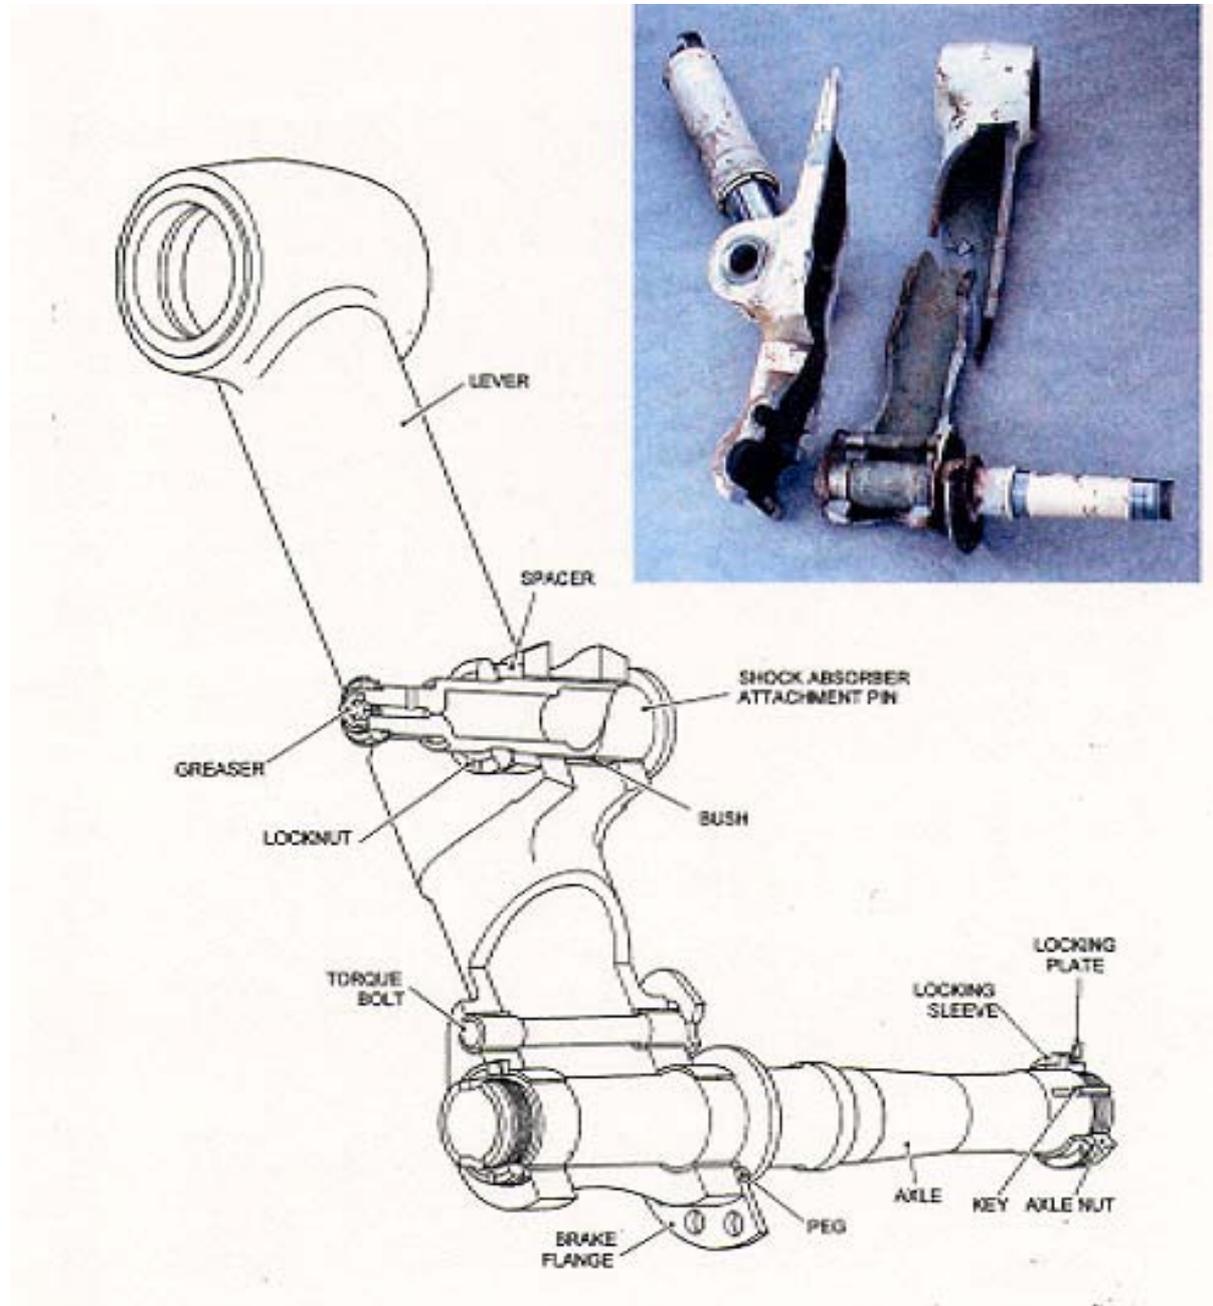
FIGURE 1 Left landing gear lever, - (viewed from underside and inboard)

(Note: for clarity, the lever is shown sectioned at lower end. By coincidence, the failure occurred along the plane of section, as seen in the inset photograph.)

A metallurgical examination of the lever revealed that the fracture had occurred in the plane of the axle and torque bolt, corresponding to the cut-away section in Figure 1 but extending further along the lever. The surface of the fracture between the axle and torque bolt, on the side nearer the brake flange, was coated with corrosion products and had clearly occurred a considerable time before the other fractures, which were clean and bright in appearance (see Figure 2). Evidence of fretting was apparent on the contact surfaces of the axle and torque bolt with the lever. All the fractures showed clear 'river markings' indicating the position of their initiation and the direction of propagation of each individual crack (see Figure 3) and it could be seen that the origin and direction of the corroded fracture differed from the pattern set by the others. After cleaning and examination using a scanning electron microscope, it was found that the initiation region of this fracture exhibited a different topography, with the fracture surface following an intergranular path. Adjacent to the bore, the surface was coated with products of corrosion. Beyond the initiation region, the fracture became one of ductile overload, as seen on the other fracture surfaces.

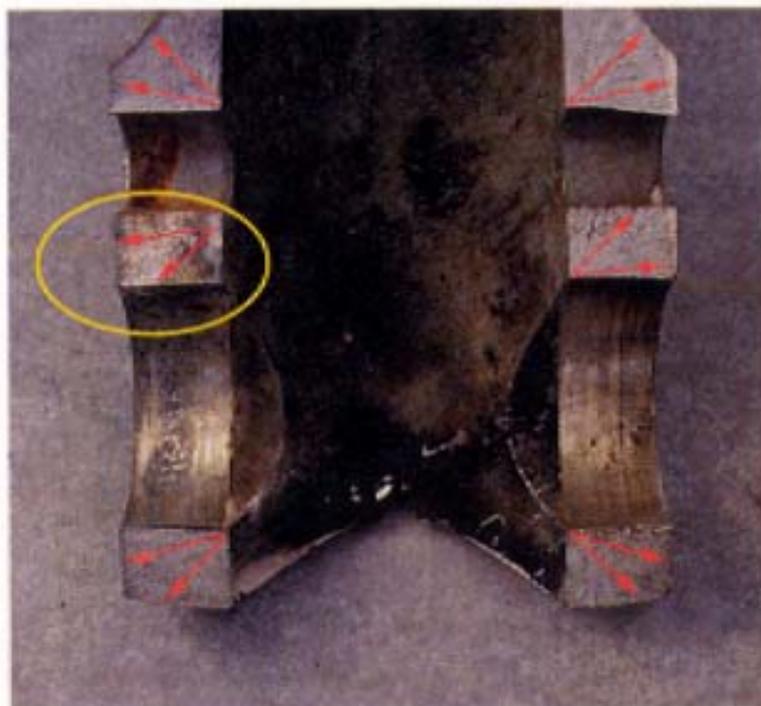
Figure 3 Initiation and propagation of the various ligament fractures. Corroded fracture (circled) characteristics are different from others

The paint finish in the bore of the lever was examined and found to be highly variable in coverage. In the region of the corroded fracture, the coating contained pinholes and was sufficiently thin to reveal the machining marks. Streaking was present, where the paint had lifted due to corrosion, which was indicative of incomplete cleaning. The landing gear manufacturer stated that, following cleaning, the coating process called for chromic acid anodising, followed by a yellow epoxy primer and a grey epoxy gloss finish. It was noted that the primer paint was missing at intervals, including the area of the fracture initiation. On the opposite side of the bore the paint coating was more uniform, although an area of unpainted surface was found, apparently uncorroded.

It was concluded that the corroded intergranular portion of the initial fracture was the result of a stress corrosion crack, one of several forming on the surface of the internal bore in an area of poor paint protection, and which would see a concentration of stress when the aircraft was parked. It is likely that the inadequate cleaning and paint finish were the critical aspects leading to the failure, since the remainder of the bore would be in the same atmospheric environment and some areas might be subjected to similar stresses. It was thus the combination of corrosion attack and stress concentration that led to the formation of the initial crack, with other areas of poor paint coverage being subjected to relatively lower stresses.
