Swearingen SA227-AC Metroliner III, OY-BPH

| AAIB Bulletin No: 6/2004 | Ref: EW/C2002/12/03 | Category: 1.1 |
| Aircraft Type and Registration: | Swearingen SA227-AC Metroliner III, OY-BPH | |

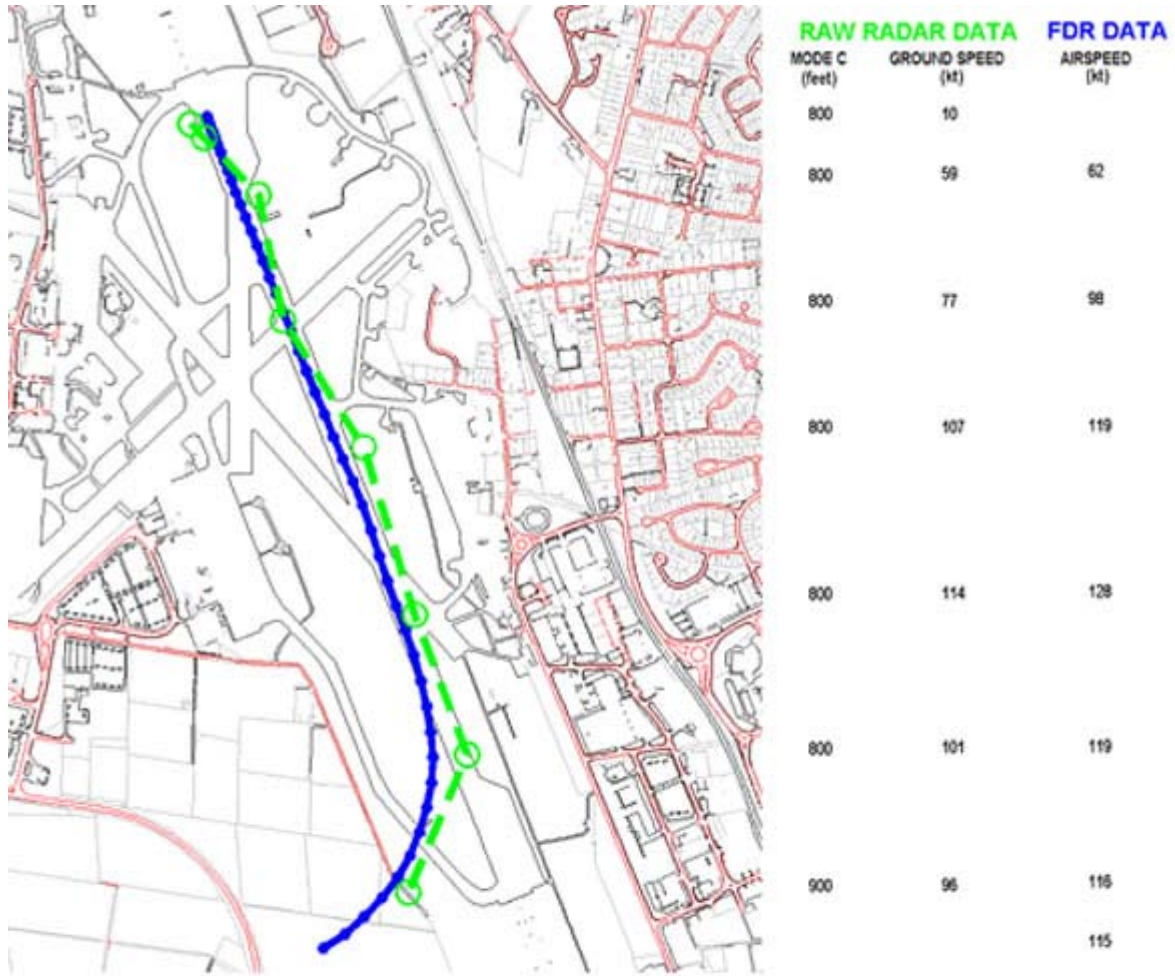
An estimated ground track of the aircraft, based on FDR, CVR, ATC communications and radar, was derived and is shown in Figure 1. A maximum airspeed of 128 kt was recorded by the FDR, and a maximum height achieved by the aircraft of 900 feet was recorded by the secondary radar. This was based on the standard pressure setting of 1013.2 Hpa, which equated to about 100 feet agl.

Radar and FDR data
(Accident to OY-BPH on 24 December 2002 at Aberdeen)
