AAIB Bulletin No: 12/95 **Ref: EW/G95/09/11** **Category: 1.3**

Aircraft Type and Registration: Piper PA-34-200T Seneca II, G-BMWP

Nature of Damage: Damage to right wingtip and propeller

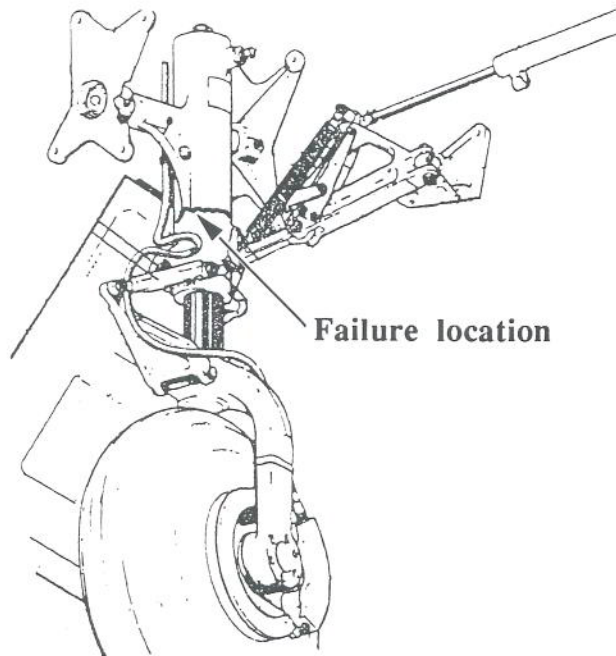
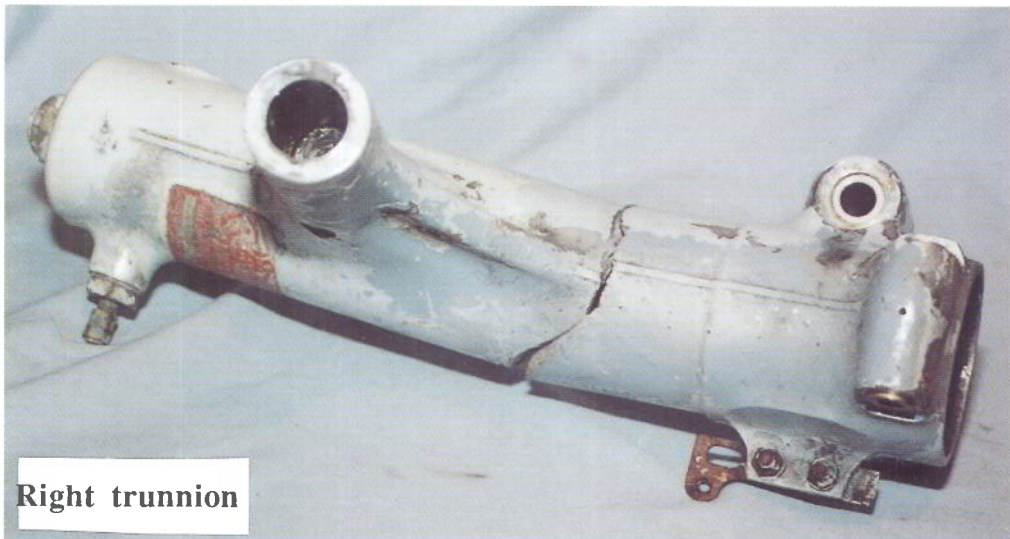
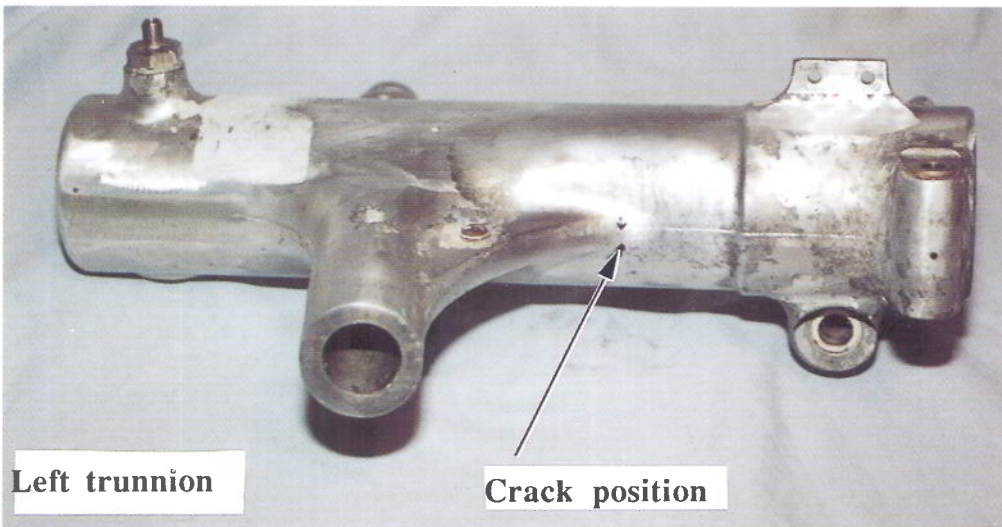
The right main landing gear leg had broken circumferentially at a point level with the lower end of the fillet. Subsequent examination of the left main gear leg revealed a small crack at the point where the fillet joined the aft side of the leg (see the appended photographs). Both legs were forwarded to the AAIB for metallurgical examination.

The main landing gear trunnions (ie legs) were manufactured from aluminium alloy forgings. Externally, both legs were in generally poor condition, with extensive surface corrosion. Some areas were devoid of paint and were heavily corroded. The paint was intact elsewhere, but blisters were present, some of which had perforated as a result of underlying corrosion.

Examination of the fracture faces of the right trunnion showed that the initiation region was both in and adjacent to the forging flash line at the lower end of the reinforcing web. Much of the fractographic evidence had been destroyed as a result of attempts to re-mate the fracture faces after the accident. However it was possible to determine that fracture initiation and initial progression was due to a combination of corrosion and a tension fatigue mechanism. Subsequent progression was the result of stress corrosion until final overload separation occurred.

Eddy-current tests confirmed the existence of a crack in the left trunnion, and the component was cut so that the suspect region could be subjected to bending loads until failure occurred. Analysis of the fracture faces thus produced indicated that the initiation region had been removed by a grinding or sanding process. However, it was apparent that crack progression, like that on the right-hand trunnion, was due to stress corrosion.

The cracks in both trunnions had originated in the same areas that have featured in other PA-34 and PA-44 trunnion failures. This problem has been the subject of a Piper Service Bulletin, No 787, of which the latest revision, 787B, was issued in August 1993. In June 1988, the UK CAA issued Additional Airworthiness Directive (AAD) No 002-01-88. This effectively reinforced Revision A of SB 787 by imposing a repetitive 100 hour inspection on trunnions with more than 1,000 hours time in service. Cracked trunnions had to be replaced with redesigned components featuring a new part number. However, failures continued to occur following the CAA AAD, leading the AAIB to make a Safety Recommendation, No 93-43, calling for the requirements of AAD 002-01-88 to be reviewed (see accident report on PA-34, G-BORH, published in AAIB Bulletin 8/93). The CAA, whilst accepting this Safety Recommendation, had already submitted comments on a US Federal Aviation Administration (FAA) Notice of Proposed Rulemaking (NPRM), which was intended to address the problem by means of an FAA Airworthiness Directive. In the event, the FAA issued AD No 94-13-11 in August 1994, at which point it formally superseded AAD 002-01-88. AD 94-13-11 used as its basis the provisions of SB 787B, and required all PA-34 and 44 main landing gear trunnions to be inspected after 500 hours time in service, and at 100 hour intervals thereafter, up to a maximum life of 2,000 hours. However, pending arrival of replacement trunnions from the manufacturer, provision was made for extension to 2,500 hours, subject to no cracks being found. Both the SB and the AD made the point that if the trunnion time in service was unknown, then the airframe hours could be substituted. One difference between the AD and the SB is that the latter requires a repetitive 10 hour inspection for trunnions with more than 2000 hours time in service. It states that; *'...it is permissible to permanently remove paint and maintain an alodined surface in the area of inspection to facilitate the ten hour repetitive inspection'*. **Note:** 'alodine' is often referred to as 'alochrom' in the UK. Its use in lieu of paint is questionable in that it forms an extremely thin layer on the surface of the metal which offers little protection against corrosion. Furthermore its presence in, and around, a crack can actually

Main landing gear trunnions from G-BMWP

95-42: In order to reduce the incidence of main landing gear leg failures, the FAA should issue an Additional Airworthiness Directive which mandates Piper PA-34 and PA-44 main landing gear trunnion inspections on the basis of calendar time as well as flying hours, in view of the fact that FAA AD 94-13-11 does not appear to acknowledge the calendar time - dependent nature of associated stress corrosion cracking.
