No: 11/90

Ref: EW/C1174

Aircraft Type and Registration: Boeing 747-200, N303TW

Incident to Nationair B747-100, N303TW, at Gatwick on 7 Aug 1990

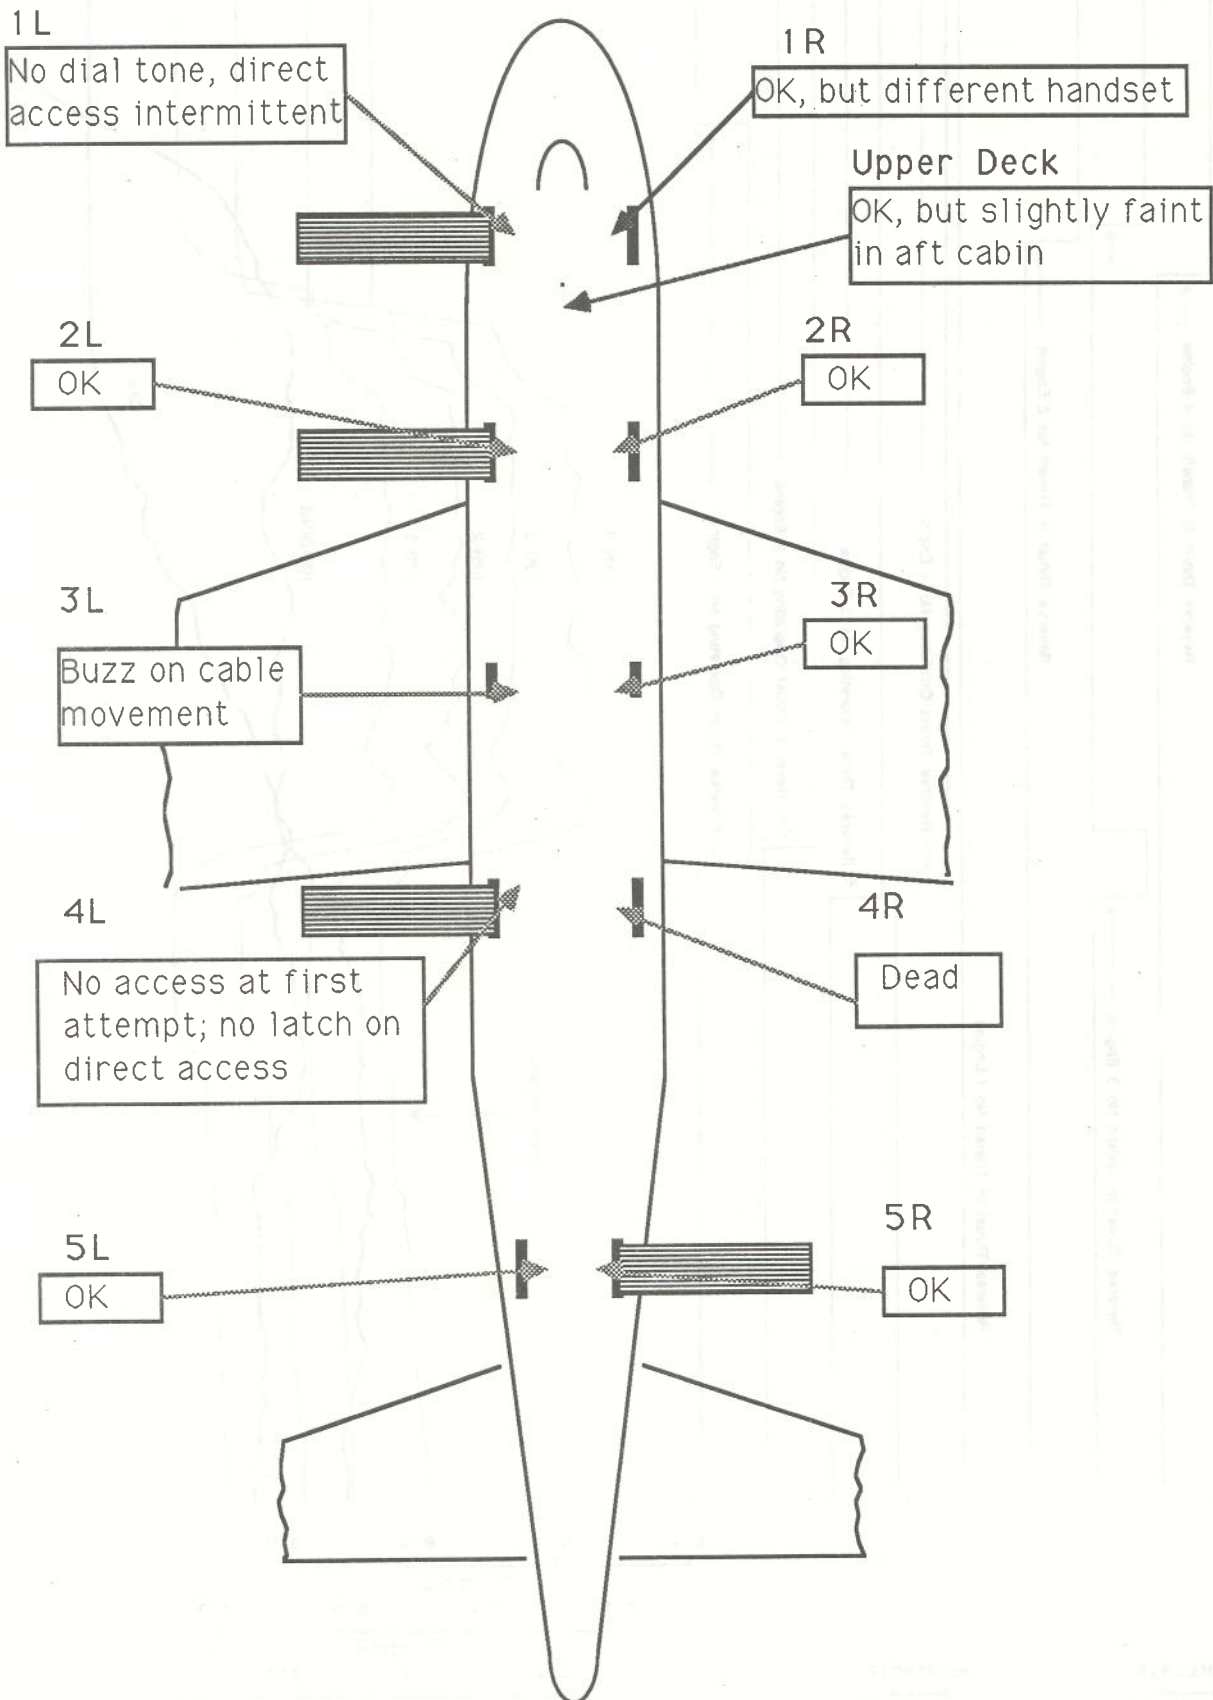
Figure 1

At the instant that they heard emergency evacuation code, the flight attendants began their emergency drills. In the passenger cabin the evacuation was ordered by shouted commands in both English and French. Escape slides were initially deployed at doors L1, L2 and L4 only (figure 1). Subsequently the slide at R5 was also deployed but not utilised for passenger evacuation. The flight attendants' reports indicated that the first reaction by passengers to the emergency evacuation order suggested an unawareness of the presence of fire, and in some cases an impression that the aircraft was parked for disembarkation. Overall there was some confusion and misunderstanding of the necessity to evacuate

Three of the four slides used to evacuate the passengers and crew functioned normally. The exception was the slide at L2, which was found in a position such that the top was at an angle relative to the door sill. This meant that the slide was above the sill level at the aft end of the door aperture although the slide was still useable and no adverse comment was made by any of the cabin crew. It was not clear whether the slide deployed in this position or adopted it during the course of the evacuation. All the slides were removed from the aircraft before it was towed clear of the runway and this action may have removed any evidence that could have revealed the reason why the L2 slide was twisted. The slide grips the side of the aircraft as it inflates and is not normally easily displaced once inflation is complete. Although a small rip in the girt (the sheet of material joining the slide with the girt bar in the door sill) was found, it is considered unlikely that this would have resulted in a loss of tension sufficient to cause the slide to move.

Shortly after take off from Montreal the PA system went unserviceable everywhere apart from the upper deck, from where all subsequent announcements had to be made. The cabin interphone system was similarly affected. When the aircraft was examined on the ground at Gatwick it was found that only one PA station (at door 4R) was completely dead although a number of defects were noted on some of the remaining stations. It was also found that the gain on two out of the three PA amplifiers was rather low. Reference to the cabin log revealed that a number of problems, some of an intermittent nature, had affected the PA system over the preceding five days. Whilst the engines were being replaced at Gatwick, one of the amplifiers and three PA handsets were replaced in order to rectify the PA system.

Diagram of escape slides deployed and condition of PA stations

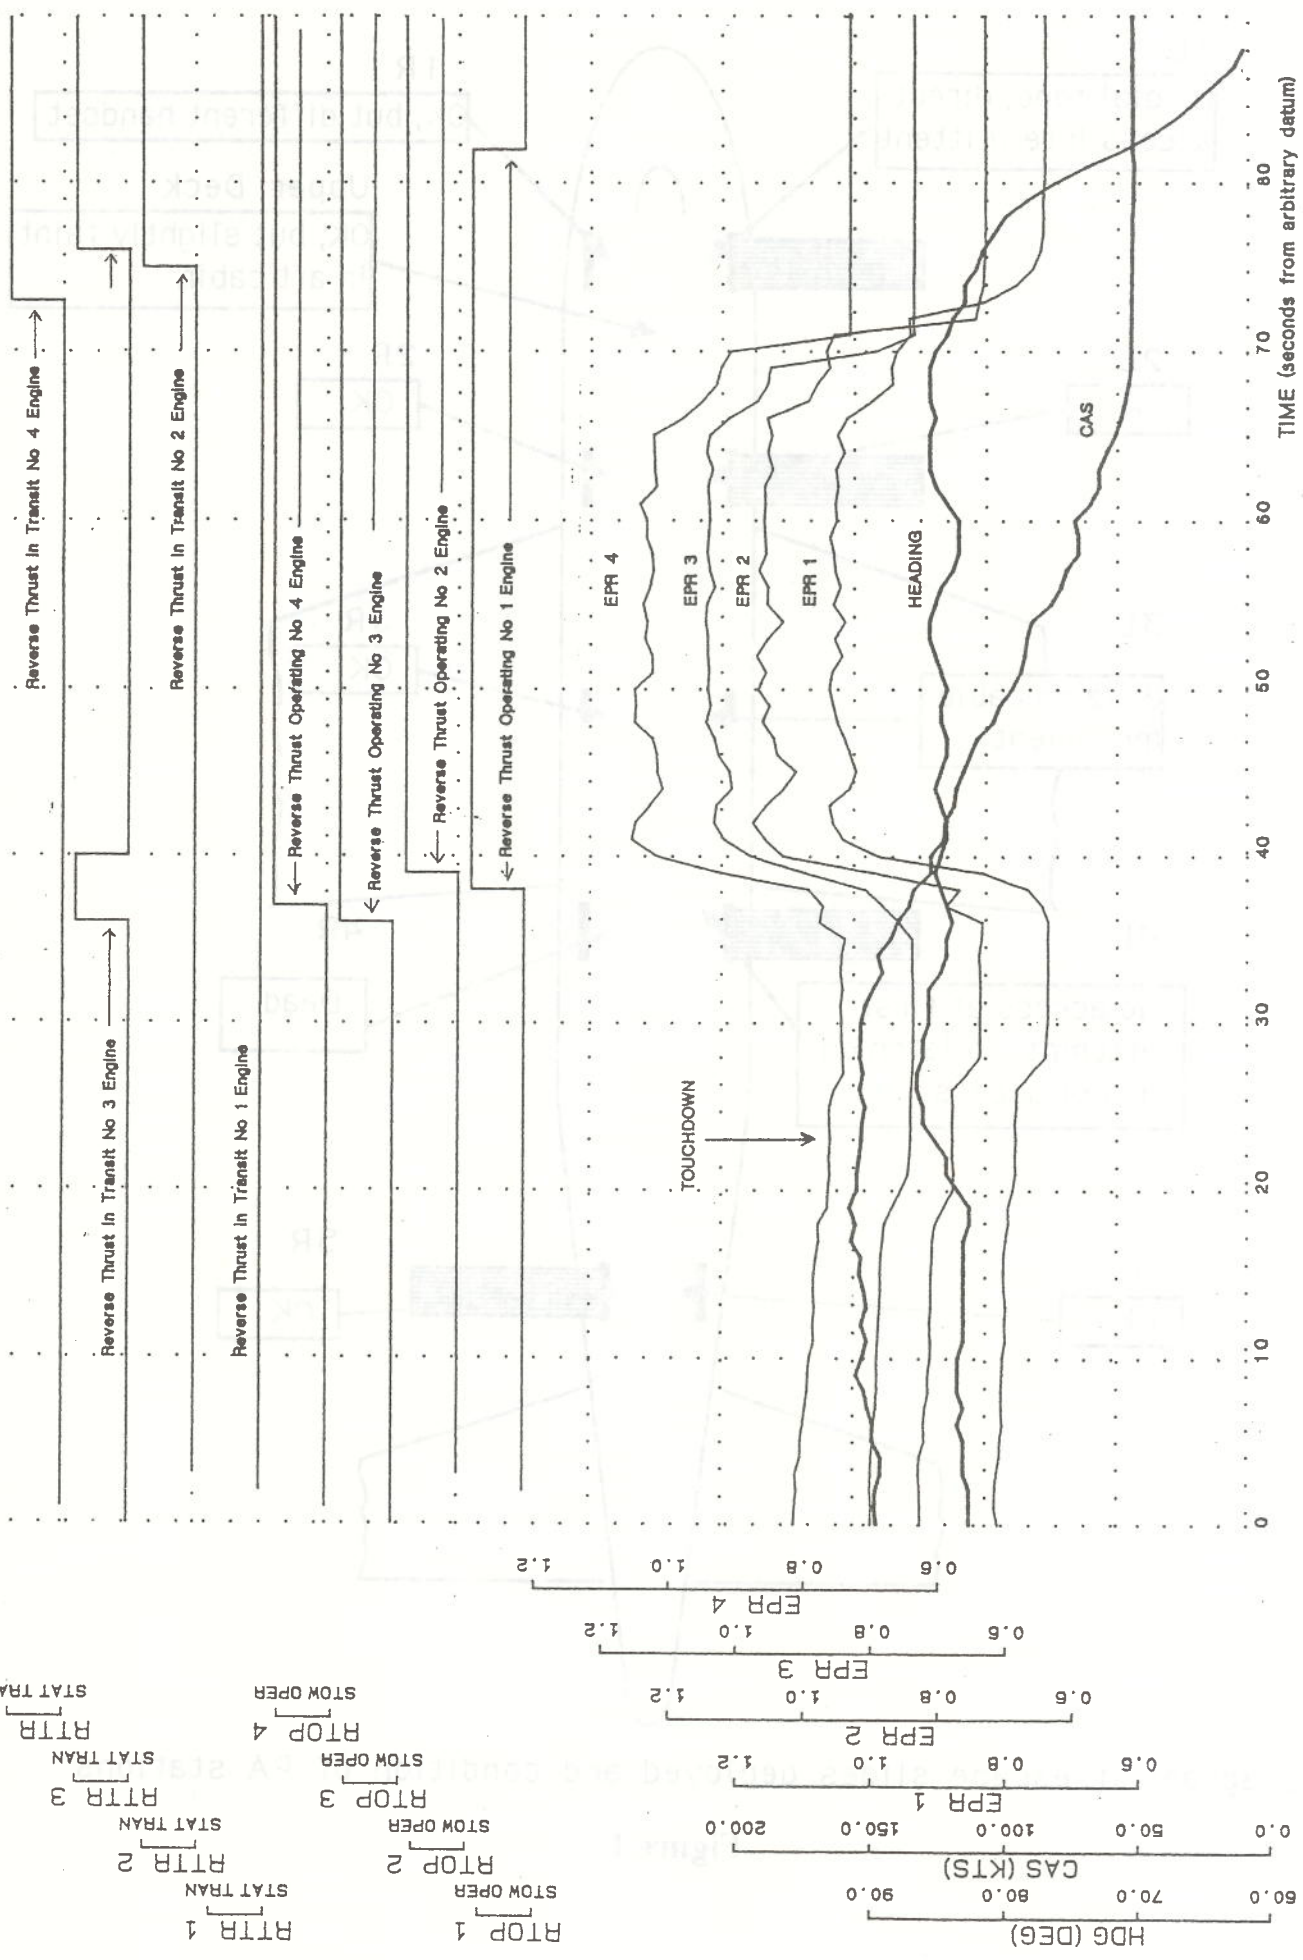
Figure 2

The attached figure (figure 2) shows selected parameters from the FDR from about 20 seconds before touchdown. The aircraft touched down at speed for 146 kts CAS, 12 seconds later the EPR increases as reverse thrust is selected on all engines. This is also shown by the reverse thrust operating discretely (RTOP) which show the transition from the stowed position to the operating position. These discretely are only recorded once per four seconds so there may be a delay of up to four seconds from the operation to this being recorded by the FDR. There is also a discrete recording reverse thrust in transit (RTTR) which again is recorded only once per four seconds. Because of this low sampling rate the discrete only shows the No. 3 engine in transit as reverse thrust is selected, the transition on the other three engines is within the four second sampling period.

The EPRs remained at around 1.02 on all engines for 25 seconds before EPR No. 4 engine reduces first, followed in the next second by the EPR on Nos 2 and 3. The run down of the three engines occurred at an airspeed recorded by the FDR as 48 kts CAS. However, at speeds below 50 kts the pitot/static system cannot be used to give reliable speed information. At about this time it can be seen from the Magnetic Heading recording that the aircraft began a left turn off the runway heading. No. 1 engine EPR also reduced, but, as can be seen from the figure, reduced at a lower rate to the other three engines which ran down immediately to around 0.7 EPR. The reverse thrust was cancelled on No. 1 engine as shown by RTOP 1, reverse thrust remained in transit on the other three engines as shown by the RTTR discretes.
