**INCIDENT**

<b>Aircraft Type and Registration:</b>	Boeing 747-136, G-AWNO	
<b>No &amp; Type of Engines:</b>	4 Pratt and Whitney JT9-D turbofan engines	
<b>Year of Manufacture:</b>	1973	
<b>Date &amp; Time (UTC):</b>	14 June 1994 at 1425 hrs	
<b>Location:</b>	West of London Heathrow Airport	
<b>Type of Flight:</b>	Public Transport	
<b>Persons on Board:</b>	Crew - 18	Passengers - 370
<b>Injuries:</b>	Crew - None	Passengers -None
<b>Nature of Damage:</b>	Localised fire damage to No 3 engine	
<b>Commander's Licence:</b>	Airline Transport Pilot's Licence	
<b>Commander's Age:</b>	N/K	
<b>Commander's Flying Experience:</b>	N/K	
<b>Information Source:</b>	AAIB Field Investigation

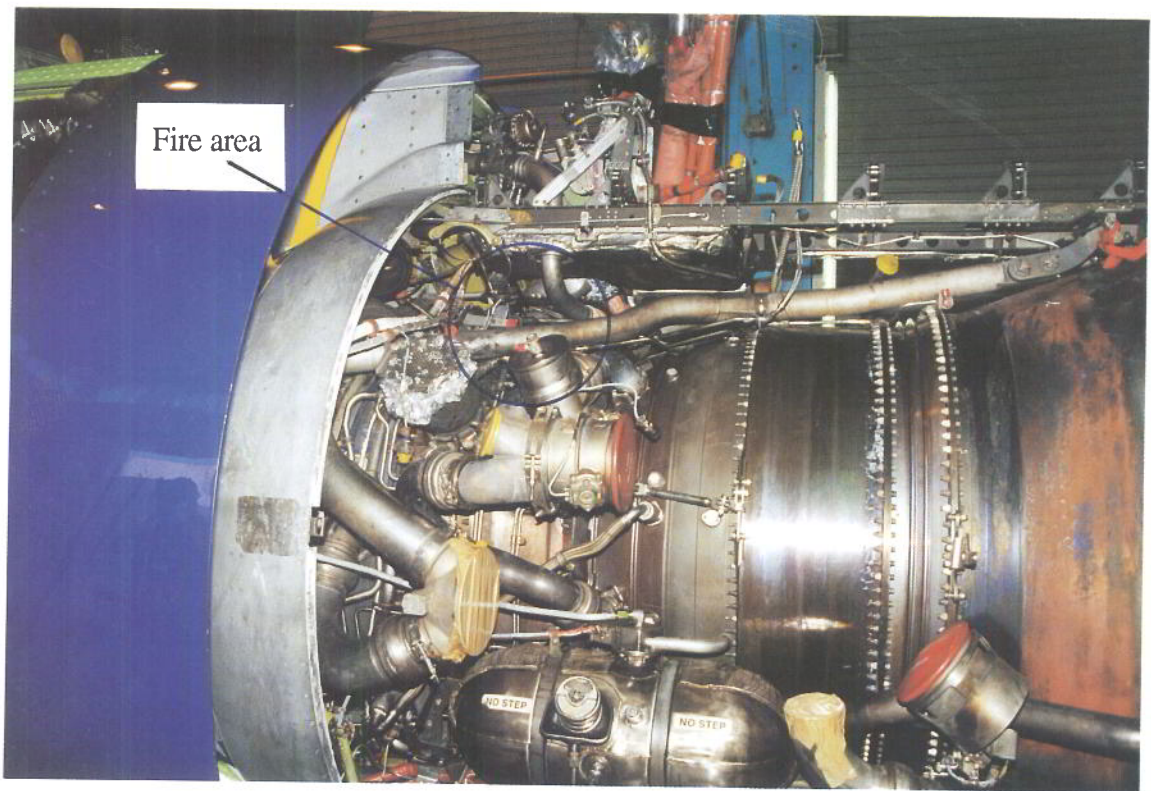
**Figure 1**

An initial examination by airline maintenance personnel of the No 3 engine revealed a localised area of 'sooting' external to the engine casing, but beneath the cowlings, in the region of the primary and secondary fuel manifold pipes at the 11 o'clock position (viewed from the rear). Sooting had occurred

to most items in this region, including a cable loom, although heat damage was present on the feed wires to the fire detector loops. Close inspection of this area revealed that hard contact was present between the primary fuel manifold pipe and the underside of the left side thrust member (Figures 1 and 2) and between the primary feed pipes to the No 1 and 2 nozzles from the primary manifold (Figure 5) at the 12 o'clock position. The engine was transferred to a specialist maintenance facility where further investigation was undertaken. After exposing the area of contact on the primary manifold, it could clearly be seen that the pipe wall had been worn through to such an extent that a split of approximately 1 mm in length had developed (Figure 3) and that wear, similar in area and depth, was present on the underside of the thrust member. Significant fretting damage was also present on both nozzle feed pipes. During the time on the wing, no recorded maintenance had taken place on or near to the area of fire.

**General View of Engine Left Side with Fire Affected Area Identified**

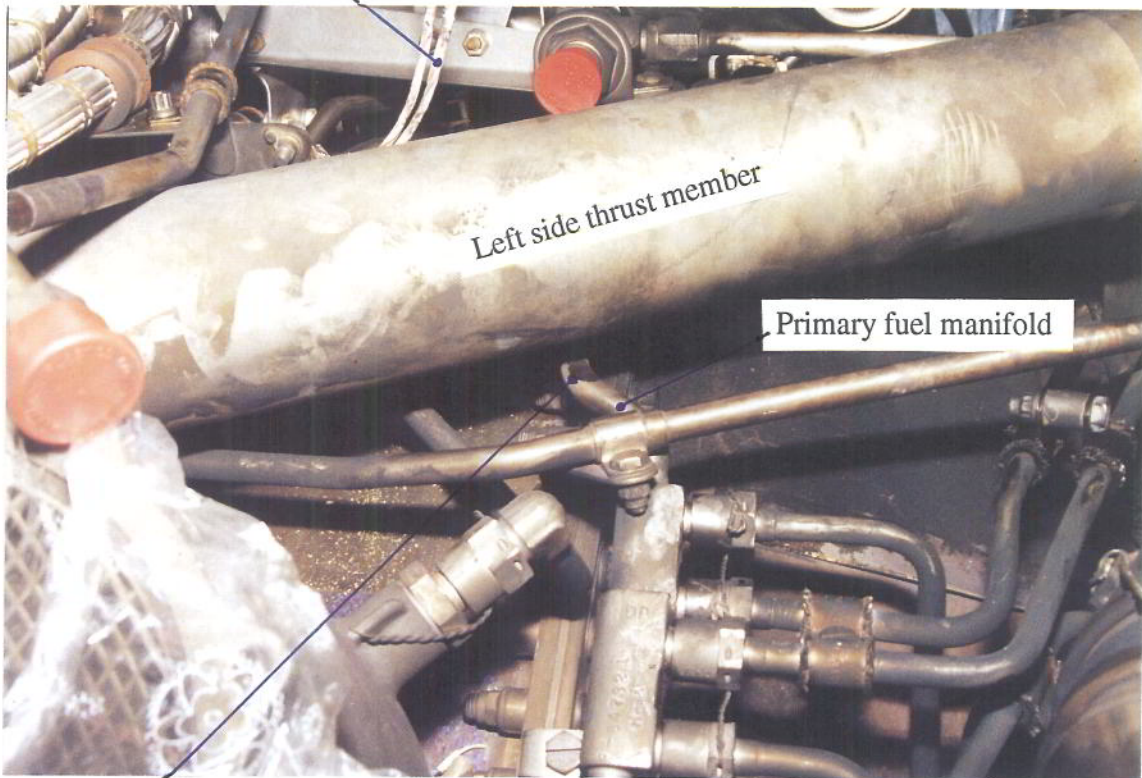
**Figure 2**

**Contact Area Between Thrust Member and Primary Manifold with Thrust Member in Raised Position**

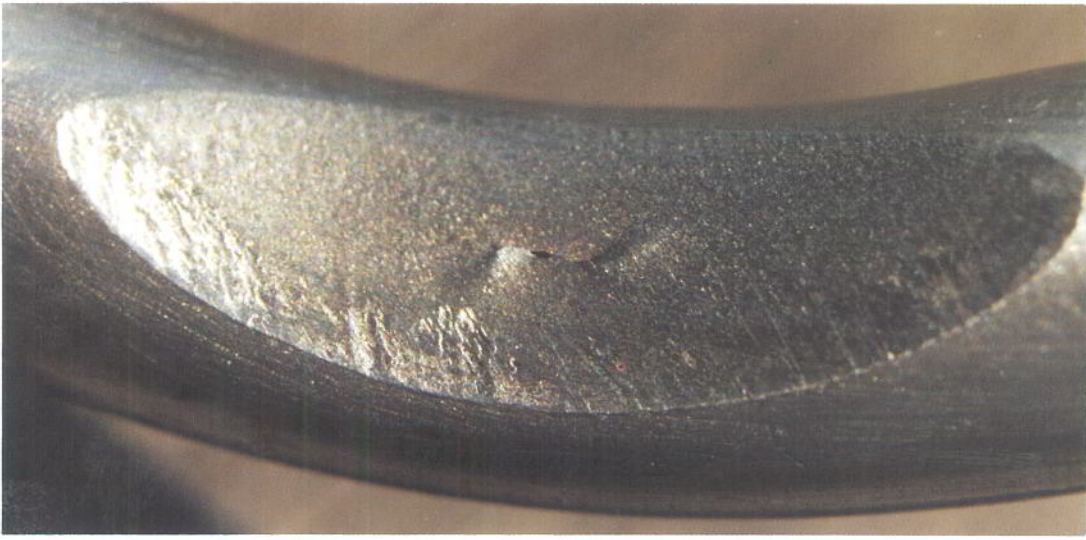
Close Up of Fuel Pipe Damaged Area Showing Central Split Figure 3

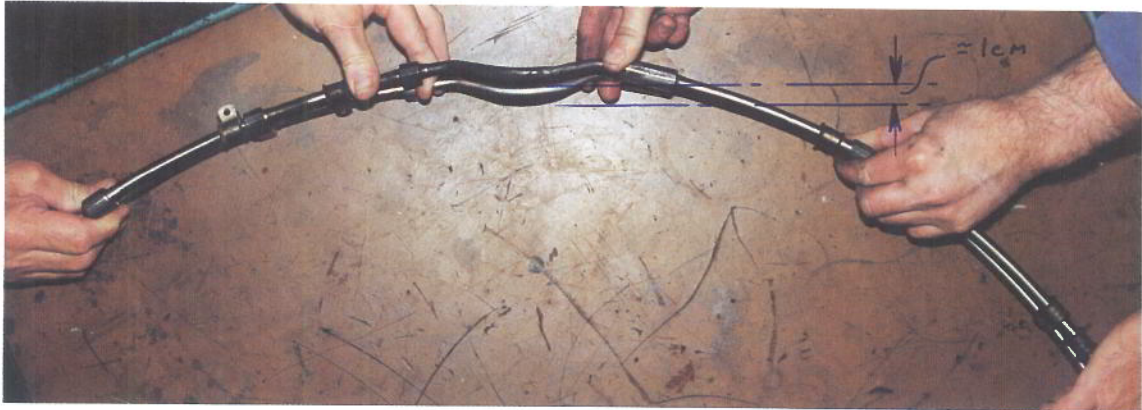
The manifold pipe was removed from the engine, examined and compared with a known serviceable manifold. It became readily apparent that the defective manifold, overall, was deformed slightly and that when strained to the correct shape, the 'S-shaped' bend (normally positioned beneath the thrust member) flexed in such a manner that would cause it to follow a path closer to the underside of the thrust member, by some 0.4 inch.

The primary fuel manifold in the area of the thrust member is the subject of Pratt & Whitney Service Bulletin No 2864, originally issued in 1970, which provided for additional clearance between it and the engine thrust frame, as a result of deflections under load. This was accomplished by modifying the S-shaped bend in the pipe in the region under the thrust frame. The Service Bulletin requires that, after installation, a clearance of 0.3 inch exists between these two items. Reference is also made to this clearance in the engine Overhaul Manual, Installation 19 (Engine Support Set), the document to which the maintenance organisation work. This engine was overhauled some 809 hours/117 cycles prior to the fire, at which time the records indicated that the manifold was passed fit for further service, and at the appropriate time refitted to the engine. This operation, however, is carried out at a different time to the refitment of the thrust frame, at which time the clearance should be checked. Although the worksheet instructions call for the installation to be carried out in accordance with the Install 19 section of the manual, there are no specific instructions on the worksheet. The examination of this engine also revealed that nozzle 1 and 2 feed pipes had not been cleared in accordance with the Overhaul Manual, although this area was visible during all stages of engine build.

Damaged Manifold (upper) Strained into Correct Shape Above an Undamaged Item. Note difference in 'height' of Curved section Figure 4

It was established from the maintenance organisation that these operations during engine re-build are carried out by personnel who are cleared to be self-authorising, ie installation, inspection and records entry are done by the same authorised person. The maintenance organisation, since this event, are considering writing a specific instruction into the worksheets to check for manifold pipe clearance and manufacturing a simple jig to check the manifolds for correct profile just prior to installation.

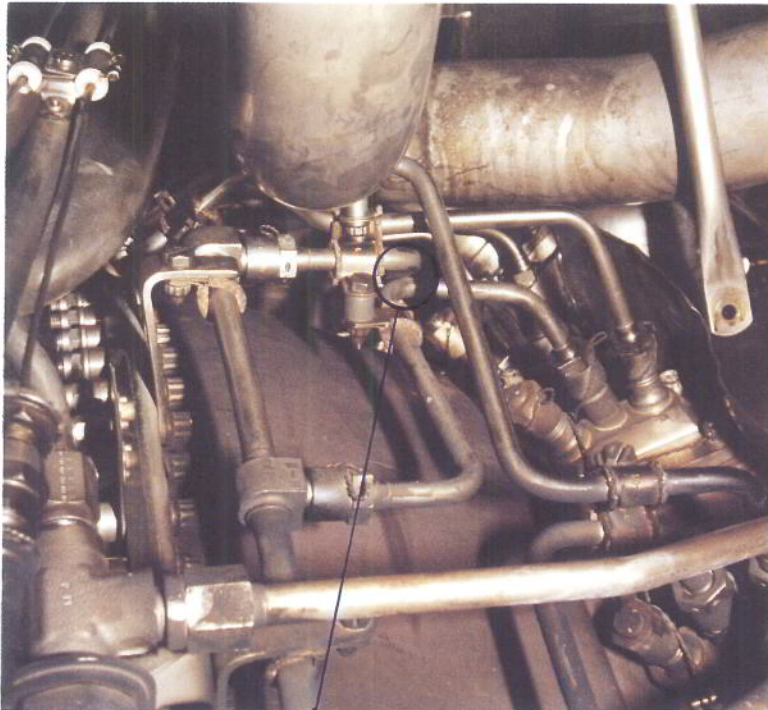
Photograph of Primary Feed Pipes to the No 1 and 2 nozzles, as installed. Contact area between these pipes identified. Figure 5
