No: 10/91

Ref: EW/C91/6/2

Aircraft Type and Registration: De Havilland DH89A Dragon Rapide Mk III, G-AHGD

Location: Near Audley End, Essex

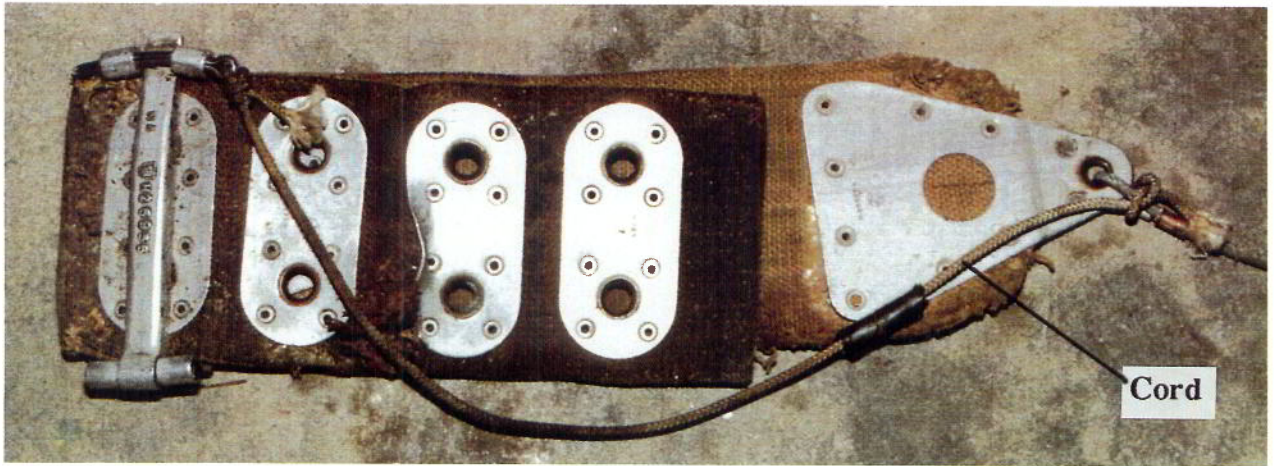
In GD the pilot was restrained by an original standard lapstrap, the two halves of which were keyed together at the centre by a locking lever attached to the left strap. This lever was itself made secure by the insertion of a split pin which, to avoid being lost and becoming a hazard in the cockpit, was attached to a length of strong terylene cord. The other end of this cord was found tied around the fitting at the end of the left strap, where a short wire strop connected this strap to the aircraft structure. The length of this cord between these two points, at 16 inches, was such that a bow was formed.

Left side of lapstrap as removed from the wreckage - view looking aft

As a result of this accident, recommendations have been made to the CAA regarding the type of lapstrap fitted to 'GD and pilot recency requirements for air displays.

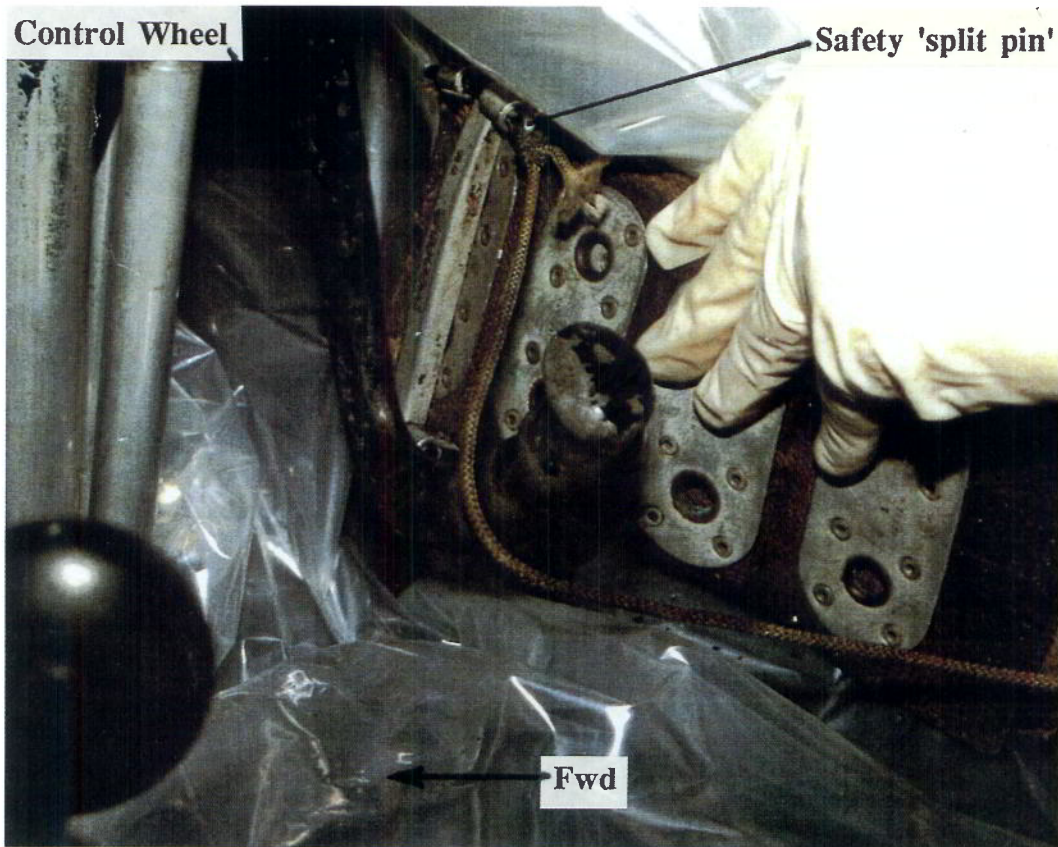
The waistband, complete with cord, was taken to another Rapide where a person of a stature similar to that of the pilot of G-AHGD was sat in the fixed pilot's seat. It was demonstrated that with the control column fully back and with the control wheel rotated to demand left roll, it was possible for this bow in the cord to easily engage over the left handgrip of the control wheel (see figure 1). It was apparent that in this situation it was unlikely the cord would be broken by forces applied by the pilot or that the pin could be fully withdrawn, and thus a severe restriction to forward movement of the control column could occur. Close examination of the cord, split pin and left handgrip from G-AHGD revealed inconclusive direct evidence that this had actually happened, but the relatively soft and rounded nature of these components made it unlikely that witness marks between them would result from such a restriction. Figure 2 shows extracts from the original De Havilland assembly drawings for this lapstrap where, as may be seen, the length of the safety pin retention cord is specified at 3½ inches. It was not established at what time in the aircraft's history the safety pin cord had been changed.

Possible snagging of control column by safety pin cord when pulled aft with left roll demanded

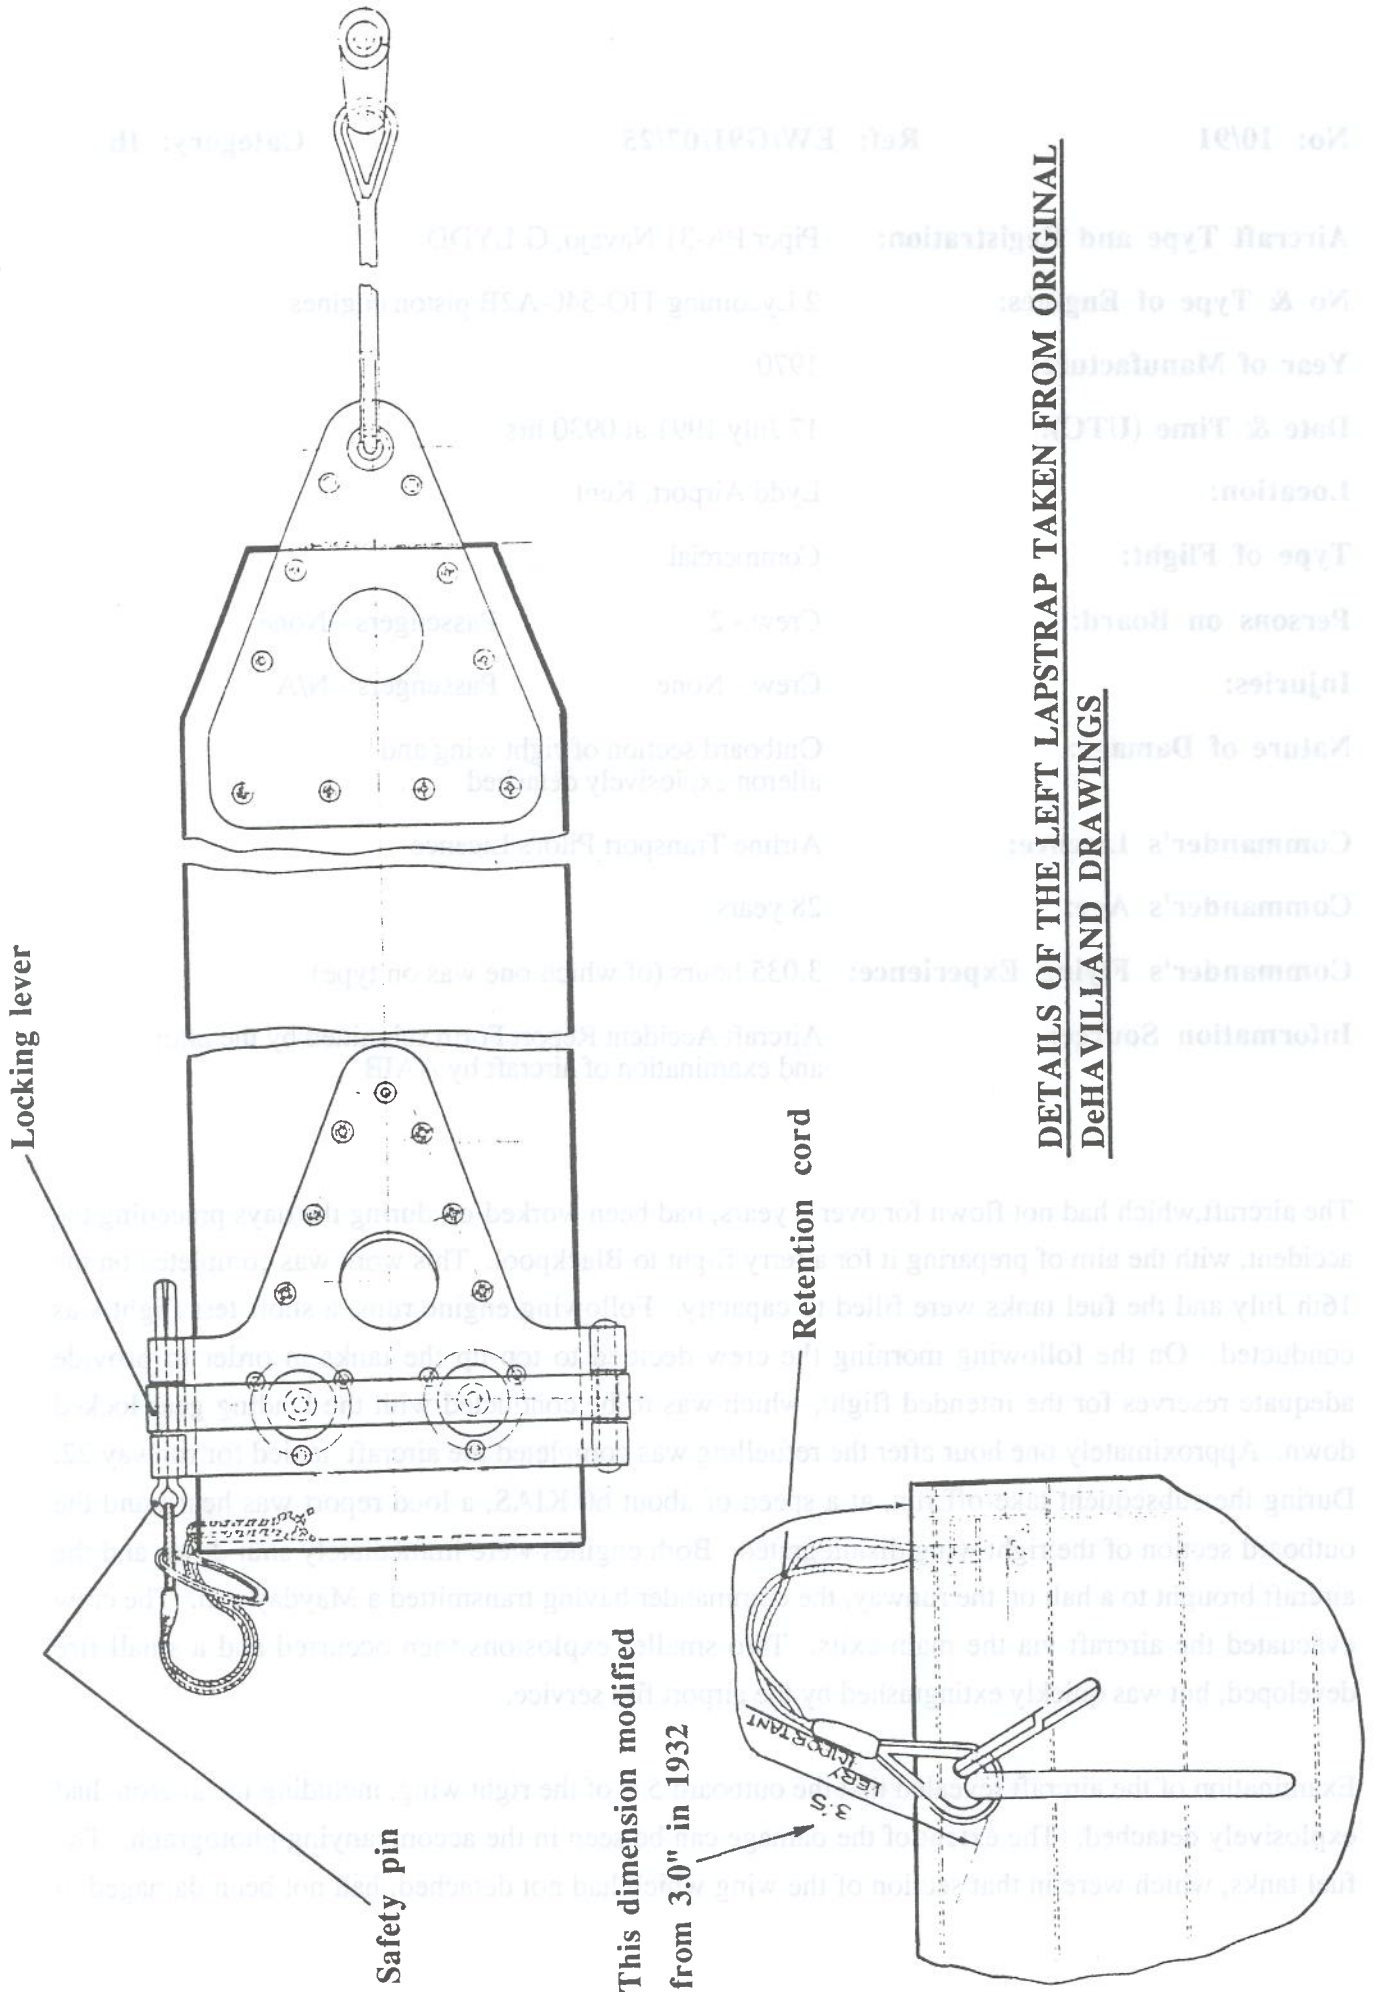
Figure 2

DETAILS OF THE LEFT LAPSTRAP TAKEN FROM ORIGINAL DeHAVILLAND DRAWINGS
