No: 1/93 **Ref:** EW/C92/11/1 **Category:** 1a

Aircraft Type and Registration: Airbus Industrie A320-211, D-AIPS

Location: Runway 27L London Heathrow Airport

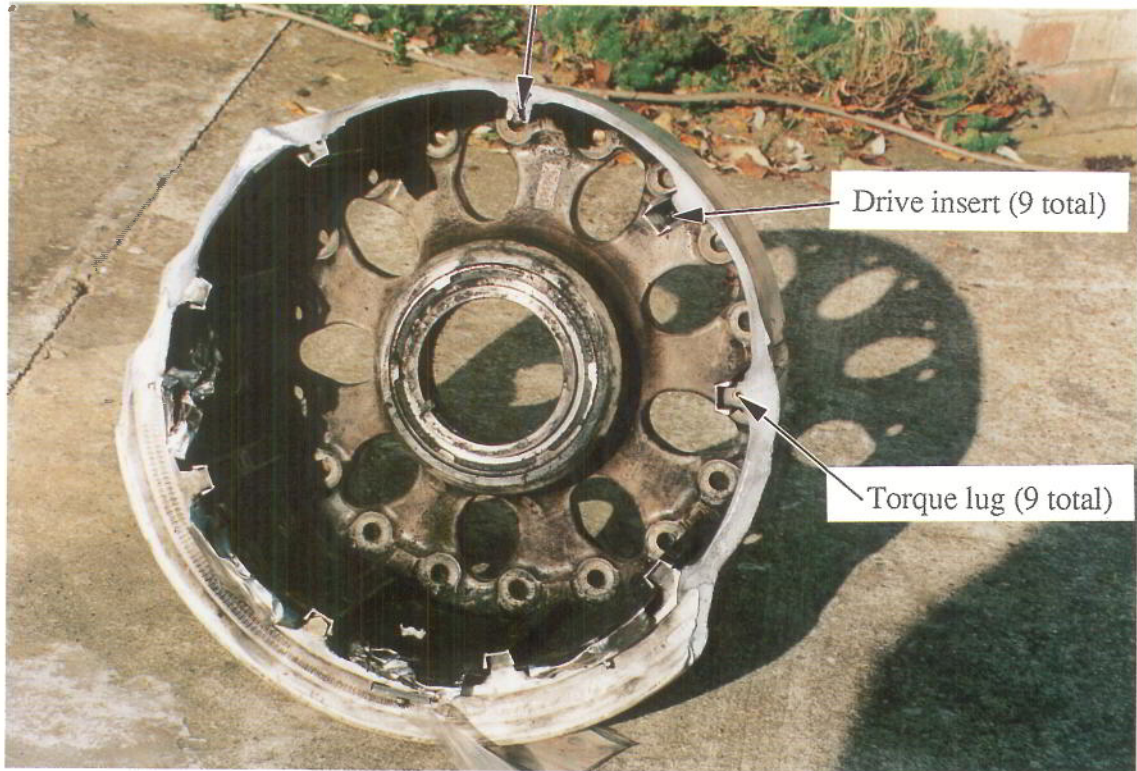
Figure 1 - Inner wheel half - (D-AIPS)

Visual examination of the fracture surfaces of the rim and wheel showed an area of fatigue fracture, originating in one of the nine torque lugs spaced around the inner circumference of the wheel (Figure 1). These nine torque lugs carry the steel 'drive inserts', which engage the 'rotors' in the brake pack. The fatigue fracture (Figure 2) also passed through the torque lugs adjacent to the lug displaying the primary fatigue initiation point, but these lugs showed no fatigue initiation themselves. In this examination, there was no evidence of corrosion which would have initiated the fatigue mechanism.

Fatigue initiation

92-112 The CAA should ensure that Service Bulletin 3-1491-32-4 (SB 571), issued by B F Goodrich Aerospace, is being fully implemented by UK operators of the A320 using this model of wheel. This safety information should also be transmitted to other regulatory authorities responsible for A320 operators.

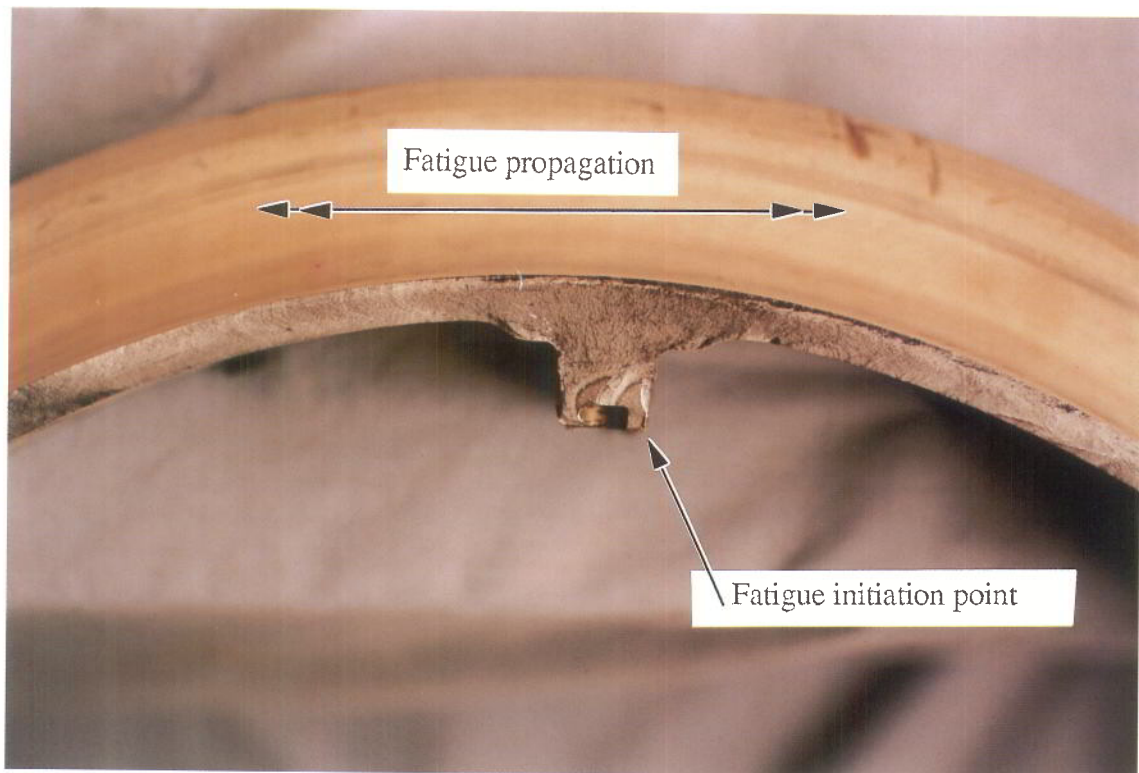
Figure 2 - Wheel rim fatigue detail - (D-AIPS)

The aircraft Technical Log showed no recent history of air leakage from this wheel. Measurement of the wheel, and the rubber markings on the outer circumference, showed that the fatigue portion of the fracture had been under the 'foot' portion of the tyre tread, preventing air leakage from the wheel through the fatigue crack. It would appear, therefore, that when the wheel failed, the tyre was close to its normal pressure.

Information from the operator shows that the average tyre service life for mainwheels on the A320 is 295 cycles and this is identical to the wheel inspection interval. The failed wheel had been installed on D-AIPS about 30 days previously; at the time of the failure the wheel had accumulated 264 cycles since this last inspection, 3693 total cycles in its life. The evidence of the fracture suggested that the fatigue crack had been present for rather longer than this one inspection interval.
