AAIB Bulletin No: 5/95

Ref: EW/G95/02/06

Aircraft Type and Registration: Reims Cessna F172M Skyhawk, G-YTWO

Date & Time (UTC): 18 February 1995 at 1140 hrs

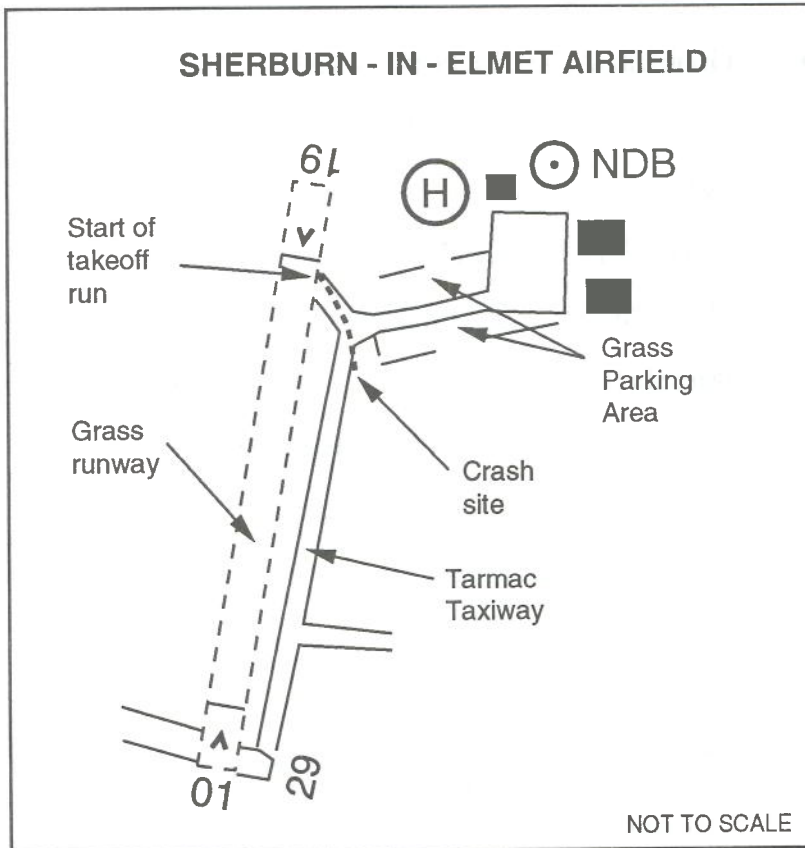
On the day of the accident both runways were waterlogged so the tarmac taxiway, that runs parallel to Runway 19 for most of its length, was being used for takeoff. Having completed his pre-takeoff checks, the pilot, following local practice, lined up for what he reported as an 'angled takeoff' using as the first part of his take-off run the initial part of the taxiway that is offset by some 20° to 30° from the main portion. The initial ground roll was satisfactory but, as he initiated the gradual turn 'round the dog leg', the aircraft began to drift to the left. As application of right rudder and aileron failed to overcome the deviation the pilot decided to abort the takeoff, reduce the power and apply the brakes with further right rudder. The aircraft drifted onto the wet grass, collided with a marker board, entered

an area of ploughed field and pitched inverted. The pilot transmitted an emergency call, shut off the fuel and vacated the aircraft as the emergency vehicle arrived.

A witness to the accident stated that it is common practice for pilots using the tarmac taxiway to start their take-off run offset from the main portion of the taxiway. The normal practice is to negotiate the turn at an approximate speed of 10 kt applying full power only when straight. Initial power on the accident aircraft, however, had been substantial and it is estimated that it had achieved a speed of approximately 50 kt by the turning point.
