ACCIDENT

Aircraft Type and Registration:	DHC-8-402 Dash 8, G-JEDN	
No & Type of Engines:	2 Pratt & Whitney Canada PW150A turboprop engines	
Year of Manufacture:	2003	
Date & Time (UTC):	22 April 2010 at 0600 hrs	
Location:	Southampton Airport, Hampshire	
Type of Flight:	Commercial Air Transport (Passenger)	
Persons on Board:	Crew - 4	Passengers - 40
Injuries:	Crew - None	Passengers - None
Nature of Damage:	Right wing leading edge damaged	
Commander's Licence:	Airline Transport Pilot's Licence	
Commander's Age:	48 years	
Commander's Flying Experience:	6,086 hours Last 90 days - 167 hours Last 28 days - 39 hours	
Information Source:	AAIB Field Investigation

Synopsis

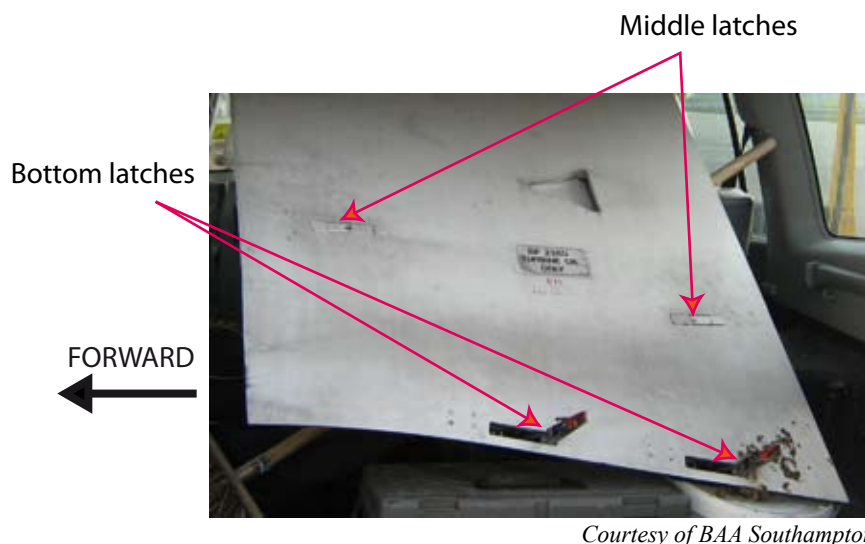
Figure 1

The No 2 engine inboard forward access door was found by airport staff in the grass area approximately halfway along and to the east of the runway. It was found with the two centre latches closed and locked but with the two lower latches fully open (Figure 1).

The lower latches had grass and dirt embedded within the lever mechanism indicating that they were in the open position when the door impacted the ground. Examination of the latch pin receivers in the nacelle structure showed no evidence of the pins having been forced out of their locked positions. All four quick-release positive-lock pin latches were found to be serviceable and showed no evidence of the latch pins having been engaged immediately prior to the engine bay door becoming detached from the aircraft.

No 2 engine inboard forward access door following recovery

The aircraft was based at Southampton where it had been parked overnight. A Daily Check and an unscheduled maintenance task were carried out during the night. One of the first tasks specified on the Daily Check was to check the engine oil quantities. This task required the No 1 engine forward outboard and the No 2 engine forward inboard access doors to be opened. The evidence suggested that the No 2 forward inboard access door had not been fully latched following the maintenance work.

Following this event the operator launched a safety campaign to highlight to aircrew, engineering and ground staff the importance of securing and checking of engine access doors on all its aircraft types.

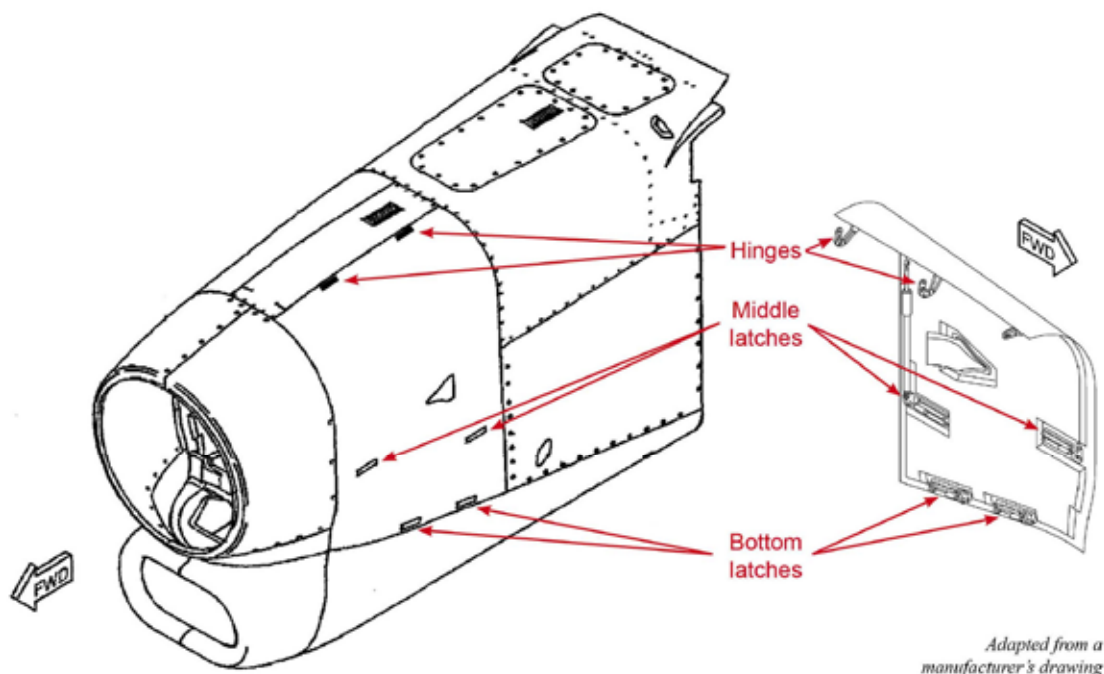
Figure 2

The main engine bay has two large forward access doors, one inboard and one outboard. These access doors are made from a carbon/epoxy composite material with integral foam filled stiffening ribs. Each door is hinged at the top and is held in the closed position by four quick release positive-lock pin latches. Each latch, when closed, engages a pin into a receiver mounted within the engine nacelle structure (Figure 2).

Forward engine bay access door
