## Stampe SV4C(G), G-OODE

<b>AAIB Bulletin No: 10/2004</b>	<b>Ref: EW/C2003/07/08</b>	<b>Category: 1.3</b>
<b>INCIDENT</b>		
<b>Aircraft Type and Registration:</b>	Stampe SV4C(G), G-OODE	
<b>No &amp; Type of Engines:</b>	1 Gipsy Major 10 Mk 1 piston engine	
<b>Year of Manufacture:</b>	1947 (airframe)	
<b>Date &amp; Time (UTC):</b>	26 July 2003 at 1532 hrs	
<b>Location:</b>	Former quarry near Redhill, Surrey	
<b>Type of Flight:</b>	Private	
<b>Persons on Board:</b>	Crew - 1	Passengers - None
<b>Injuries:</b>	Crew - None	Passengers - N/A
<b>Nature of Damage:</b>	Separation of propeller, forward portion of crankshaft and forward upper portion of engine crankcase	
<b>Commander's Licence:</b>	National Private Pilot's Licence	
<b>Commander's Age:</b>	61 years	
<b>Commander's Flying Experience:</b>	1,586 hours (of which 398 were on type)	
	Last 90 days - 4 hours	
	Last 28 days - 1 hour	
<b>Information Source:</b>	AAIB Field Investigation

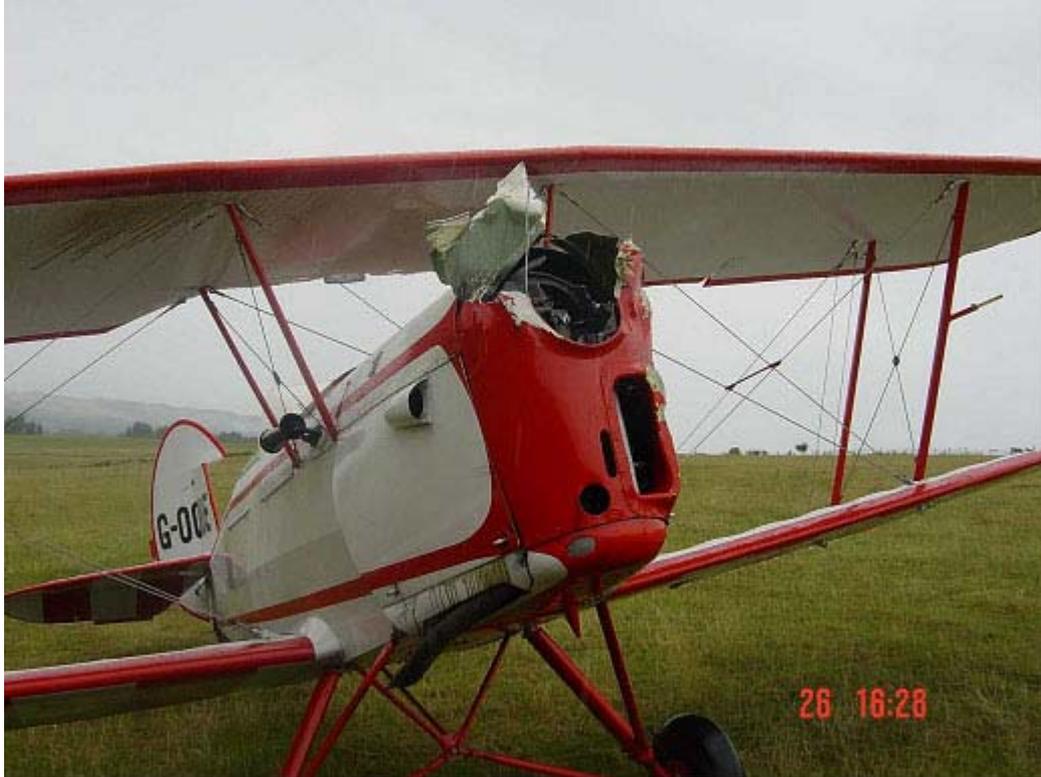
Figure 1 shows G-OODE shortly after its forced landing.

Figure 1 - G-OODE after forced landing

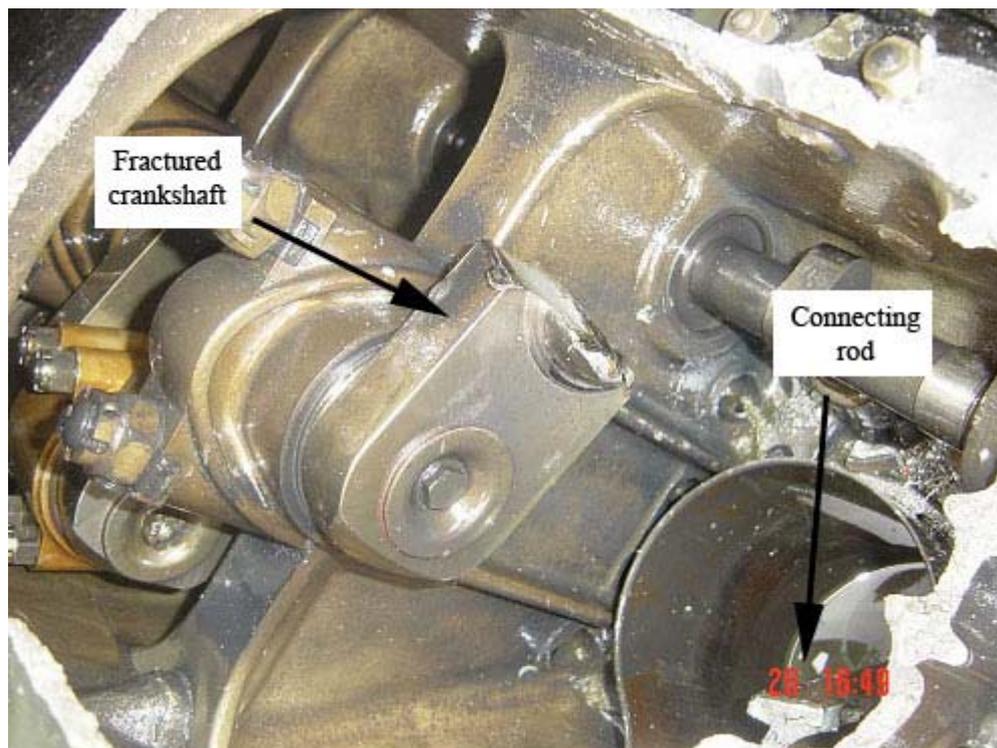
It was immediately apparent that there had been a substantial failure at the front end of the engine, resulting in fractures of the crankshaft beside the No 1 cylinder big-end bearing (see Figure 2), the No 1 cylinder connecting rod and the front end of the crankcase.

**Figure 2 - Failed crankshaft, No 1 cylinder and fractured connecting rod**

A detailed examination of the fractures was undertaken by a specialist metallurgist. This indicated that the big-end cap was properly in place when it had been subjected to a high twisting load, resulting in the failure of the big-end bolts and separation of the big-end from the crankshaft. This was also consistent with the failure of the connecting rod when it was subjected to a high overload by the failure of the crankshaft and collision between the cylinder skirt and the connecting rod (see Figure 2).

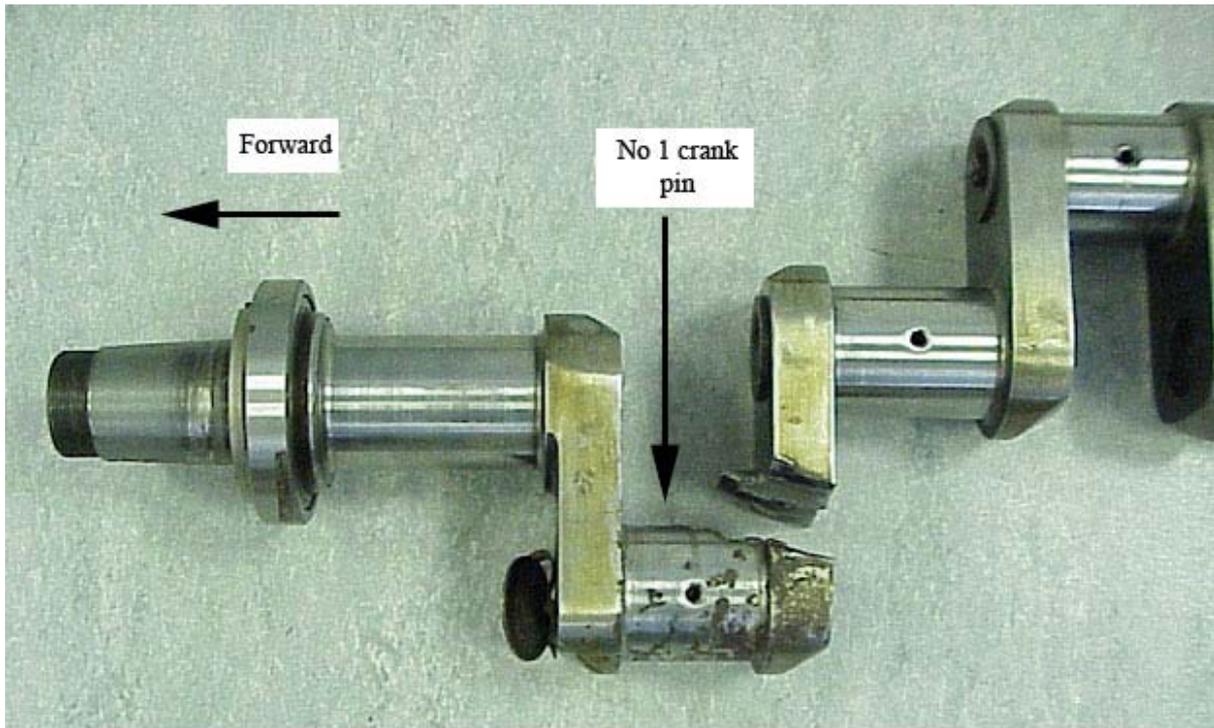
The crankshaft failure showed evidence of fatigue. Figure 3 shows the fractured crankshaft as received, with the fracture at the junction of the No 1 crank pin and its web, the forward portion of the crankshaft having suffered extensive corrosion damage before recovery.

**Figure 3 - Fractured crankshaft**

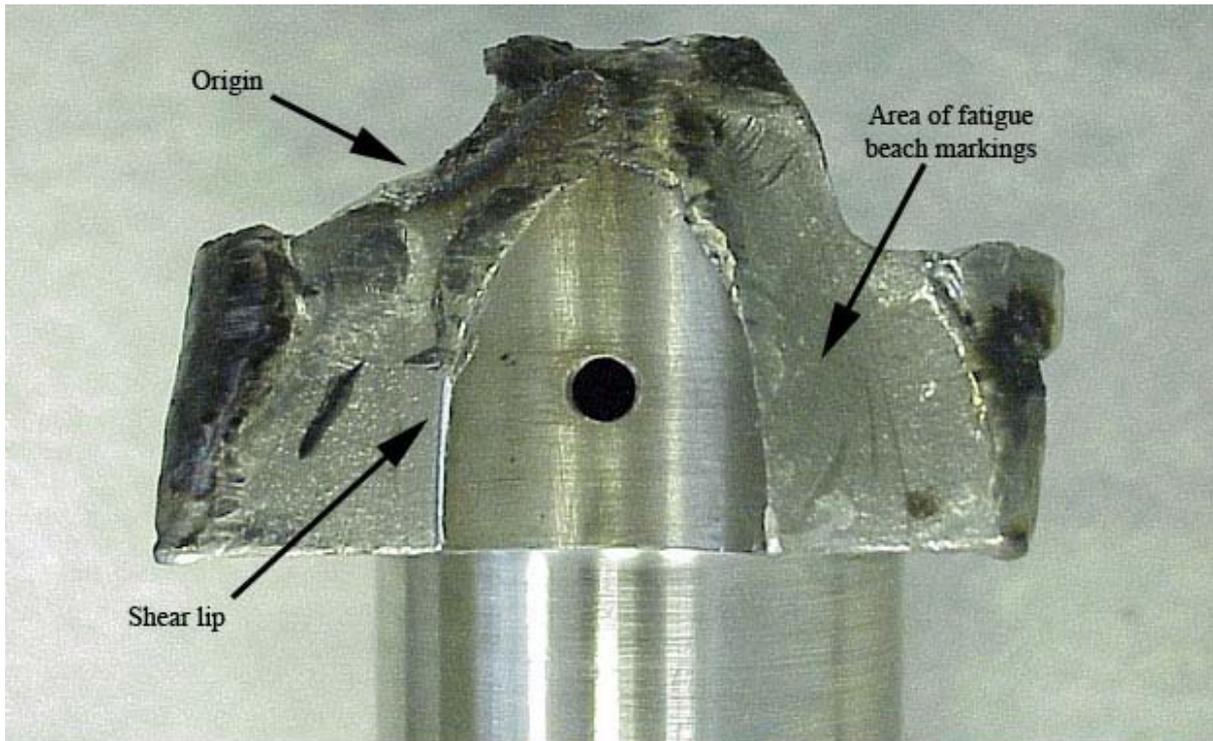
The fracture surface (Figure 4) of the main portion of the crankshaft showed hemispherical beach markings on both sides of the bore, characteristic of fatigue cracking. On one side of the bore (the left side in Figure 4) the presence of a shear lip at the bore and the direction of the ridges running across the beach markings (at approximately 90°) indicated that the fracture had initiated in the radius of the No 1 crank pin. On the other side (the right side in Figure 4) the direction of these ridges indicated that the fatigue crack had originated at the surface of the crank pin bore.

Figure 4 - Detail of crankshaft fracture surface

It appeared, therefore, that the mechanism of the crankshaft failure was fatigue cracking, initiated in the rear radius of the No 1 crank pin, at 45° to the axis of the crankshaft. The crack had propagated through to the crank pin bore and had combined with a secondary crack initiated on the opposite side of the bore, parallel to the initial crack. Because of the impact damage to the initiation region in the radius of the No 1 crank pin (see Figure 4), it was not possible to confirm that the crack had initiated at a corrosion pit. However, the pitting and fatigue cracking identified on the No 2 crank pin indicates that this was probably the case.

It is recommended that the UK Civil Aviation Authority specifies a calendar time limitation for Gipsy engines, at least for those aircraft operating in the Public Transport and Aerial Work categories, to cover areas where periodic predictive inspections are not effective.
