# Pierre Robin R1180T Aiglon, G-BLZD, 8 February 1996

**AAIB Bulletin No: 5/96 Ref: EW/G96/02/02 Category: 1.3**

**Aircraft Type and Registration:** Pierre Robin R1180T Aiglon, G-BLZD

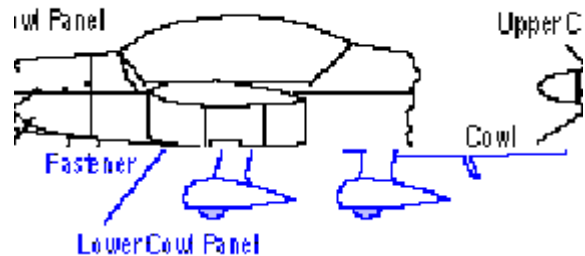
a flange formed along the edges of the lower panel. Attachment is by means of camlock type fasteners, with two provided to secure the upper panel to the firewall flange and three along each side connecting upper and lower panels together. For convenience these are designated from the front L1L4 and R1R4 for left and right sides respectively. Each fastener consists of two

fittings, one attached to the panel and the other riveted to the fixed components. The panel fitting contains a rotatable barrel with a cross bar attached and the fixed fitting contains a keyhole plate and cam plates. To engage the fastener the end of the barrel is passed through the keyhole and the barrel is rotated 90° by means of a screwdriver slot in its end to drive the cross bar up the cam plates into a detent, thus drawing together and securing the components.

The upper cowl panel was not available for inspection but reportedly the panel fittings of the R1 and R2 fasteners had pulled through the upper panel and were found in place and locked in the lower panel fittings. The upper panel had apparently remained attached to the aircraft by the R3 fastener and possibly by the R4 fastener. Both the panel fittings and the fixed fittings of the four left side fasteners that had disengaged remained in place with no signs of damage. It was noted that when the fastener is unlocked the head of the barrel tends to protrude only slightly further from the outer face of the panel fitting than when the fastener is locked and the difference in appearance between the two conditions is small.
