SERIOUS INCIDENT

Aircraft Type and Registration:	Boeing 747-436, G-BNLW	
No & Type of Engines:	4 Rolls-Royce RB211-524G2-T-19 turbofan engines	
Year of Manufacture:	1992 (Serial no: 25432)	
Date & Time (UTC):	14 October 2013 at 0630 hrs	
Location:	In flight, approx 2 hours from London Heathrow Airport	
Type of Flight:	Commercial Air Transport (Passenger)	
Persons on Board:	Crew - 17	Passengers - 274
Injuries:	Crew - None	Passengers - None
Nature of Damage:	Fire damage to In-Flight Entertainment (IFE) unit and surround	
Commander's Licence:	Airline Transport Pilot's Licence	
Commander's Age:	42 years	
Commander's Flying Experience:	14,574 hours (of which 6,578 were on type) Last 90 days - 187 hours Last 28 days - 24 hours	
Information Source:	Aircraft Accident Report Form submitted by the pilot

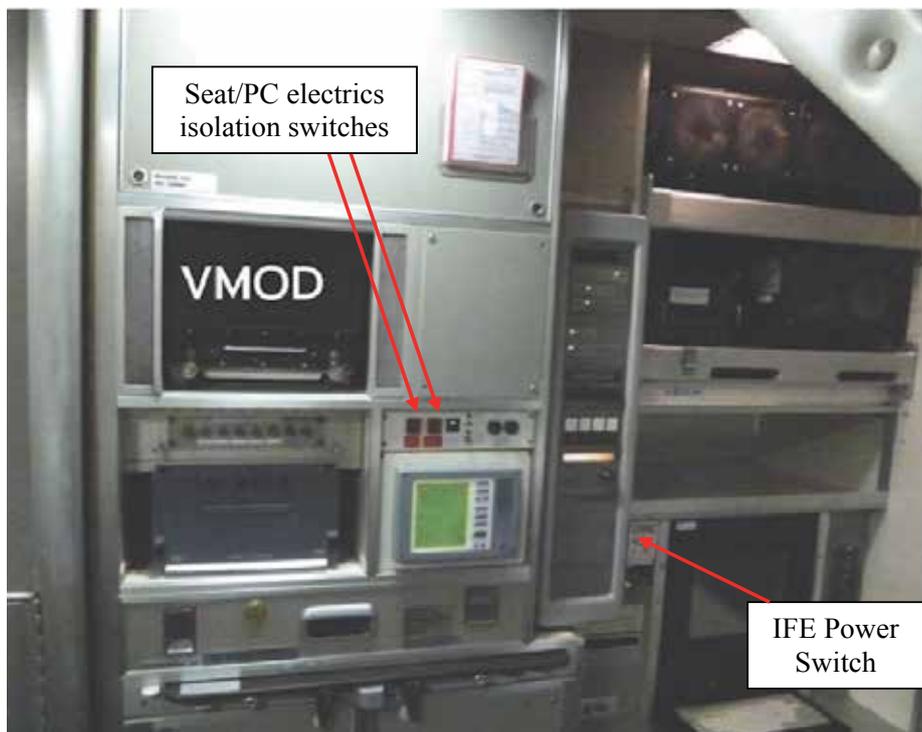
Figure 1

View of Galley 4 and CSD's office showing location of IFE VMOD and associated switches

The first action was to press two guarded switches in the CSD's office (Figure 1) labelled 'SEAT/PC ELECTRICS ISOLATION' for first class and business/premium economy class cabins.
