SERIOUS INCIDENT

Aircraft Type and Registration:	Boeing 747-436, G-BNLW
No & Type of Engines:	4 Rolls-Royce RB211-524G2-T-19 turbofan engines
Year of Manufacture:	1992 (Serial no: 25432)
Date & Time (UTC):	14 October 2013 at 0630 hrs
Location:	In flight, approx 2 hours from London Heathrow Airport
Type of Flight:	Commercial Air Transport (Passenger)
Persons on Board:	Crew - 17 Passengers - 274
Injuries:	Crew - None Passengers - None
Nature of Damage:	Fire damage to In-Flight Entertainment (IFE) unit and surround
Commander's Licence:	Airline Transport Pilot's Licence
Commander's Age:	42 years
Commander's Flying Experience:	14,574 hours (of which 6,578 were on type) Last 90 days - 187 hours Last 28 days - 24 hours
Information Source:	Aircraft Accident Report Form submitted by the pilot

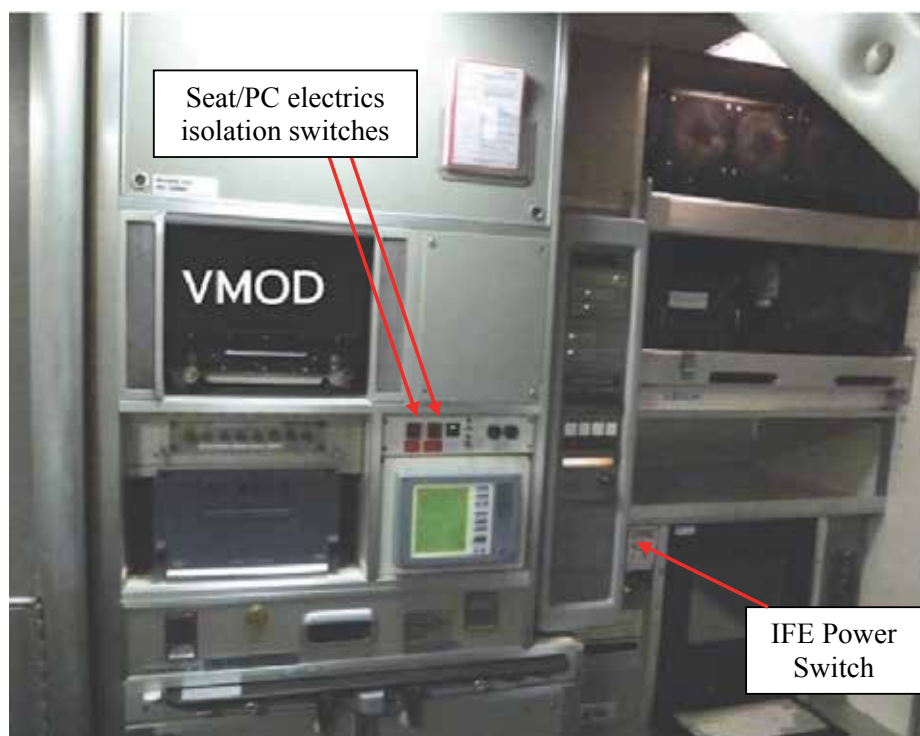
Figure 1

View of Galley 4 and CSD's office showing location of IFE VMOD and associated switches

The first action was to press two guarded switches in the CSD's office (Figure 1) labelled 'SEAT/PC ELECTRICS ISOLATION' for first class and business/premium economy class cabins.

An internal investigation by the operator concluded that it was likely the VMOD had remained powered during the incident and this was the reason it continued to re-ignite. One of the cabin crew described how he believed he had isolated the IFE, but his description of events suggested that he had only actioned the 'SEAT/PC ELECTRICS ISOLATION' part of the 'Safety Equipment and Procedures Manual' and that this had been done from memory.

The operator's investigation included a number of Recommended Actions concerning cabin crew training, both in regard to use of checklists, operation of extinguishers and their understanding of the electrical equipment in the CSD's office.
