AAIB Bulletin No: 2/95

Ref: EW/G94/11/05

Aircraft Type and Registration: Boeing 747-2J6F, B-2462

Location: London Stansted Airport, Essex

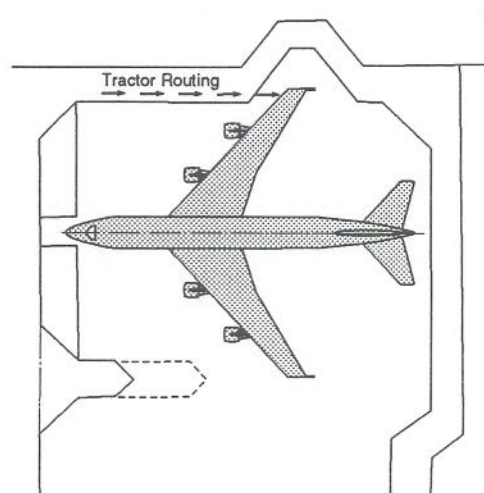
The aircraft arrived on Stand A6 at Stansted Airport at 1553 hrs and shortly afterwards a Ground Handling Agency employee proceeded to position a 747 tailpost from the head of the stand to the rear of the aircraft. He towed the stand with a tractor along the marked out roadway along the right side of the aircraft but on reaching a bend where the roadway diverges away from the stand centreline to avoid the area under the outer part of the wing he continued in a straight line, believing that the tailpost would pass beneath the wing. However, the tailpost had been extended prior to the aircraft's arrival to allow for more rapid positioning and embedded itself in the wing leading edge. The leading edge was extensively damaged over a length of about 2 feet and a panel on the underside of the wingtip was holed.

The driver was suspended from his duties and has subsequently received a ramp procedures refresher course and undergone a further airside driving test. Since the accident the Airport Operator has issued a Ramp Instruction:

'RE: 747 TAILPOST

When positioning the 747 tailpost where ever possible it should be positioned at the bottom end of the stand prior to the aircraft arrival.

When this is not possible the post must only be towed along the marked out roadways and **NEVER UNDER THE WINGS'**
