No: 10/88

Ref: EW/C1048

Aircraft Type and Registration: Boeing 747-136 G-AWNB

Nature of Damage: Left landing gear support beam end fitting failed, damage to wing top skin panels and secondary structure

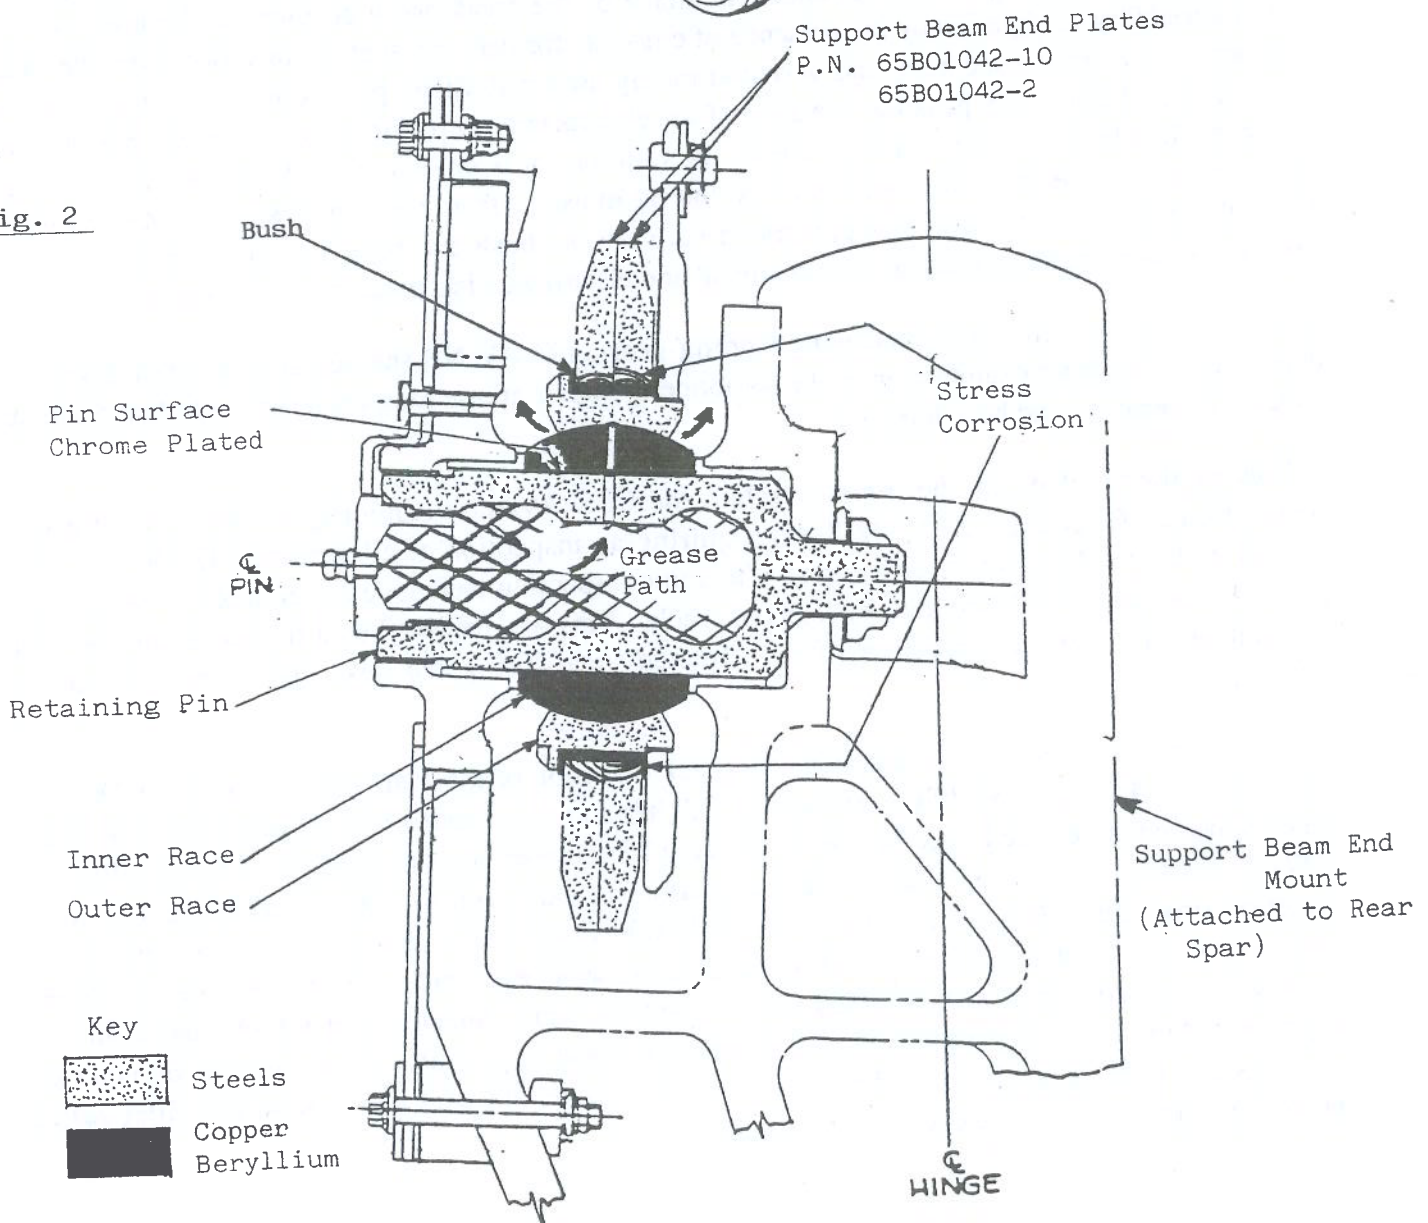
Fig. 2

The outboard end fitting (Fig. 2) is an articulated joint comprising a spherical bearing on the beam which attaches to a separate vertical hinge on the rear wing spar. The spherical bearing is mounted in doubled plates which are clamped to either side of the support beam end. The central retaining pin for the spherical bearing is a hollow fuse pin and lubrication is by grease injected through a nipple into the pin core. Grease then flows outward through passages in the pin and in the copper-beryllium inner race to lubricate the surfaces between the pin (chrome plating on steel) and the inner race and between the inner race and the outer race (stainless steel). The outer race is located in copper beryllium bushes in the support beam end plates. These bush surfaces are not lubricated but are assembled into the beam end plates with wet primer to provide a seal against moisture ingress.

A preliminary metallurgical inspection was carried out by the Materials Department, RAE Farnborough and a full examination by the aircraft manufacturer. The end plates had both suffered nearly identical fractures initiating from the internal bore surfaces; two fractures in each case running inboard along lines focusing on the centre of the bore and angled at about 45° above and below the beam spanwise direction. Small areas of pre-existing cracking could be seen emanating from the bore internal surface (which mates with the copper-beryllium bush). This surface was severely pitted by corrosion which was unevenly distributed over the bore surface but was present at the origins of the cracks. The pre-existing cracking was found to be predominately due to stress-corrosion and the four separate areas of cracking (top and bottom fractures, fore and aft end plates) had penetrated by between 0.1 and 0.3 ins (combined penetration of corrosion and cracking). Later analysis of the end plate material (9Ni-4Co-0.3C) showed it to be within specification.

Although fresh grease was found inside the fuse pin the material on the bearing surfaces between the pin and the inner race and between the inner race and outer race showed signs of stagnation and deterioration. The chrome plating on the surface of the pin had been almost completely destroyed. An area of intact plating remained, close to the grease transfer passages, and it was apparent that during re-greasing it had been possible for fresh grease to be forced through to the spherical bearing surfaces, ejecting old grease from the periphery, but that old grease was not being purged from all the areas requiring lubrication. It should be noted that this bearing assembly experiences minimal movement and there is no requirement in normal servicing for the components to be rotated or exercised in any way to keep the grease mobile. Furthermore, there is no requirement for this assembly to be dismantled and visually inspected other than during major structural surveys. On G-AWNB the assembly had last been dismantled in 1973 during implementation of a service bulletin and would have been last lubricated in June 1987. At the time of the failure the aircraft had completed 63,721 flying hours and 15,887 landings.

The surface deposit which was recovered from the bore containing the fractures did, therefore, appear to be a mixture of the greases which had been previously used together with their products of deterioration and metallic corrosion debris. This surface is not intentionally lubricated but it would appear that, as the assembly's exterior became congested with ejected, used grease this was induced in between the bushing and the bore by the "working" of the bush in the bore under load.

It is not clear what the precise process was that led to the corrosion and pitting of the bore surfaces. Originally, the surface was plated with a cadmium/titanium finish. This would have been damaged by **mechanical wear during service but chemical** attack by the break-down products of the greases was also a possibility as signified by the presence of chloride, formate and acetate ions. However, the basic component materials used here, and very commonly used elsewhere, place copper and iron in close proximity and allow the possible creation of an electrolytic corrosion process, in the presence of moisture, in which the iron would sacrifice. In addition, it is unlikely that the deteriorated greases would be able to perform the function of excluding moisture from the surfaces which they covered. Once the degraded lubricants had penetrated between the bush and bore it is likely, therefore, that moisture also entered and assisted both chemical and electrochemical processes of corrosion.

Following the incident, on the 11th November, the Civil Aviation Authority issued an Emergency Airworthiness Directive (A.D. 012-11-87) requiring an inspection of all Boeing 747-100 and -200 aircraft with over 7 years service using an ultrasonic inspection technique developed by the operator (British Airways J57U113) to detect defects or cracks. This was followed by a further requirement for dismantling and visual inspection of the affected area during the next appropriate scheduled maintenance.

Boeing developed an ultrasonic technique for crack detection of the beam end fitting (NDT Manual, D6-7170, Part 4 Chapter 57-40-03 revision 15 Feb 88) and developed a rework procedure and limits which appeared in Service Letter 747-SL-57-50-A (11 December and subsequent). A Service Bulletin (747-57-2244) issued on 31 March urged operators to carry out the described ultrasonic crack detection procedure upon the accumulation of 30,000 flight hours or 8 years service (whichever earlier) or within 18 months after receipt of the bulletin, whichever later. The bulletin also described the reworking procedure to be carried out if cracking were detected and which also could be implemented to terminate a requirement for 18 monthly repeat inspections. From airframe 696 onward bushings and bolts in the beam end assembly will be assembled with wet sealant and fillet sealed where appropriate to improve corrosion protection.
