**No: 10/88**

**Ref: EW/C1048**

**Aircraft Type and Registration:** Boeing 747-136 G-AWNB

**Nature of Damage:** Left landing gear support beam end fitting failed, damage to wing top skin panels and secondary structure

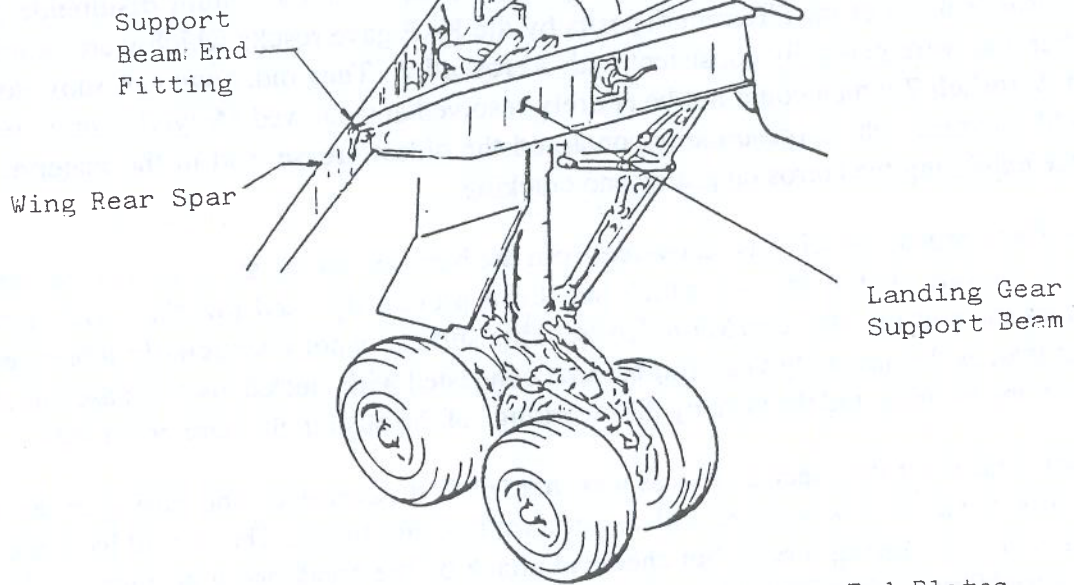
Fig. 1

Examination showed that there had been a failure at the outboard end of the left wing landing gear support beam where it attaches to the aft face of the rear wingspar. The wing gear is mounted between the rear spar and the support beam (see Fig.1). The support beam is designed to be fail-safe in the event of any disconnection at the outboard end. If unsupported at the outboard end the beam, acting as a cantilever, is capable of supporting 90% of the design ultimate undercarriage loads but, at any given load, will deflect to a far greater degree than it would intact. Such deflection will result in abnormal movement of the undercarriage leg and also of the inboard flap, the inboard rail of which is attached to the support beam. There would have been some increased movement of the flap under flight loads but no adverse effect on the aircraft's performance or control was remarked upon by the crew. Upward

bending of the beam had caused it to hit and rupture the light structure and honeycomb sandwich panelling which form the top wing skin aft of the wing box. With this type of failure there is also the possibility of damage to adjacent control cables and hydraulic lines.

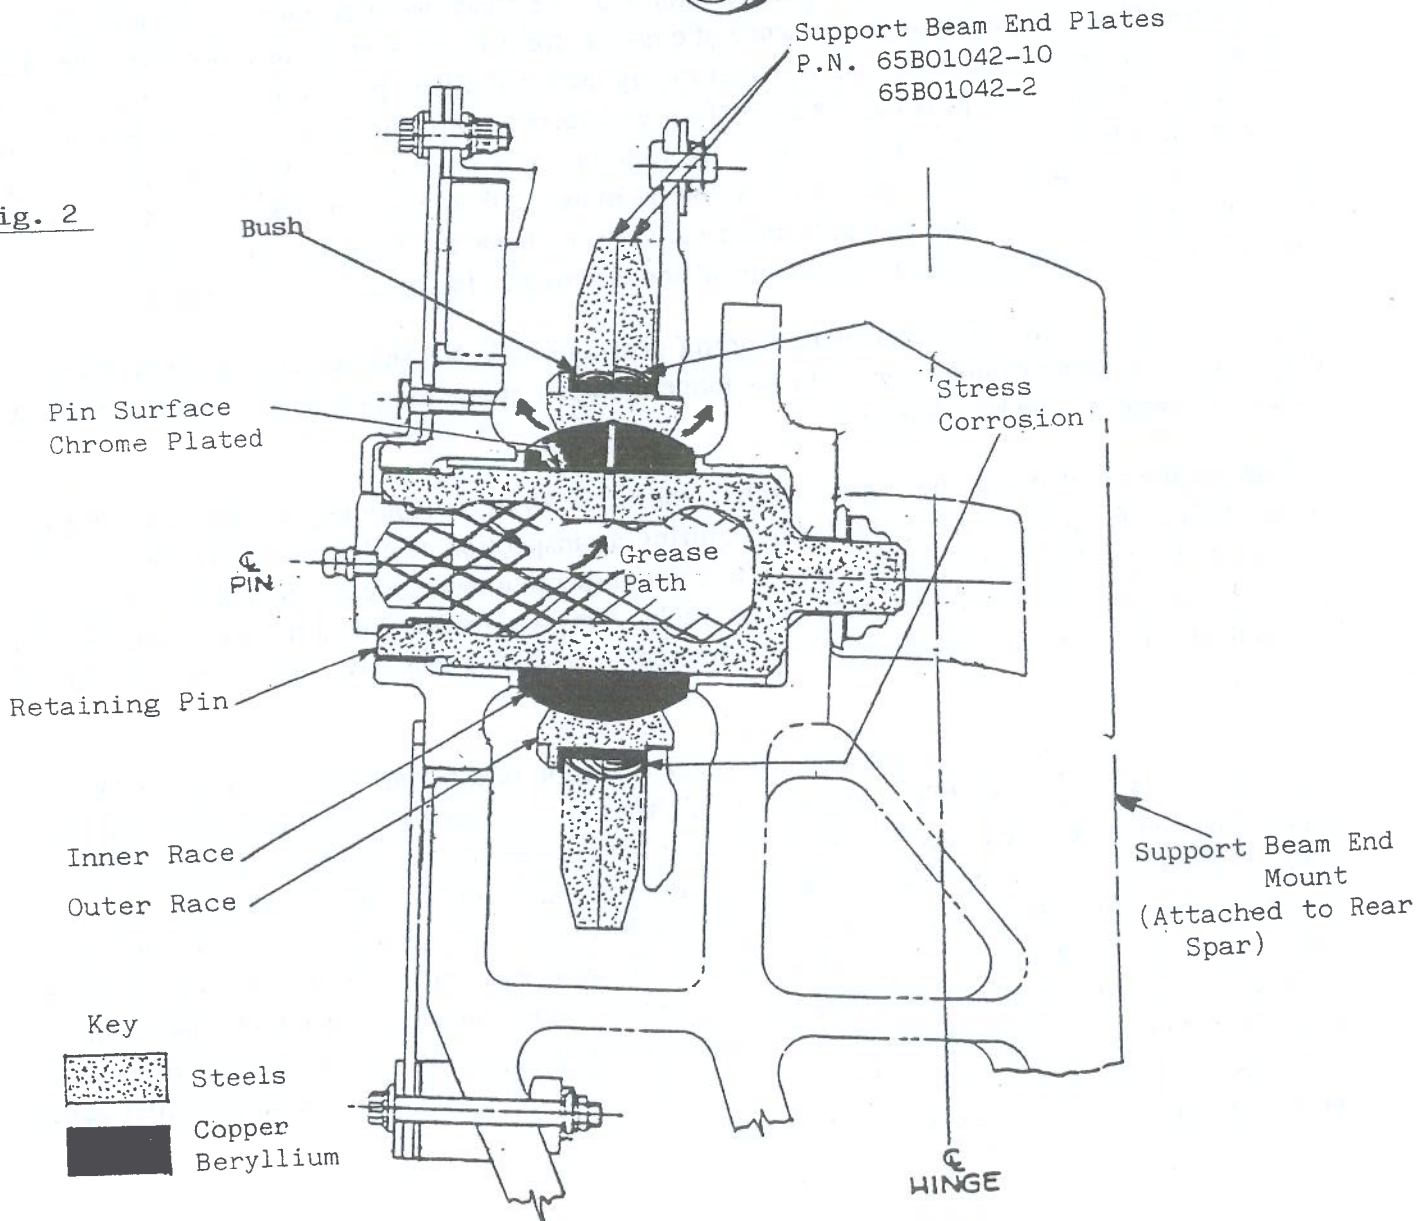
Fig. 2

The outboard end fitting (Fig. 2) is an articulated joint comprising a spherical bearing on the beam which attaches to a separate vertical hinge on the rear wing spar. The spherical bearing is mounted in doubled plates which are clamped to either side of the support beam end. The central retaining pin for the spherical bearing is a hollow fuse pin and lubrication is by grease injected through a nipple into the pin core. Grease then flows outward through passages in the pin and in the copper-beryllium inner race to lubricate the surfaces between the pin (chrome plating on steel) and the inner race and between the inner race and the outer race (stainless steel). The outer race is located in copper beryllium bushes in the support beam end plates. These bush surfaces are not lubricated but are assembled into the beam end plates with wet primer to provide a seal against moisture ingress.

A preliminary metallurgical inspection was carried out by the Materials Department, RAE Farnborough and a full examination by the aircraft manufacturer. The end plates had both suffered nearly identical fractures initiating from the internal bore surfaces; two fractures in each case running inboard along lines focusing on the centre of the bore and angled at about 45° above and below the beam spanwise direction. Small areas of pre-existing cracking could be seen emanating from the bore internal surface (which mates with the copper-beryllium bush). This surface was severely pitted by corrosion which was unevenly distributed over the bore surface but was present at the origins of the cracks. The pre-existing cracking was found to be predominately due to stress-corrosion and the four separate areas of cracking (top and bottom fractures, fore and aft end plates) had penetrated by between 0.1 and 0.3 ins (combined penetration of corrosion and cracking). Later analysis of the end plate material (9Ni-4Co-0.3C) showed it to be within specification.

Boeing developed an ultrasonic technique for crack detection of the beam end fitting (NDT Manual, D6-7170, Part 4 Chapter 57-40-03 revision 15 Feb 88) and developed a rework procedure and limits which appeared in Service Letter 747-SL-57-50-A (11 December and subsequent). A Service Bulletin (747-57-2244) issued on 31 March urged operators to carry out the described ultrasonic crack detection procedure upon the accumulation of 30,000 flight hours or 8 years service (whichever earlier) or within 18 months after receipt of the bulletin, whichever later. The bulletin also described the reworking procedure to be carried out if cracking were detected and which also could be implemented to terminate a requirement for 18 monthly repeat inspections. From airframe 696 onward bushings and bolts in the beam end assembly will be assembled with wet sealant and fillet sealed where appropriate to improve corrosion protection.
