Lockheed L1011-500 Tristar, CS-TMP

AAIB Bulletin No: 10/2004	Ref: EW/C2003/08/04	Category: 1.1
Aircraft Type and Registration:	Lockheed L1011-500 Tristar, CS-TMP	
No & Type of Engines:	3 Rolls-Royce RB 211-524B turbofan engines	
Year of Manufacture:	1983	
Date & Time (UTC):	19 August 2003 at 1106 hrs	
Location:	Runway 23 at Stansted Airport, Essex	
Type of Flight:	Public Transport (Positioning)	
Persons on Board:	Crew - 13	Passengers - None
Injuries:	Crew - None	Passengers - N/A
Nature of Damage:	Scoring and deformation to underside of aft fuselage, damage to No 2 engine translating cowl and hot stream duct	
Commander's Licence:	Airline Transport Pilot's Licence and Type Rating Instructor	
Commander's Age:	54 years	
Commander's Flying Experience:	11,300 hours (of which 1,200 were on type)	
	Last 90 days - 60 hours	
	Last 28 days - 28 hours	
Information Source:	AAIB Field Investigation

Synopsis

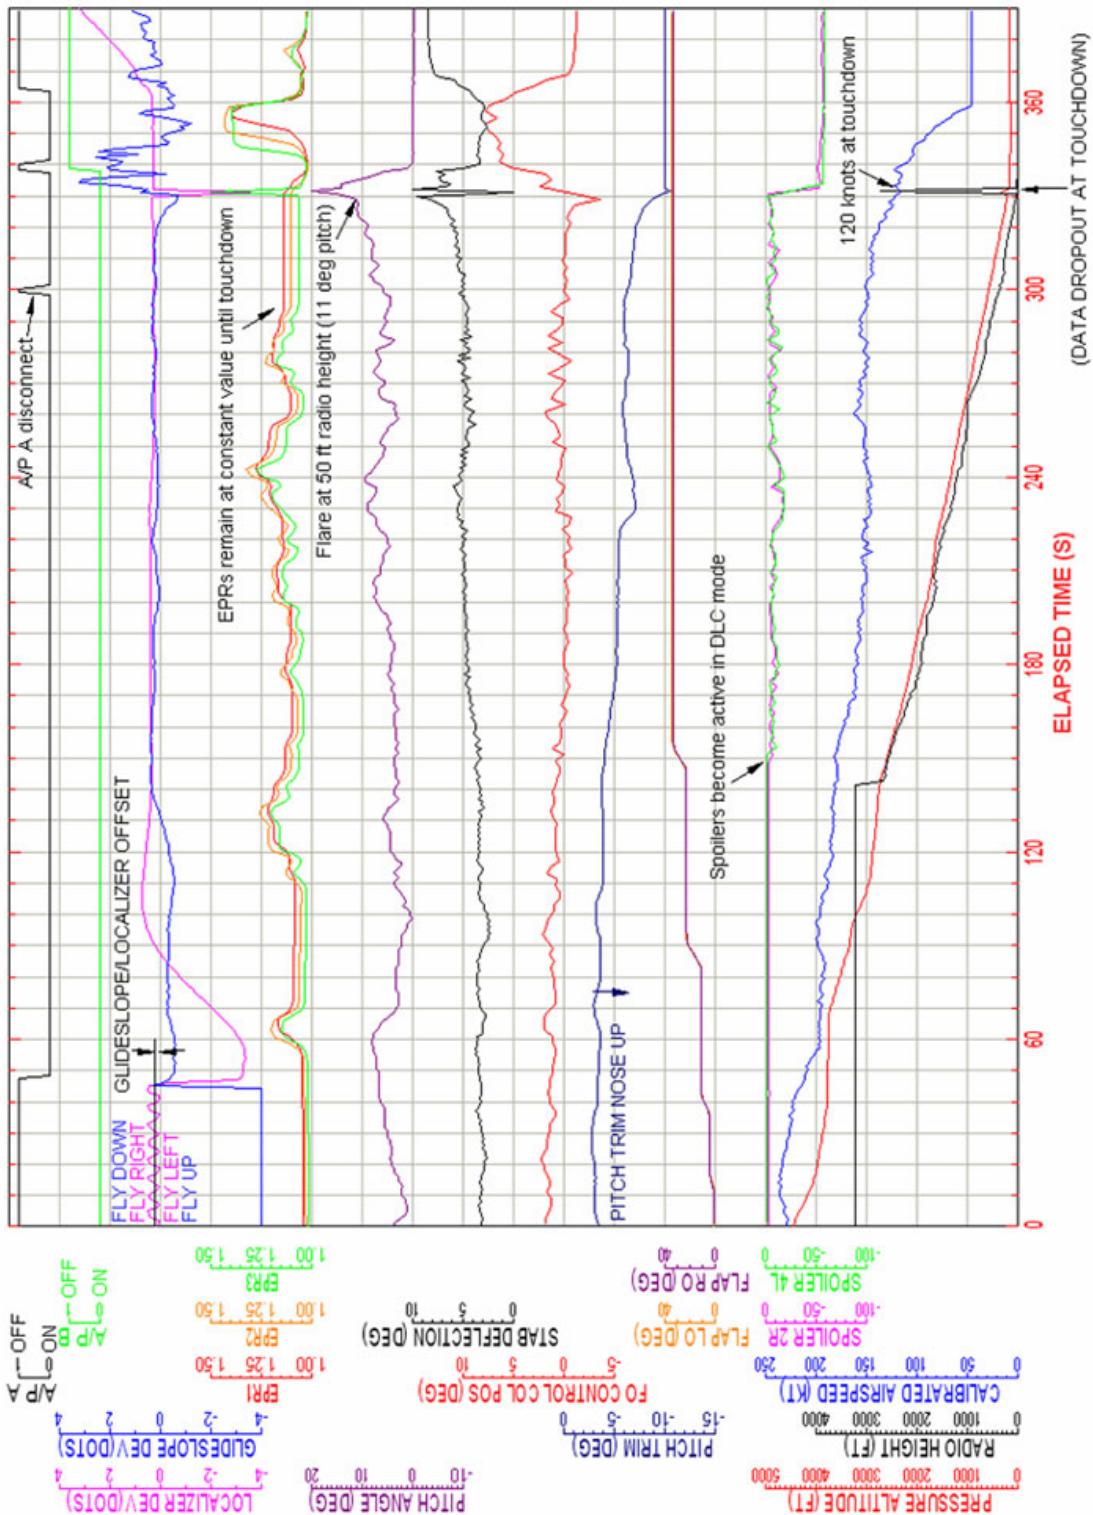
Figure 1

A time history of the relevant parameters during the landing at Stansted is shown in Figure 1. From this figure, it can be seen that A/P 'B' was already engaged when A/P 'A' was selected during the descent, at about 3,750 feet amsl, just under 5 minutes before touch down. No other distinct A/P mode discrete parameters, such as ATS or Approach/Land Mode, were available on the FDR. At A/P 'A' engagement, the localiser and glideslope deviation signals become active shortly followed by changes in the engine pressure ratios (EPRs), which had remained fairly constant at values between 1.02 and 1.05, for the previous 100 seconds. These changes in the EPRs were consistent with the ATS being active.

Salient FDR Parameters
 (Accident to CS-TMP on 19 August 2003 at Stansted Airport)

At about 30 seconds prior to touchdown, 350 feet agl, A/P 'A' disconnected and then re-engaged. From this point, the three EPRs remained fixed at values between 1.06 and 1.14 and remained at these values until touchdown. (Five seconds prior to this point, the EPRs were already at these values, following a period where the aircraft was on or above the glideslope.) Thereafter, the aircraft pitch increased, the airspeed reduced and there was an increasing divergence below the glideslope.

At 50 feet agl, four seconds before touchdown, the pitch attitude was 11° nose-up and the airspeed was 128 kt. At touchdown, the aircraft pitch attitude was in excess of 15° nose up and the recorded airspeed was 120 kt.
