Ref: EW/G91/09/17

Aircraft Type and Registration: Piper PA-34-200 Seneca, G-BARB

Location: Birmingham International Airport

Nature of Damage: Left main landing gear and local wing structure damaged

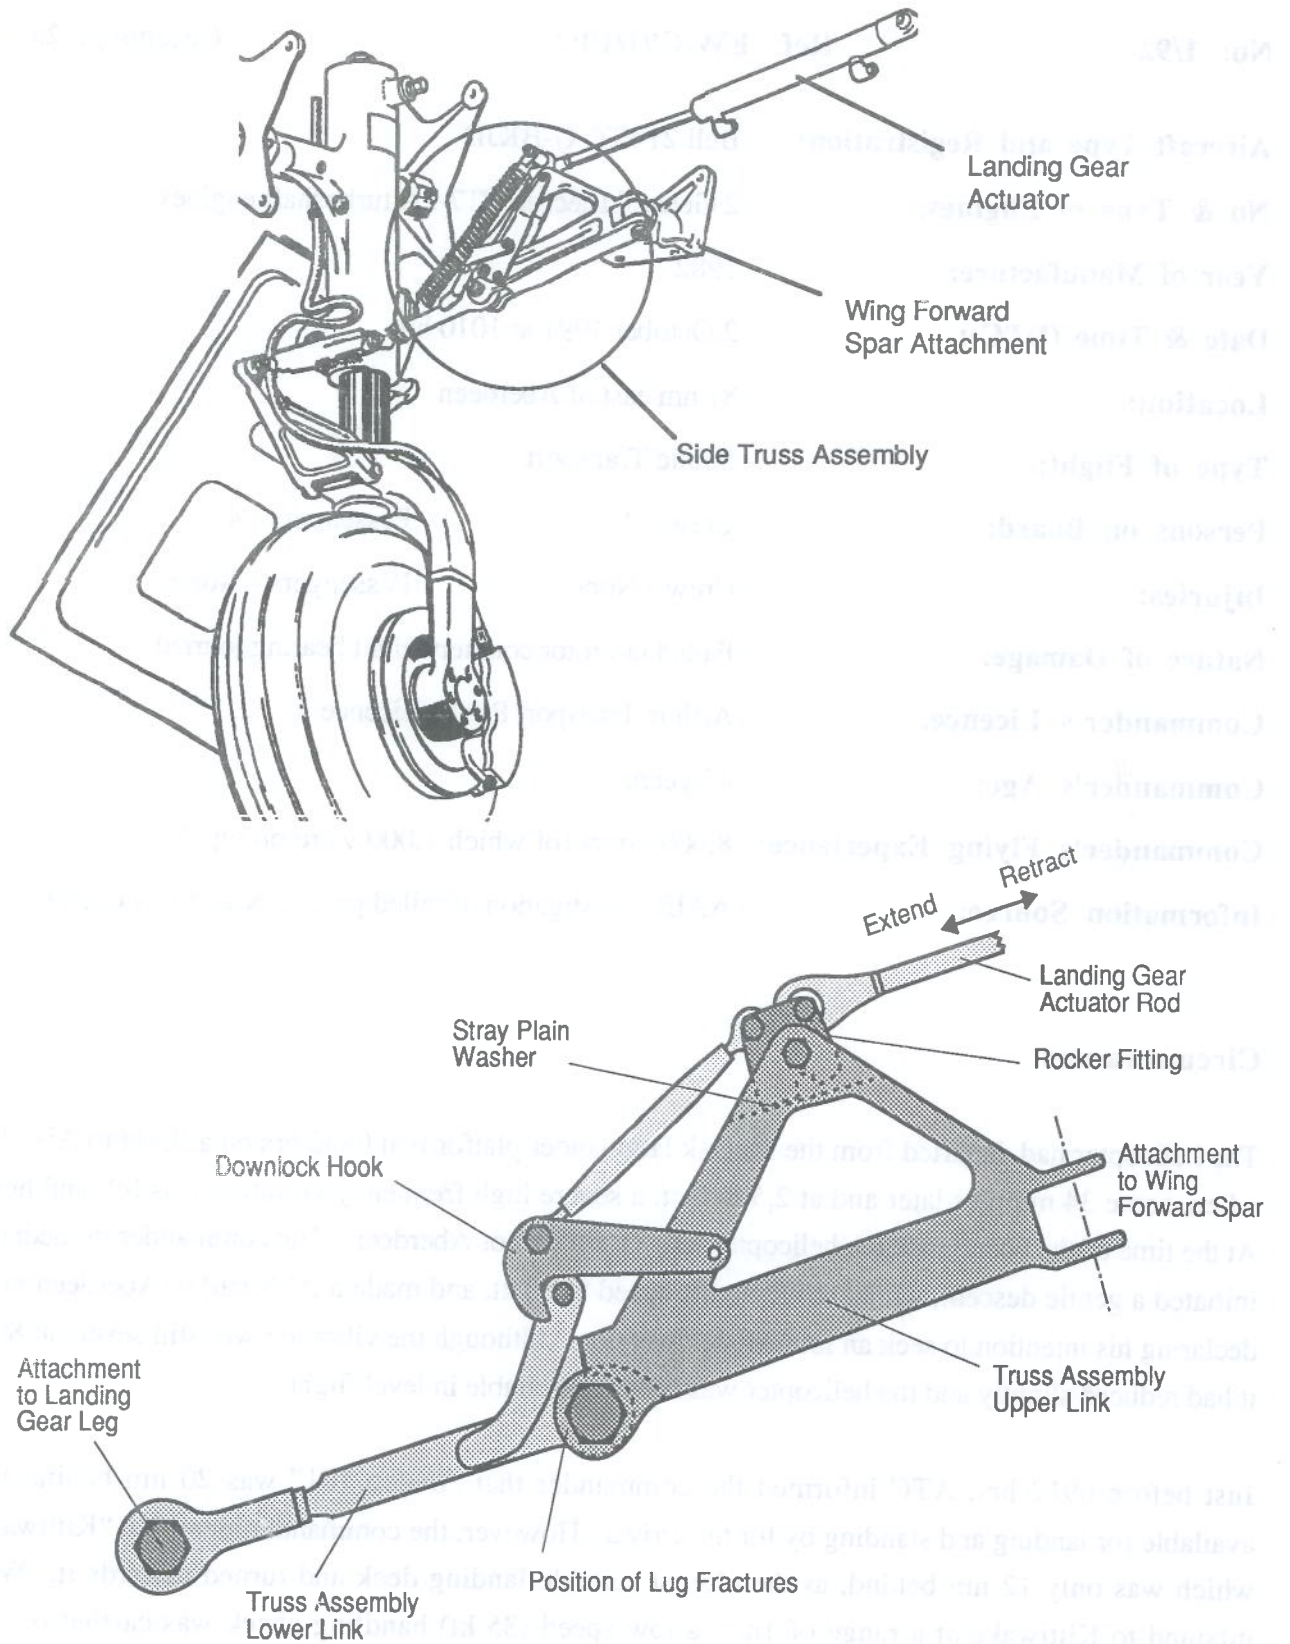
FIG 1

Aircraft damage was limited to the left main landing gear area and comprised fracture of the the landing gear truss assembly, crushing of the landing gear door, abrasion of part of the brake assembly, and local deformation of the wing rib forming the outboard wall of the landing gear bay.

The landing gear retracts and extends by pivoting of the leg on two trunnions about a fore and aft axis. Lateral bracing of the extended leg is by a truss assembly (Fig 1), comprising an upper link attached to a pivot on the wing forward spar and connected by a pivot bolt to a lower link attached to a pivot on the leg. The truss assembly overcentres when the leg is locked down and is retained overcentred by a hook that is carried on the upper link and engages with spigots on the lower link, and in the locked-down condition a large spring acts to maintain the truss assembly overcentred and to keep the hook engaged. The truss assembly and the hook are driven by a landing gear operating actuator that acts on a rocker fitting, pivoted on the upper link.

Examination of G-BARB showed that both outboard lugs of the truss assembly upper link had fractured in two places, allowing the link to separate from the pivot bolt connecting the upper and lower links and the leg to pivot outwards. Deformation of the link adjacent to the failures was clearly indicative of an overload condition in the truss assembly, in the mainwheel outboard sense, and inspection by a materials specialist revealed no signs of pre-existing cracking or material defect and concluded that the failure had resulted from overload.
