No: 7/92

Ref: EW/C92/2/3

Aircraft Type and Registration: Cessna 172N Skyhawk, N9998E
No & Type of Engines: 1 Lycoming O-320-H2AD piston engine
Year of Manufacture: 1979
Date & Time (UTC): 15 February 1992 at 1838 hrs
Location: West Thurrock, Essex
Type of Flight: Private
Persons on Board: Crew - 1 Passengers - 3
Injuries: Crew - Serious Passengers - 2 fatal, 1 serious
Nature of Damage: Aircraft destroyed - minor damage to electricity power lines
Commander's Licence: Commercial Pilot's Licence (USA)
Commander's Age: 24 years
Commander's Flying Experience: 302 hours (170 on Cessna single engine variants)
Information Source: AAIB Field Investigation

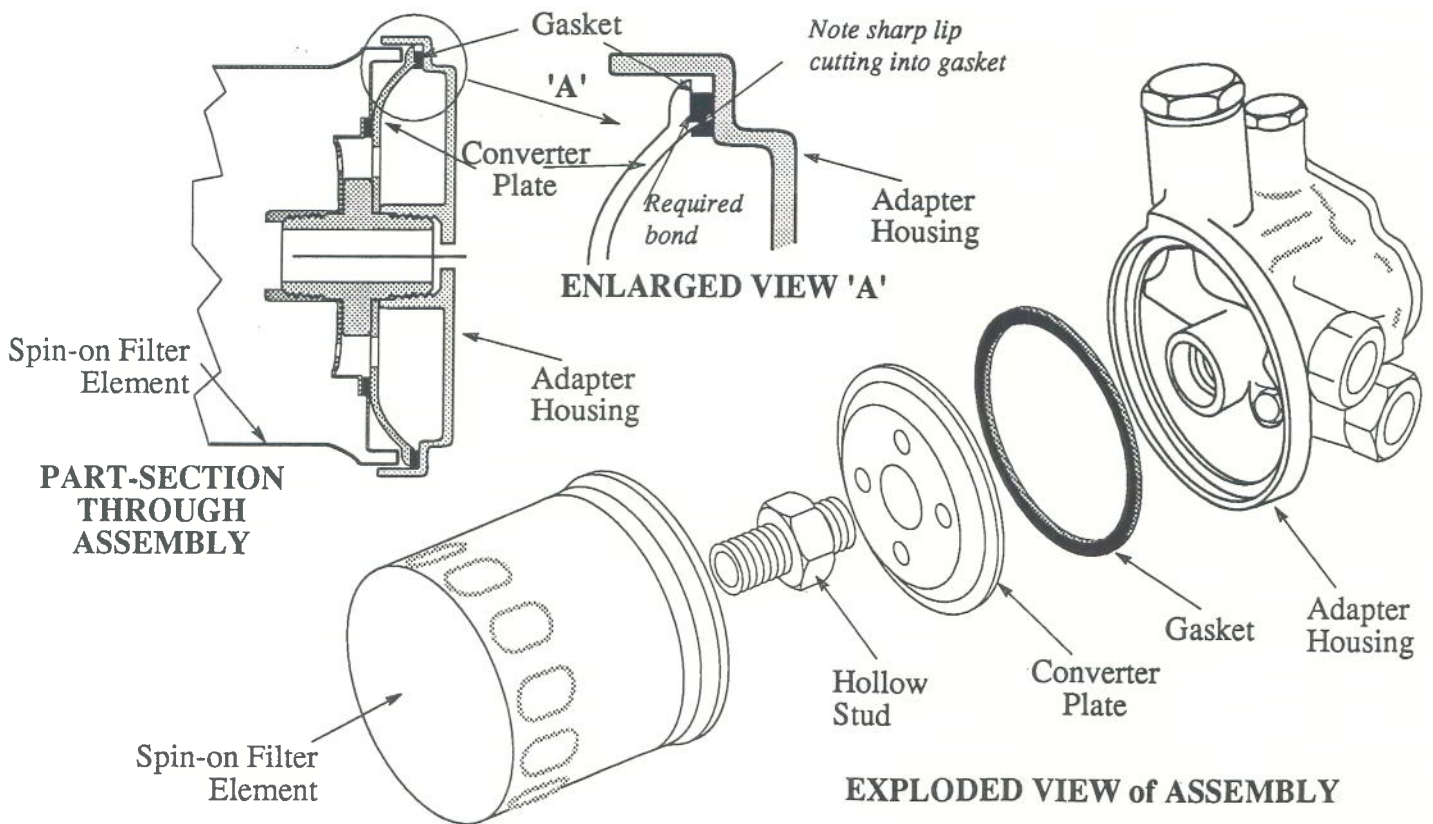
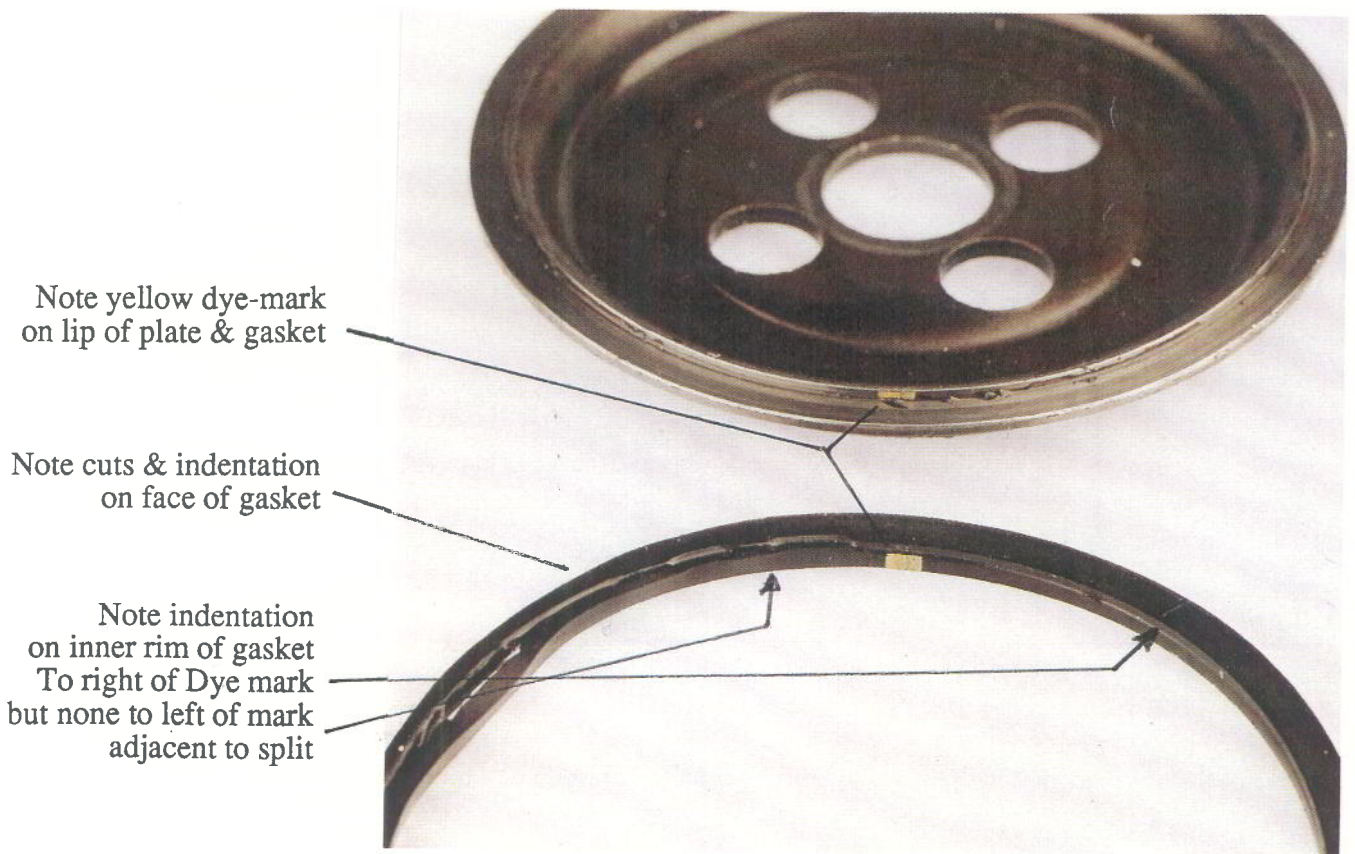
Oil Filter Assembly

Examination of the engine oil filter (which was of the 'spin-on', disposable type) revealed that an oil seal gasket on the filter mounting had 'split'. Since this seal is designed to contain the pressurised oil, this split would have allowed the oil to leak away steadily. Close examination of the engine cowling and firewall bulkhead showed that there was a greater, though not severe, 'oiliness' of the structure and components in the area of the filter and immediately below it. The filter, as installed on the engine,

Detailed examination of this sealing gasket revealed evidence that it had been fitted as a replacement for a previous seal at some time during the aircraft's life. It could be identified as a replacement by the presence of a dye marking on the inner rim, and it should have been bonded to the converter plate before being fitted to the engine. On disassembly of the filter there was no evidence of a bonding agent having been used to attach the gasket to the converter plate.

If the gasket is fitted without being bonded to the plate, gravity will tend to distort the gasket into an 'oval shape' because of the orientation of the filter housing. Witness impressions on the seal showed that it was incorrectly positioned at the time of the accident and that the way in which it was seated had not altered since it had been installed (see illustrations). This error in the way in which the seal had been fitted would not have been visible immediately after its installation had been completed; nor would it have resulted in an oil leak, the accepted indicator of satisfactory fitting. Subsequently, the error would not have been visible without dismantling the filter mounting assembly, which is not a normal procedure whilst changing the oil filter.

The result of this incorrect assembly had been to 'pinch' the seal between a sharp lip, normally used to locate the seal radially whilst bonding it to the converter plate, and the body of the filter mounting (see illustrations). This pinching had induced local tears in the seal which had been extended, by a mechanism with characteristics consistent with fatigue driven by the variations of oil pressure resulting from the engine being started and stopped, until one tear reached the free edge of the seal.

The gasket was not available as an individual spare part until fairly recently and so it had previously to be obtained already bonded to the converter plate. However, after it had been made available as a single part, service experience led the engine manufacturer to suspect that the bonding of the gasket to the converter plate was not always performed. The engine manufacturer therefore issued (in May 1991, when this aircraft was also in transit to Belgium from the USA) a Service Instruction, No. 1453, reiterating the required procedure for fitting a replacement gasket and recommending replacement of the oil converter plate at overhaul.
