**INCIDENT**

| <b>Aircraft Type and Registration:</b> | Avro 146-RJ100, G-CFAF | |
| <b>Date &amp; Time (UTC):</b> | 1 October 2004 at 1355 hrs | |
| <b>Location:</b> | Near Birmingham Airport, West Midlands | |

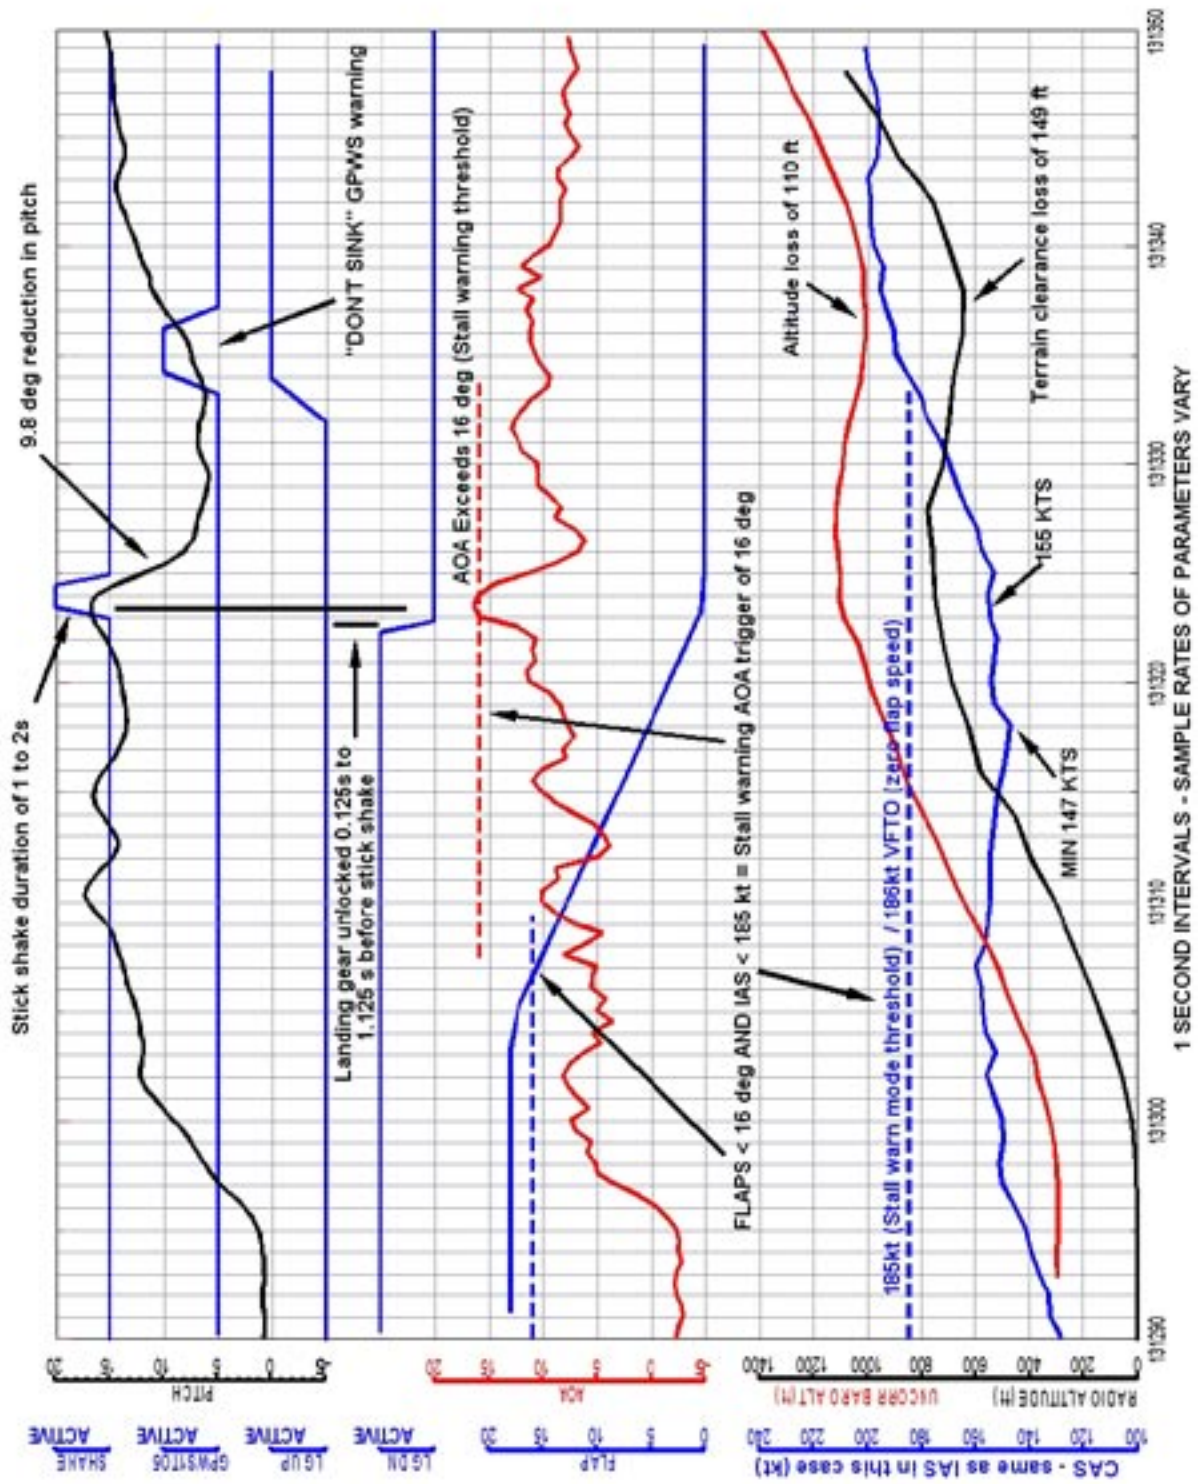
Figure 1

The flight data for the event is given in Figure 1.

- Flap retraction started 5 to 6 seconds after takeoff (defined as weight off wheels from all three gear squat switches) with a Computed Air Speed (CAS) of 157 kt.

- Flap retraction took between 18 and 22 seconds to complete.
- Approximately 23.5 seconds after takeoff the gear status changed from locked down to not locked down.

- Approximately 24 seconds after takeoff, between 0.125 and 1.125 seconds after the landing gear was unlocked from the down position, the stick shake warning was initiated. At this point, the CAS was between 154.5 kt and 155 kt, the altitude was approximately 800 ft AAL, the height was 750 ft AGL, the Angle Of Attack (AOA) was between 15.8 and 16.4 degrees, the flaps were still moving but were at less than 1 degree, the pitch attitude was 16.6 degrees nose up and the wings were within 0.5 degrees of level.

- The stick shaker operated for between 1 and 2 seconds when the design alert criteria were exceeded.

Key flight parameters  
 (Incident to G-CFAF on 1 October 2004 at Birmingham)

- After the stick shake, the pitch was reduced by 9.8 degrees over a period of approximately 6 seconds.
- Approximately 10 seconds after the onset of the stick shake warning, the aircraft reached the  $V_{FTO}$  of 186 kt and the Ground Proximity Warning System (GPWS) issued a mode 3 “Don’t Sink” alert.
- The altitude loss during the event was 110 ft, with a reduction in terrain clearance to 624 ft.
- The thrust levers were not moved during the event.
- There were very slight fluctuations in N1% on all four engines during flap retraction.
