AAIB Bulletin No: 9/94

Aircraft Type and Registration: Piper PA-28-161 Cherokee Warrior II, G-NINA

Date & Time (UTC): 31 May 1994 at 0855 hrs

Location: Near Blackbushe Airport, Hampshire

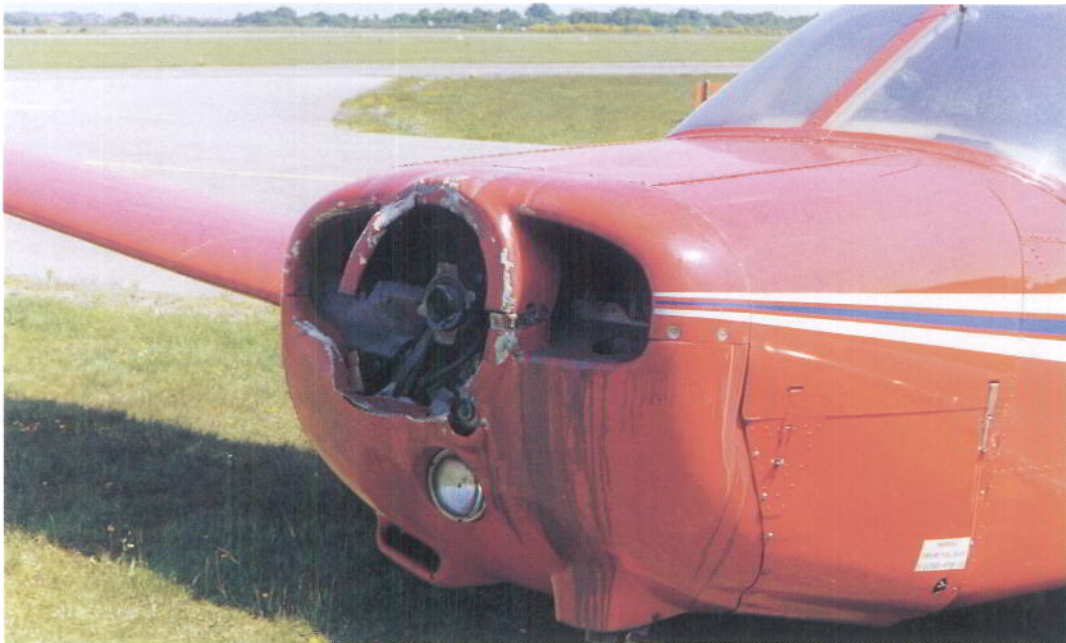
After landing, it was apparent that the propeller, which was of fixed-pitch, had separated at the forward end of the engine crankshaft, with some damage to the front end of the engine and to the engine cowlings (Figure 1). A copy of the radar recording from Heathrow was obtained from LATCC. Plotting these data, and using the timings from the ATC tape at Farnborough, it appeared that the propeller had become detached over Bramshill Plantation, near Eversley. This is a substantial area of dense conifers and it is unlikely that the propeller will be located until the timber is harvested.

Figure 1 - G-NINA at Blackbushe Airport

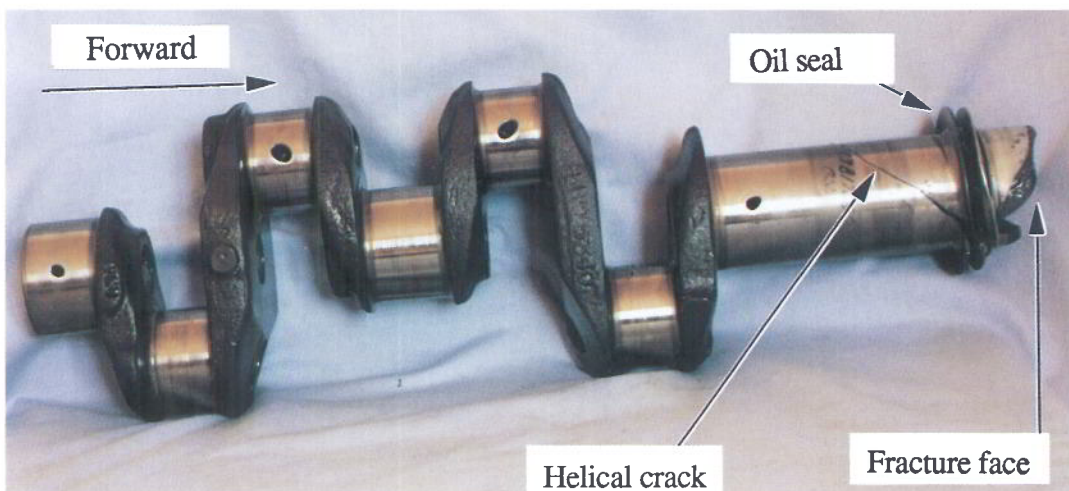
Detailed examination of the crankshaft showed that the fracture path was helical and had been caused by a torsional fatigue mechanism (Figures 2 and 3). The main crack had run rearwards (Figure 2) from the primary fatigue initiation region (shown as 'A' on Figure 3) towards one of the two holes drilled for the governor oil transfer tube; a smaller crack ran rearwards from the secondary initiation point (shown as 'B' on Figure 2). The primary initiation (A) was associated with a surface pit in the bore of the shaft whereas the secondary initiation (B) was on an undamaged area on the outer surface of the shaft. A large number of surface pits were found within the bore, some containing iron oxide, and it appeared that the pits were the result of long term corrosion.

Figure 2 - Crankshaft from G-NINA

Partly in response to the AAIB Safety Recommendation (94-7), on 21 July 1994 the CAA issued advance notice of 'CAA Additional Airworthiness Directive 006-07-94, Direct Drive Piston Engines with Hollow Forward Crankshaft, Crankshaft Corrosion Inspection', with an effective date of 15 August 1994. The two-part inspections detailed in the AD apply primarily to Textron Lycoming and Teledyne Continental engines fitted to fixed-pitch propellers and take place with the crankshaft in place. The outer surface of the forward crankshaft is inspected for cracks within 10 flight hours of the effective date and, within 50 flight hours (or six months), there is a dye penetrant inspection of the outer surface and an internal inspection of the crankshaft bore. For engines fitted to variable-pitch propellers, only the second (50 hour) part of the inspection is required, at the sooner of the next propeller removal or Airworthiness Notice No 75 inspection.

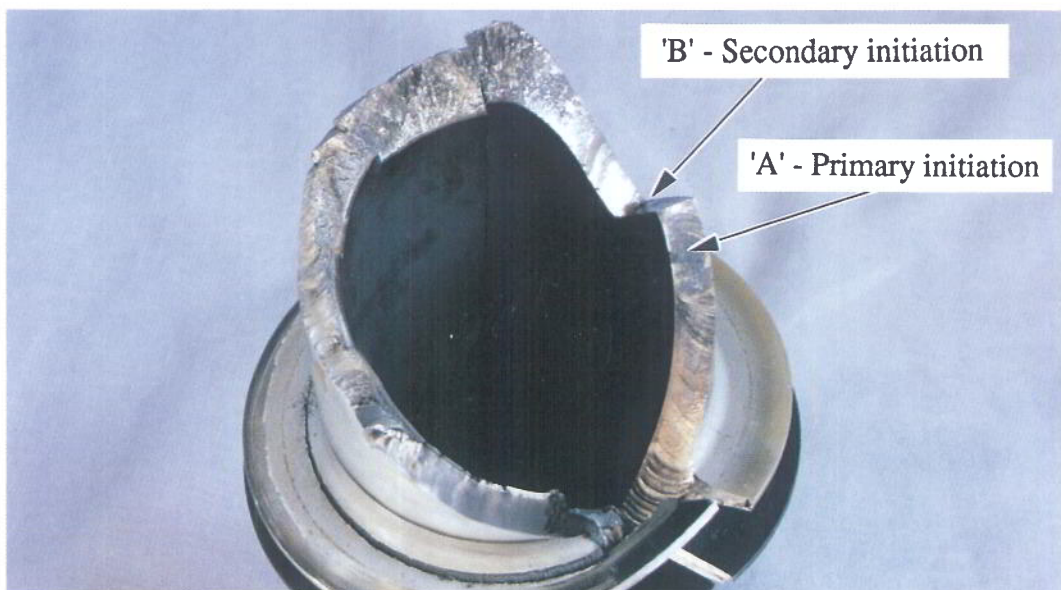
Figure 3 - Fracture face of crankshaft from G-NINA
