**ACCIDENT**

<b>Aircraft Type and Registration:</b>	Beech A36 Bonanza, G-CDJV	
<b>No &amp; Type of Engines:</b>	1 Continental Motors Corp IO-520-BA piston engine	
<b>Year of Manufacture:</b>	1976	
<b>Date &amp; Time (UTC):</b>	25 June 2008 at 1640 hrs	
<b>Location:</b>	Lydd Airport, Kent	
<b>Type of Flight:</b>	Private	
<b>Persons on Board:</b>	Crew - 1	Passengers - None
<b>Injuries:</b>	Crew - None	Passengers - N/A
<b>Nature of the Damage:</b>	Damage to left wing and landing gear door	
<b>Commander's Licence:</b>	Airline Transport Pilot's Licence	
<b>Commander's Age:</b>	53 years	
<b>Commander's Flying Experience:</b>	12,000 hours (of which 600 were on type) Last 90 days - 150 hours Last 28 days - 50 hours	
<b>Information Source:</b>	AAIB Field Investigation

**Synopsis**

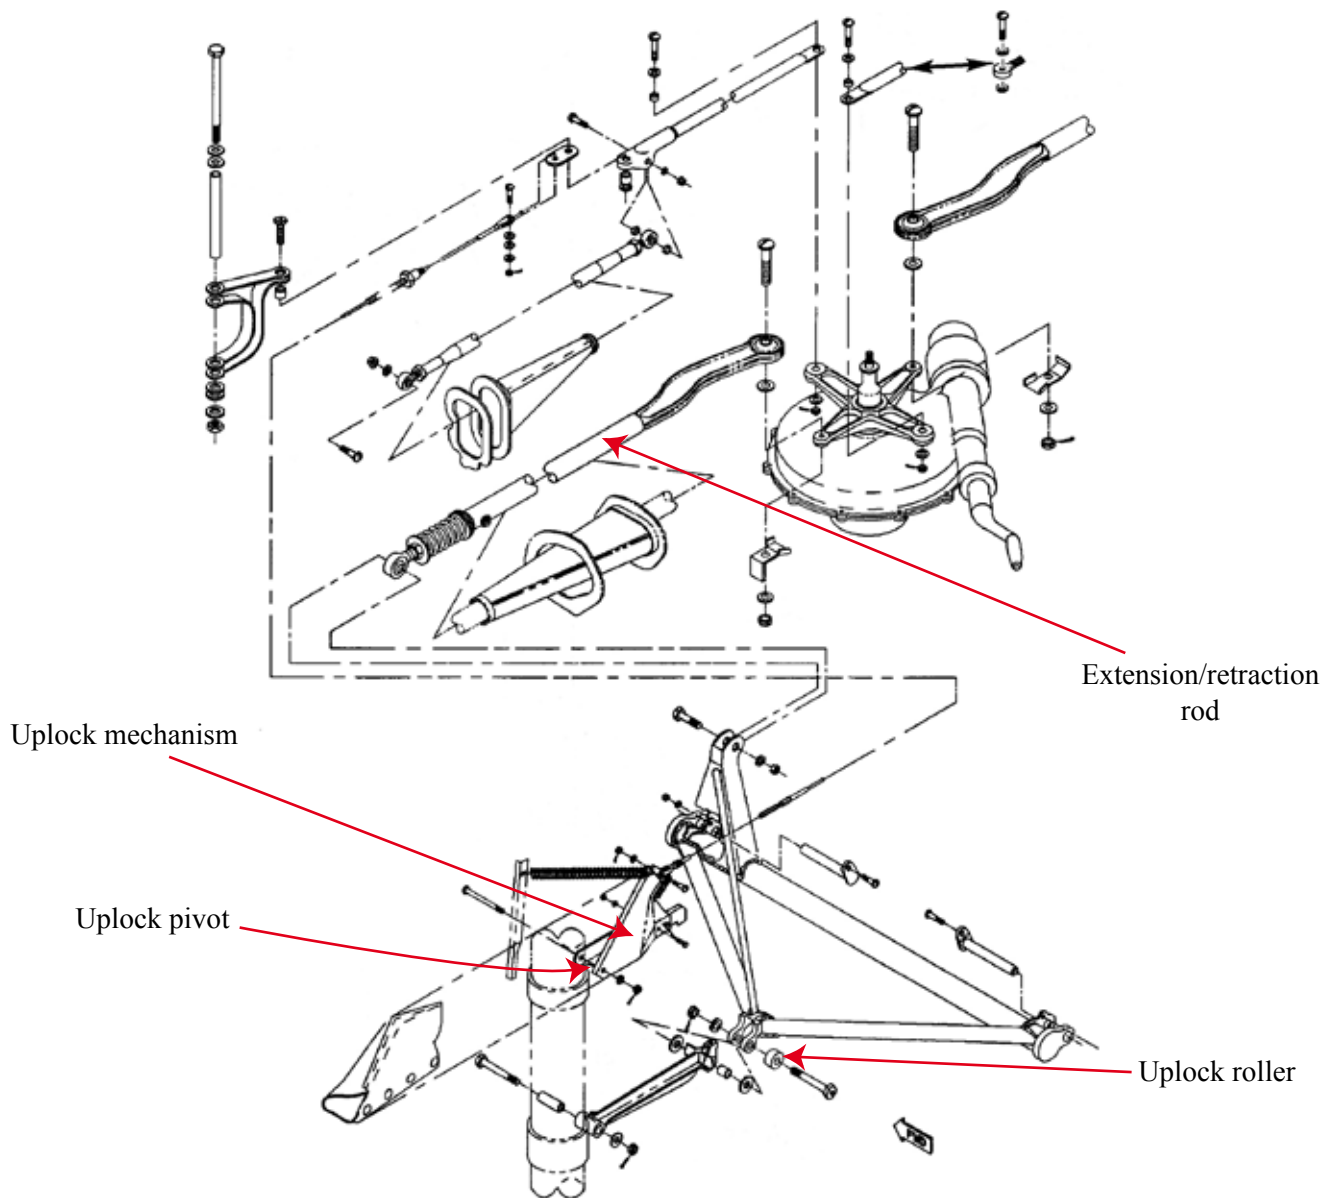
**Figure 1**  
Main Landing Gear Mechanism

and reported the problem to the resident maintenance organisation who, upon examination, found that the left landing gear extension/retraction rod (Figure 1) was bent in two places and the landing gear downlock was not engaged. The engineers were surprised that the left landing gear had not collapsed during the landing. The extension/retraction rod was replaced, the landing gear system inspected, retraction/extension cycles performed and no further fault was found.

Initial examination of the aircraft was carried out by the same maintenance organisation that had repaired the aircraft following the previous landing gear problem and they found that the replacement left landing gear extension/retraction rod had bent in an almost identical way to the previous rod. Further examination revealed that the landing gear lock mechanism (Figure 1) was not free to move around its pivot, due to corrosion and lack of lubrication and that the uplock roller was seized. Examination of the right landing gear revealed that the lock mechanism had restricted movement around its pivot and the uplock roller was very stiff to rotate. Both uplock rollers were of the latest standard, which incorporate grease points in the form of grease nipples.

The aircraft manufacturer, Hawker Beechcraft, has reviewed this accident and intends to include the uplock roller mechanism in the Pre-flight Inspection section of the A36 AFM.
